San Juan Mine Remediation and Restoration Study

July 1, 2025

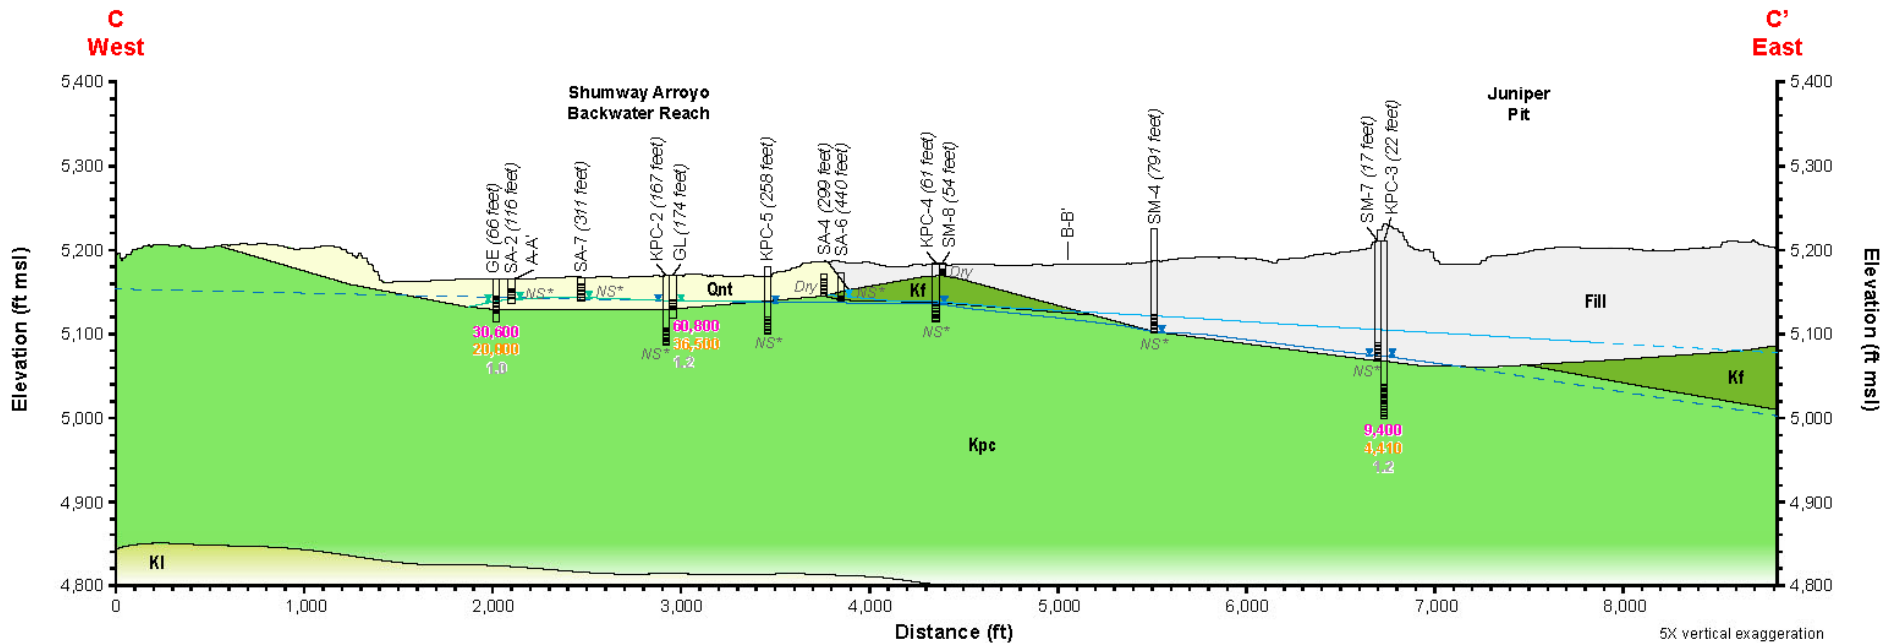
Hydrogeologic Cross Section

- Notes:
1. Water levels and chemistry values are from April 30 to June 26, 2024.
 2. **Bold** indicates that chemistry value exceeds the Section 3103 standard.
 3. Surface elevation data from July 2022.
 4. * Insufficient water to sample.
