**Shiprock Associated Schools Inc. Residential Program
Dormitory Construction Project
Shiprock, New Mexico**

**New Mexico Indian Affairs Committee
Funding for New Dormitory Construction
Presentation**

**September 24, 2013
12:30 p.m. to 1:00 p.m.**

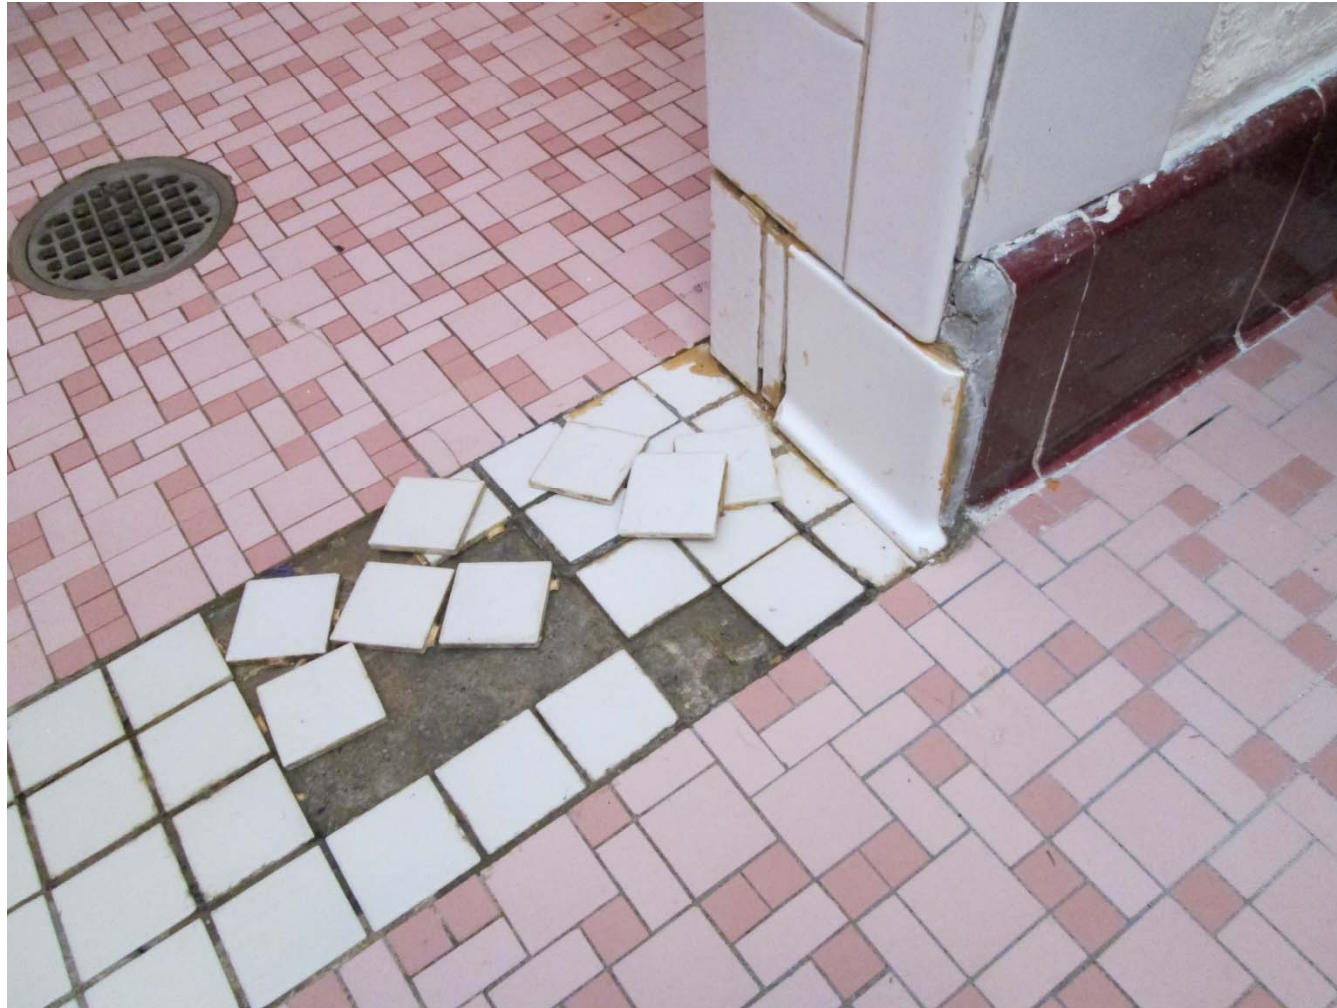
SASI Dormitory - floor tiles deteriorating, loose, male dormitory. Problem is common and Work Order made. Update photo 09/18/13.

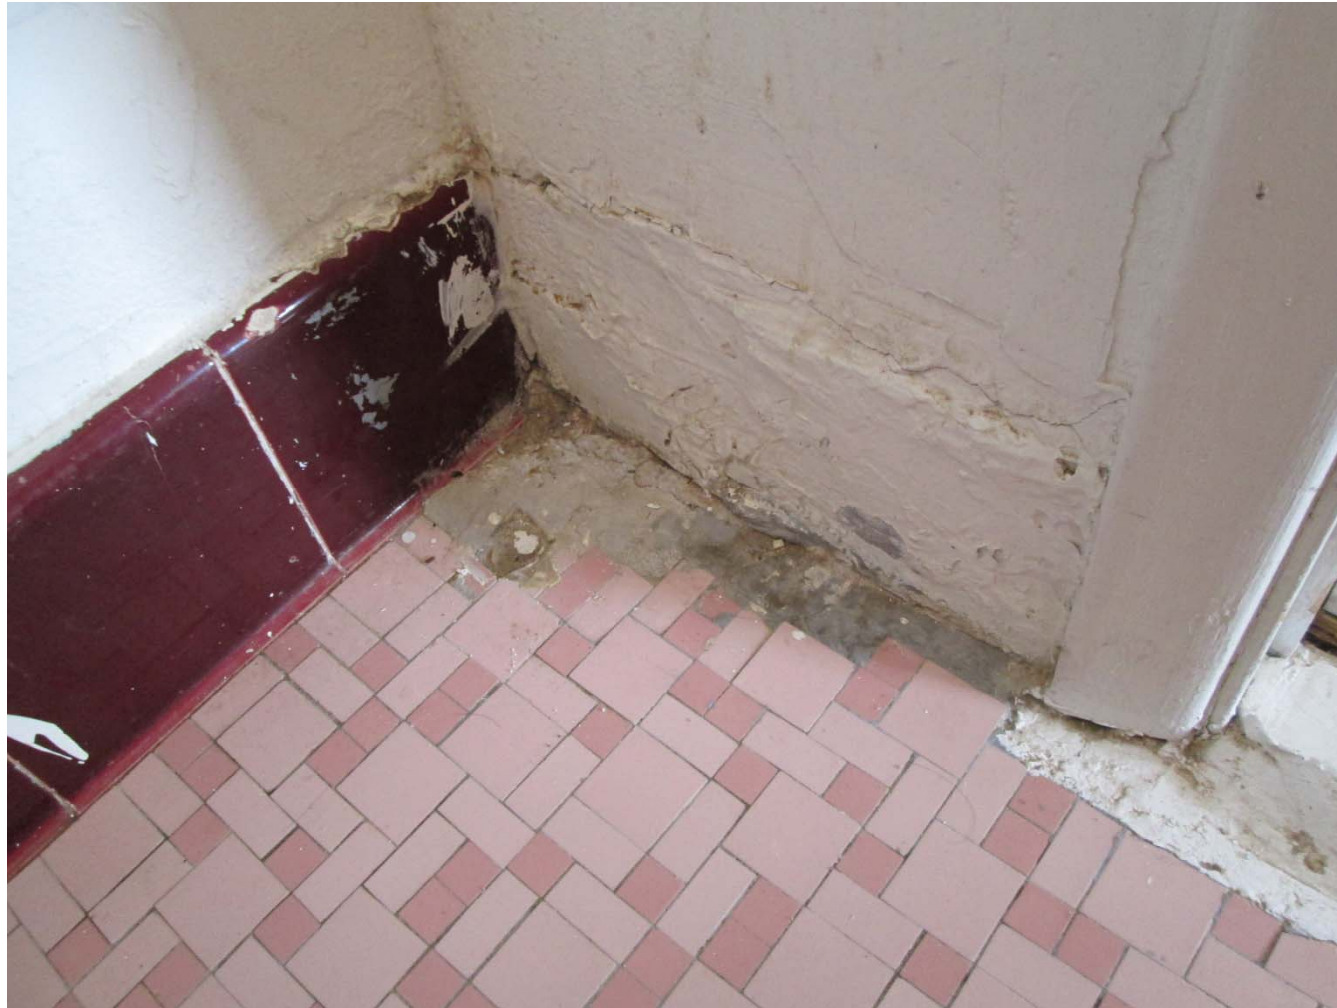
SASI Dormitory - student restrooms floor tiles missing. Common problem in several areas. Work Orders submitted to repair. Updated photo 09/18/13.

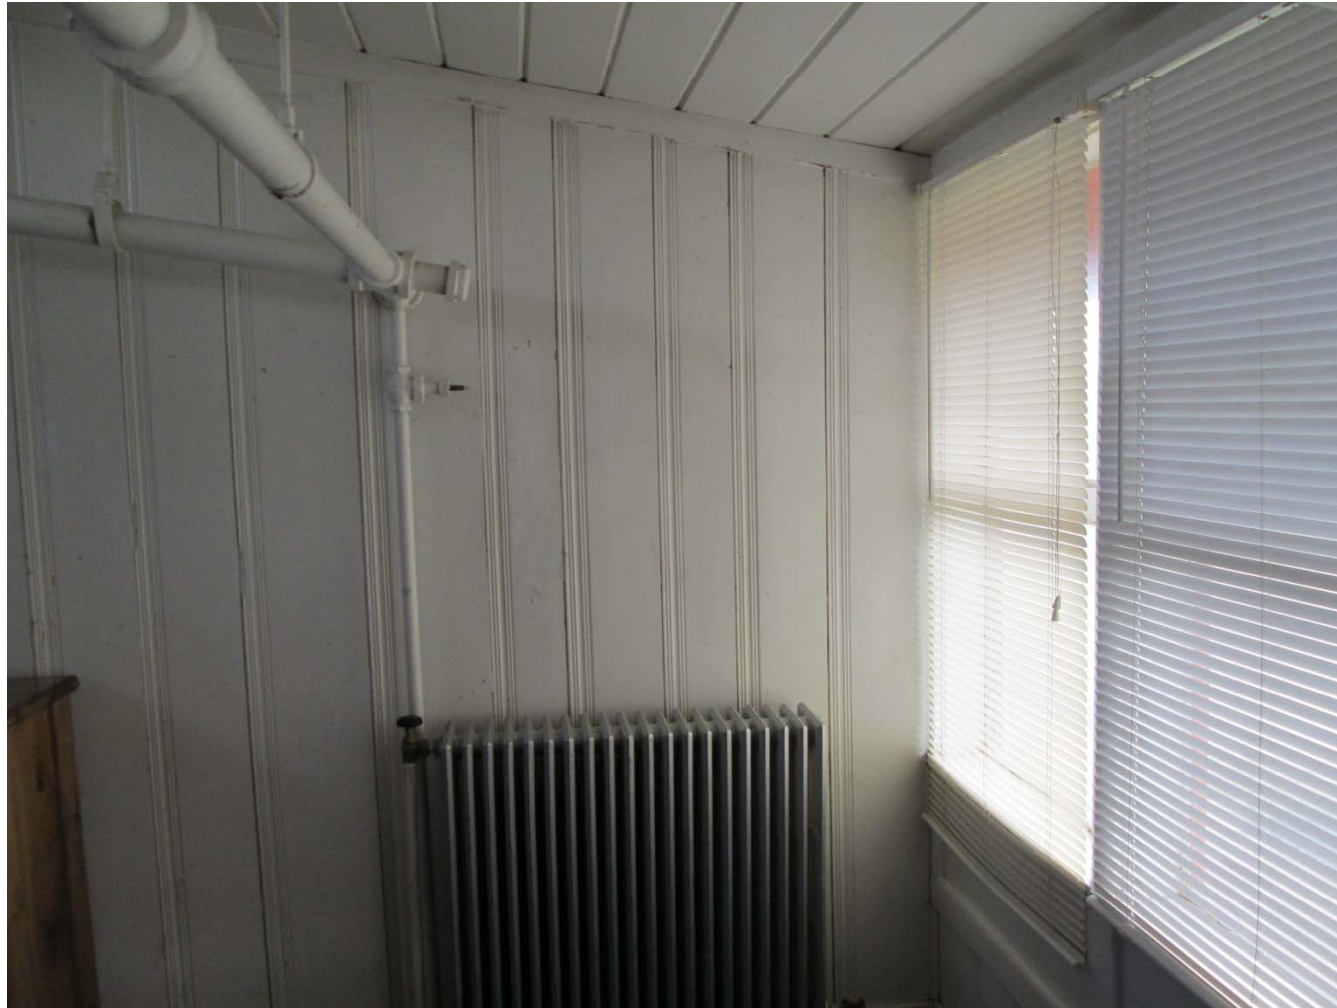
**SASI Dormitory student rooms. Radiator heaters, no thermostat.
Exposed water pipes in all student rooms. Gaps in wall and ceiling
need to be filled all rooms per Indian Health Service Reports.
Updated photo 09/18/13.**

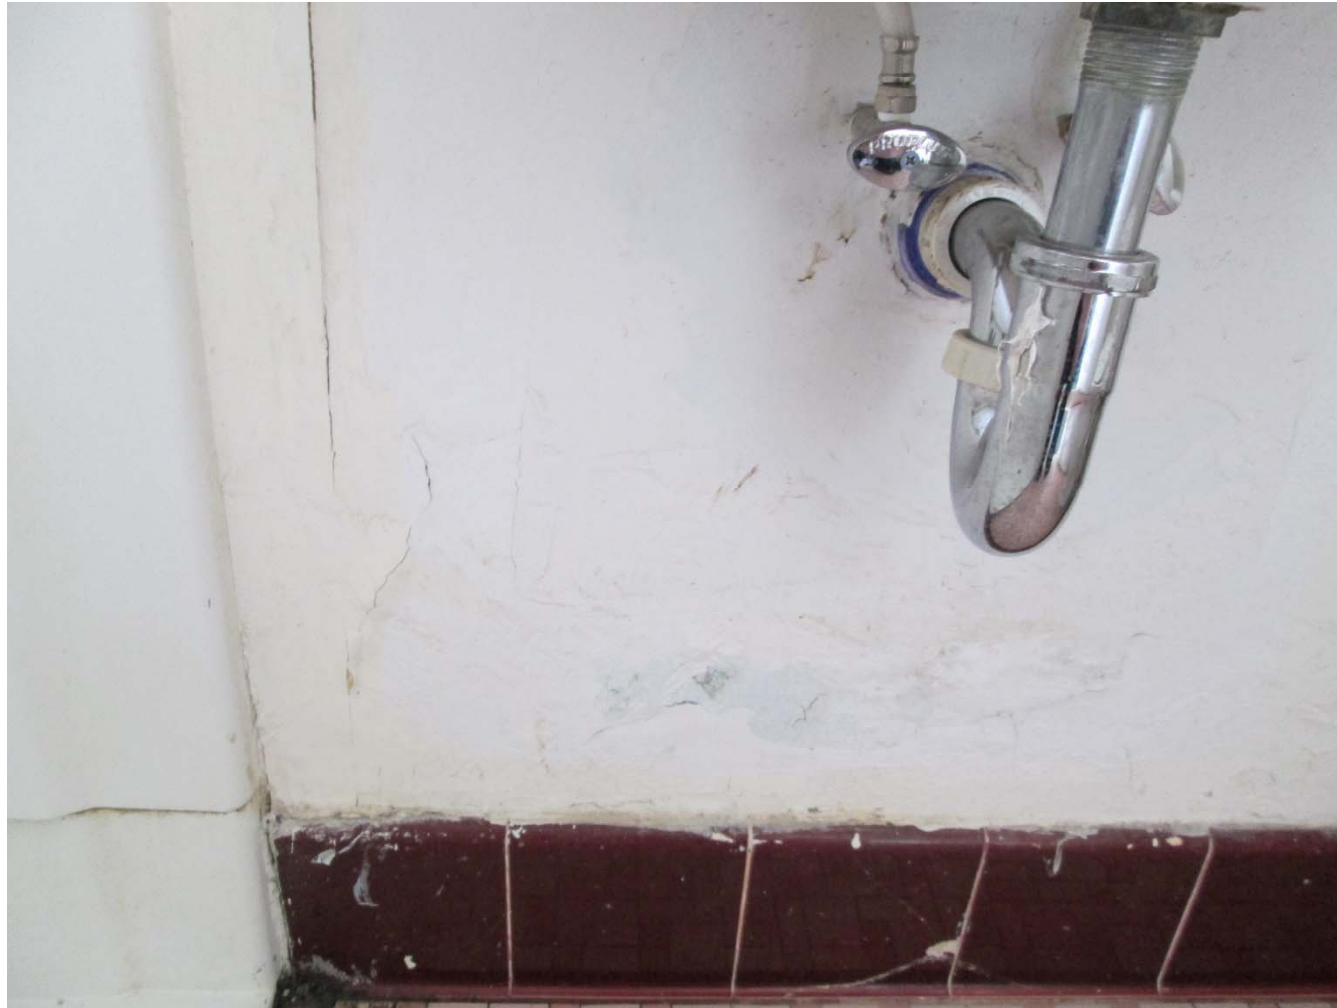
SASI Dormitory - Most restrooms walls underneath lavatory decomposing due to moisture. Constant repair with drywall and painting. Continuous repair as needed. Updated photo 09/18/13.

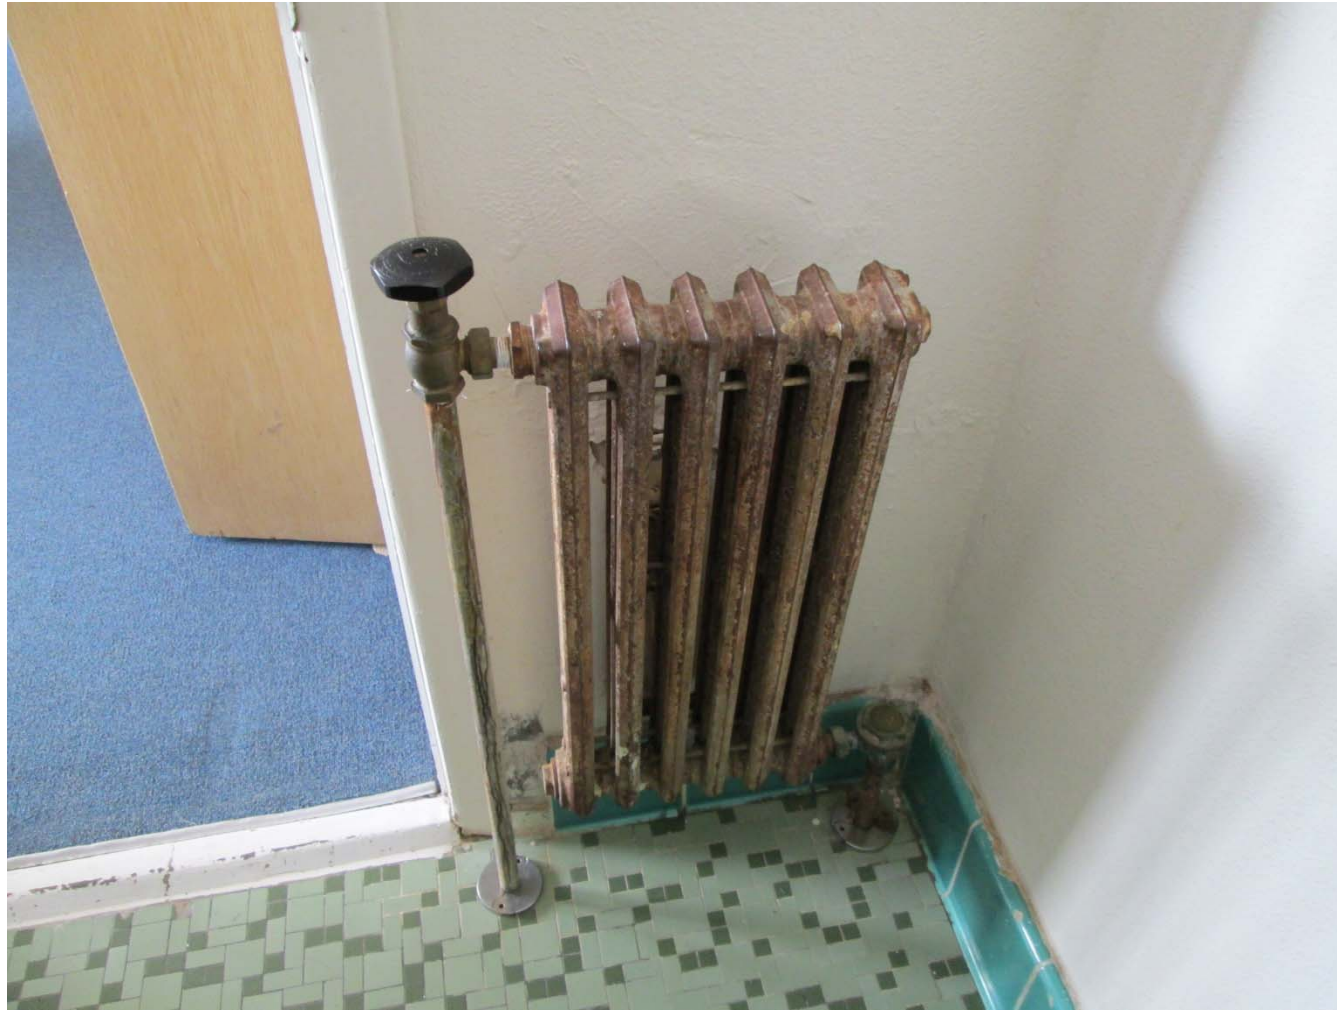
SASI Dormitory - Radiator heaters in student restrooms throughout dormitory. Heated by steam boilers. Rusty conditions. Knocking noises at night, no thermostats. Updated photo 09/18/13.

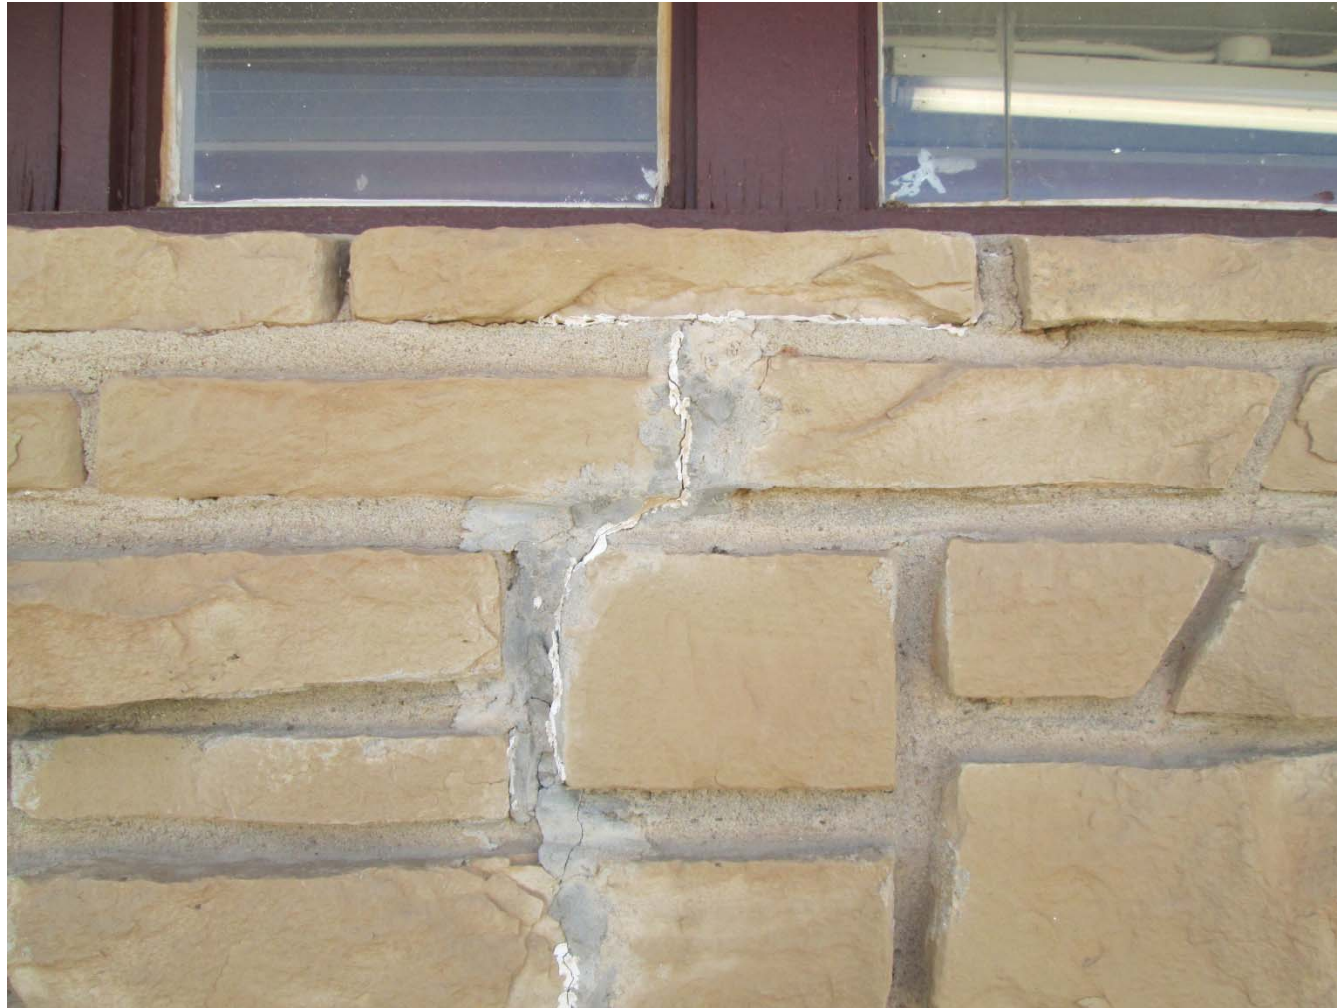
SASI Dormitory - Cracks common along exterior walls to the foundation. Water seeps through wall to the interior walls. All three dormitory buildings have cracks different areas. Updated photo 09/18/13.

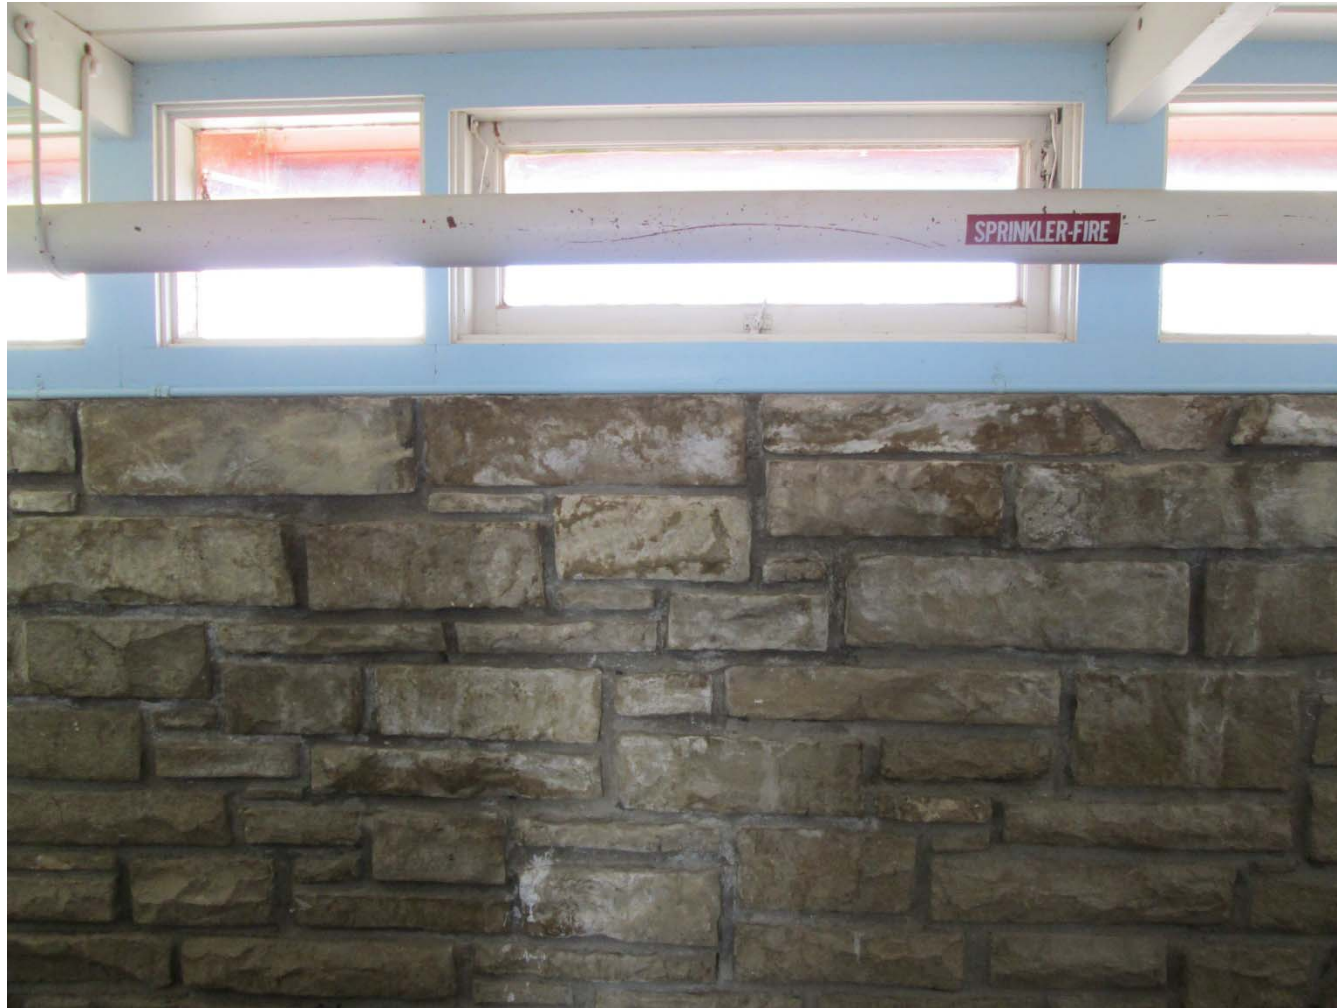
SASI Dormitory - Moisture from outside cracked walls to the interior wall. Cracks filled from outside as moisture barrier. Updated photo 09/18/13.

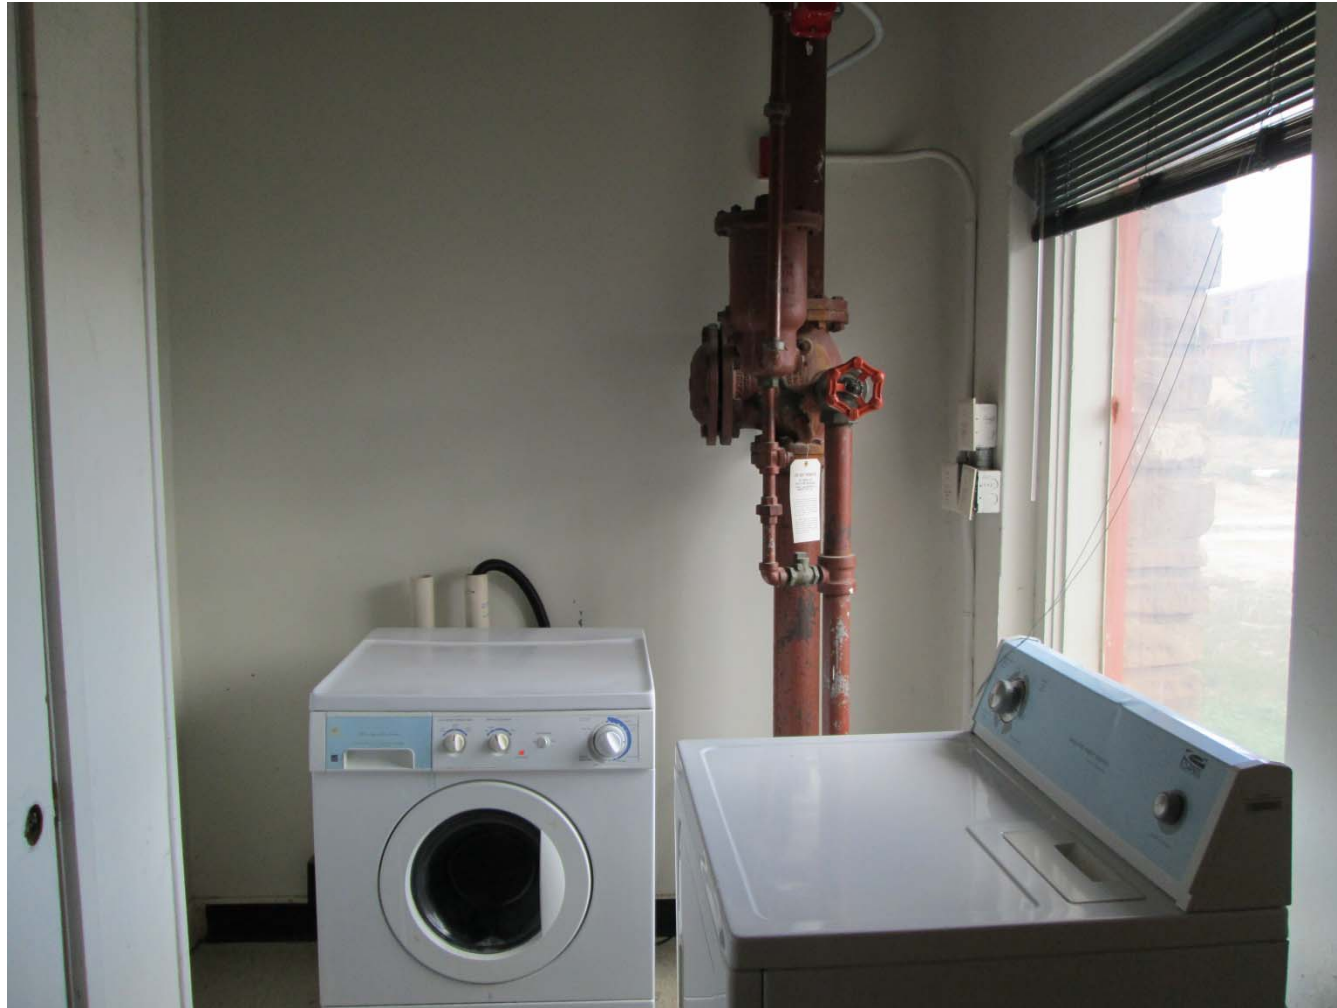
SASI – Dormitory exposed main water lines and valves in several areas of the dormitories. Note topical electrical conduits in the corner of the room. Updated photo 09/18/13.

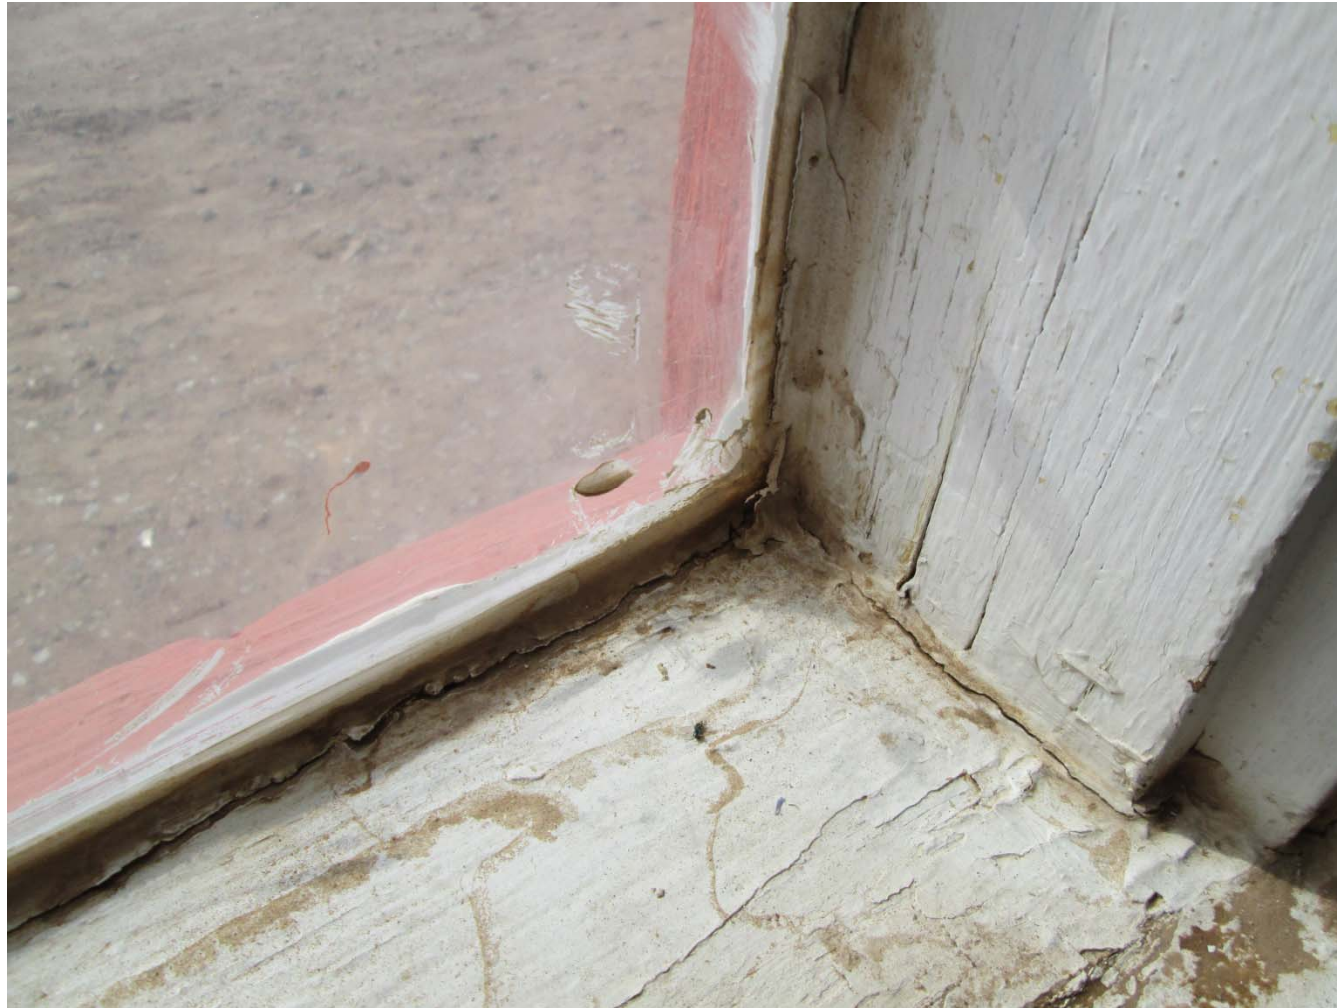
SASI Dormitory - Cracks along windows very common through out each dormitory. These are filled once a year. Weather damage from heat. Sand buildup during harsh windy days. Updated photo 09/18/13.

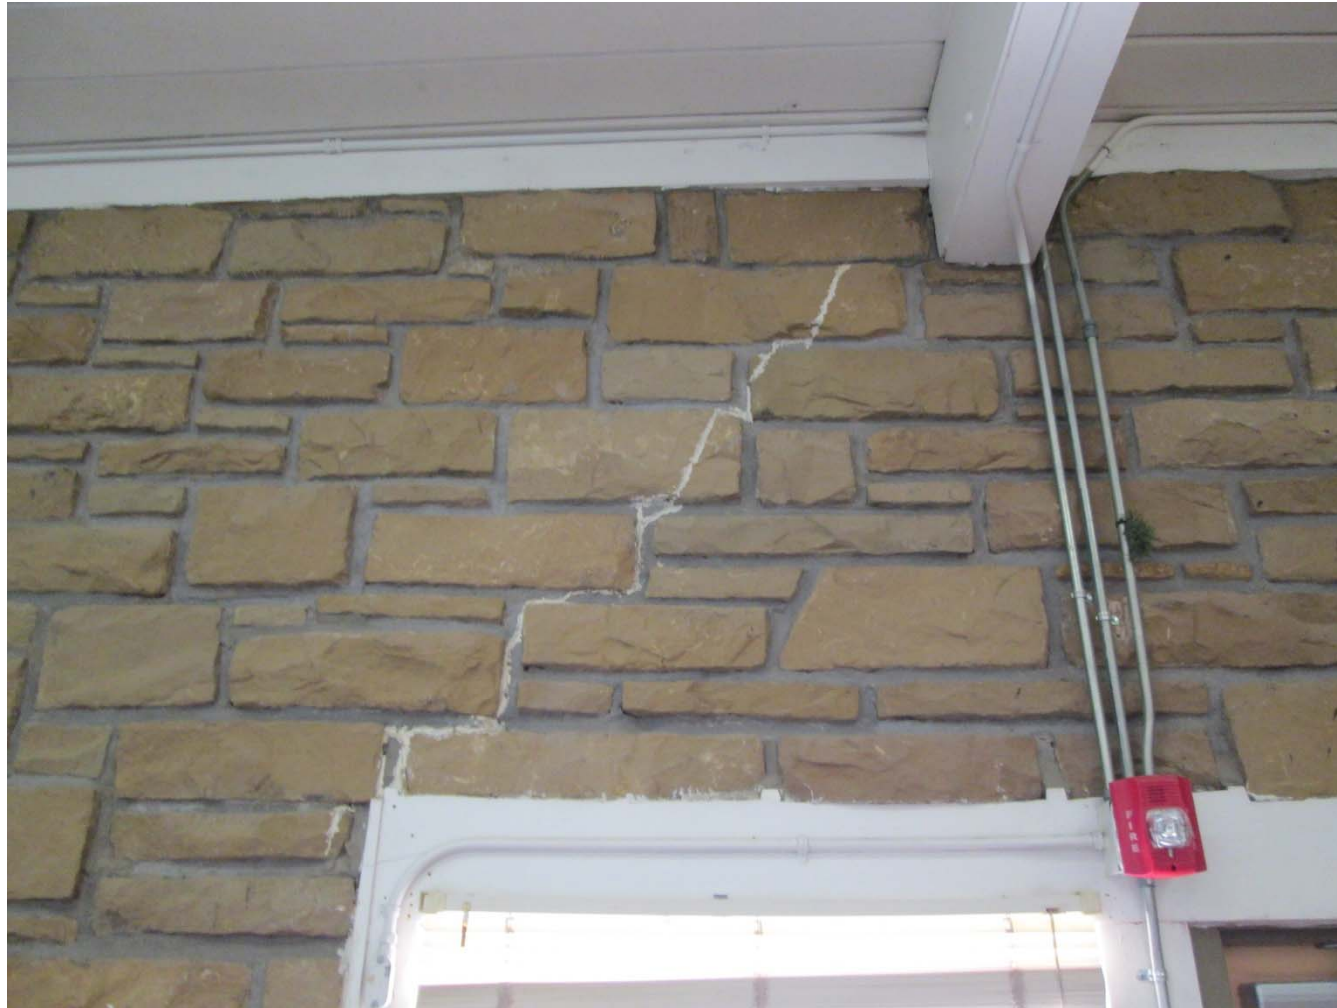
SASI Dormitory - Crack along the main exterior wall in two of the dormitories from the ceiling down to the floor .Patched. Note exposed outdated topical conduits for Fire Alarm System. Updated photo 09/18/13.

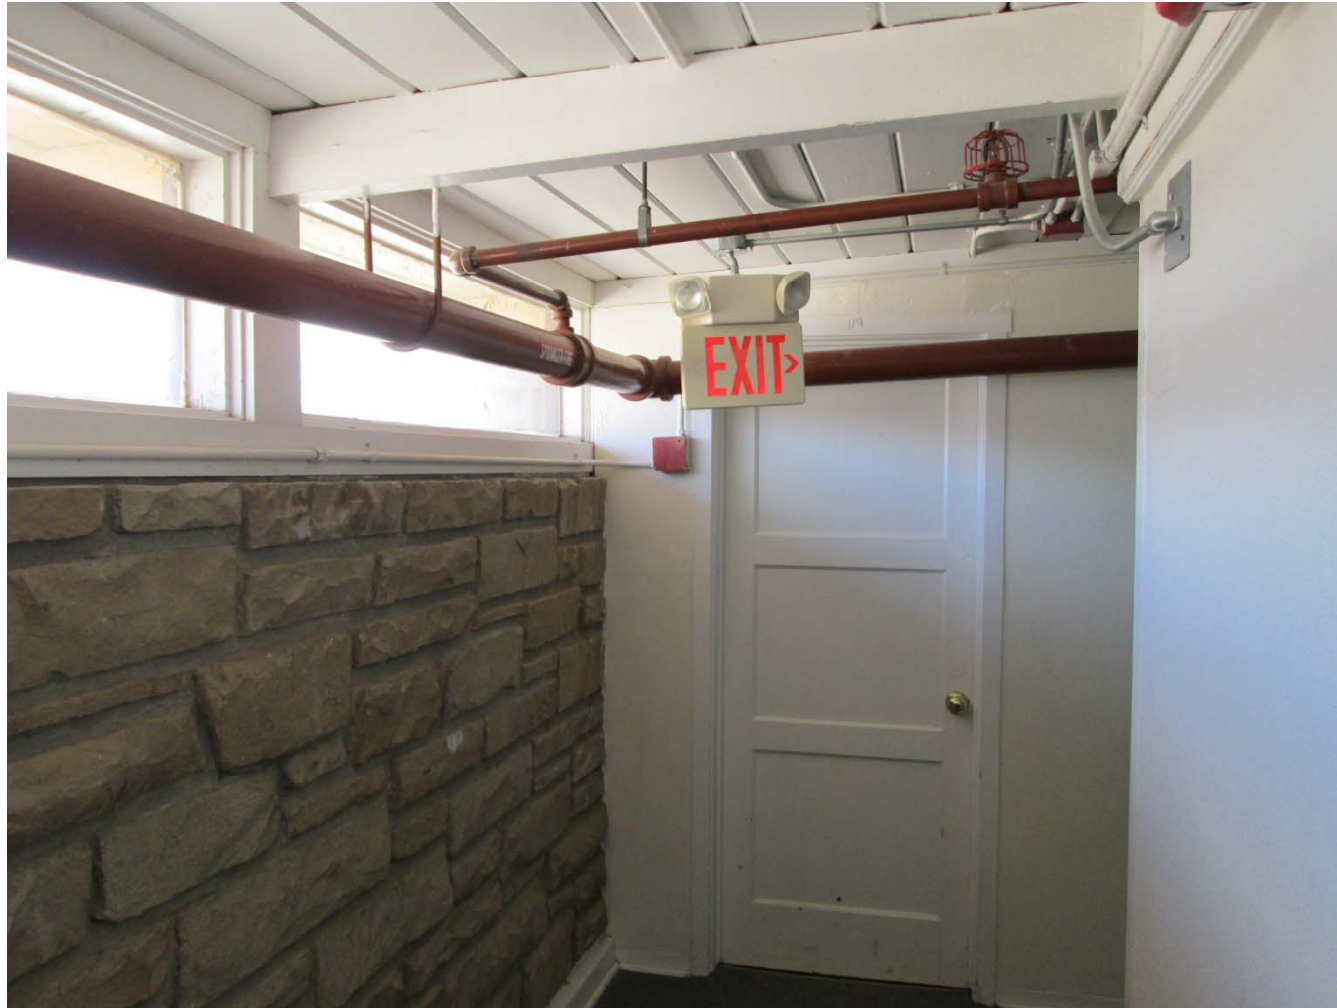
SASI Dormitory – Overhead water pipes common through out each of the three buildings. Plexi-glass windows. Exposed outdated conduits for electrical, Fire Alarm system, gaps in ceiling panels need to be filled per Indian Health Service Reports. Updated photo 09/18/13.
