**Indian Affairs Las Conchas Fire  
Talking Points  
For  
Governor Walter E. Dasheno  
Prepared by: J. Michael Chavarria  
Forest Development and Restoration Manager  
Santa Clara Pueblo Forestry Department  
November 1, 2011**

# POST LAS CONCHAS FIRE IMPACTS SANTA CLARA PUEBLO

## Fire Altered Hydrology for Santa Clara Creek

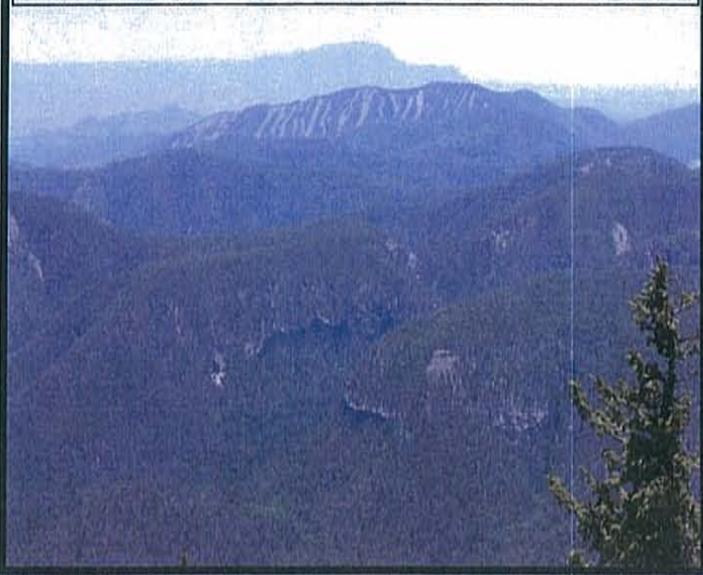
**Pre Fire Photo view is from Tsikumu Ping looking South towards the Pajarito Ski Basin**

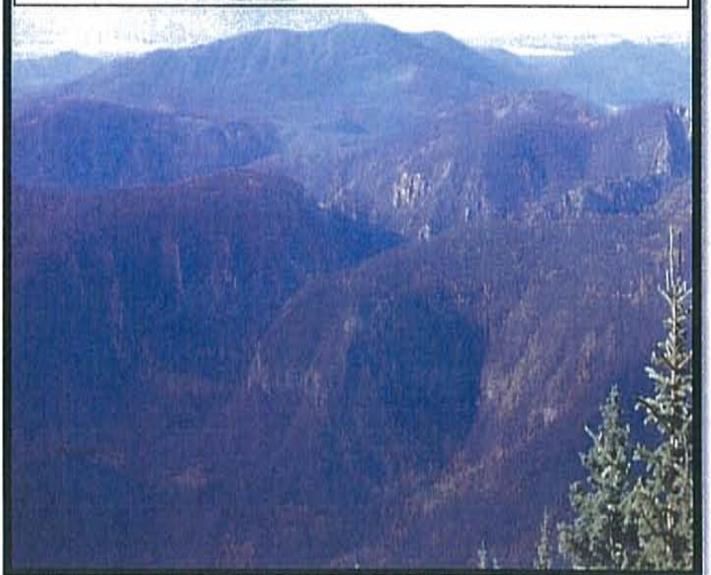
**Post Fire Photo view is from Tsikumu Ping looking South towards the Pajarito Ski Basin**

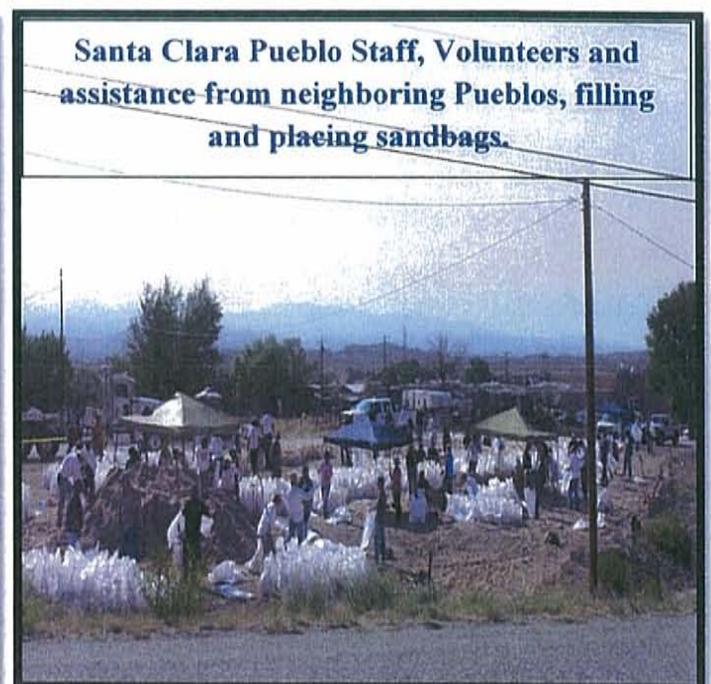
**Santa Clara Pueblo Staff, Volunteers and assistance from neighboring Pueblos, filling and placing sandbags.**

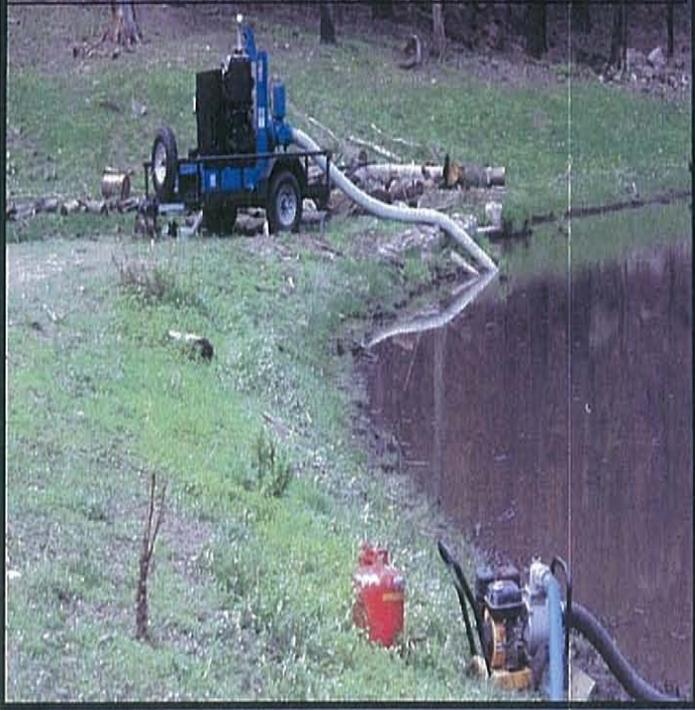
**Trash Pumps utilized to drain water control facilities**

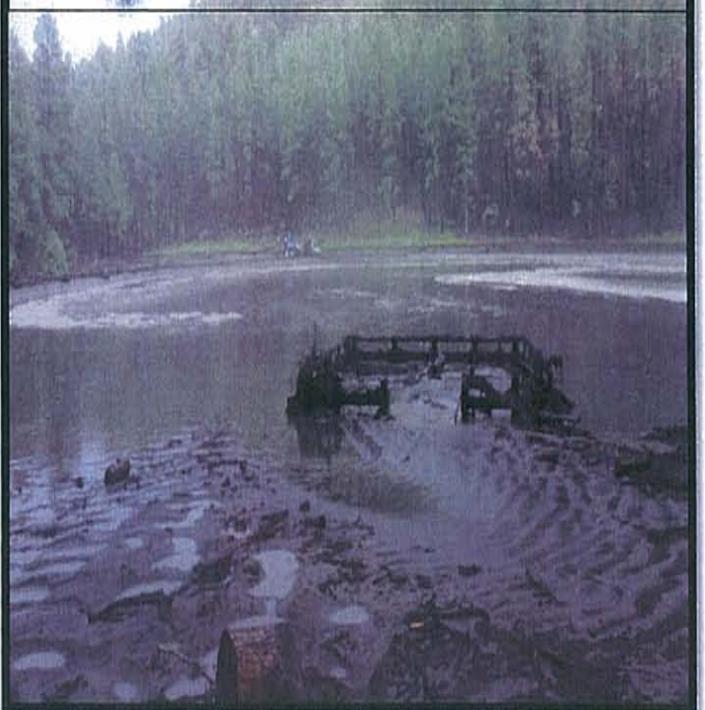
The Pueblo Forestry Staff, Public Works Department and Tribal Rangers had began the implementation of draining of the 1st water control facility utilizing two Trash Pumps, but were over powered by the forces of Mother Nature. Which was an estimated 1.3 tenths of an inch of rain event on August 21, 2011 that produced an estimated 1,700 cfs flood event. Currently the Four water control facilities are not adequately serving their purposes, because they are currently filled with sediment, wood debris, sand, mud, silt, boulders and gravel. (Working with FEMA on this issue - Debris Removal – Category A).

**View of Trash Pumps after 8-21-11 Flood event**

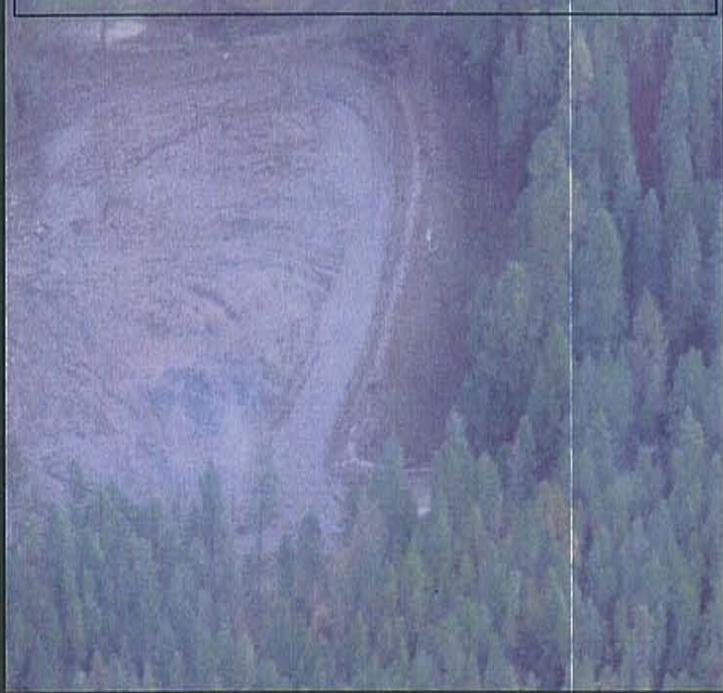
**Arial Photo of the 2<sup>nd</sup> water control facility after 8-21-11 flood event**

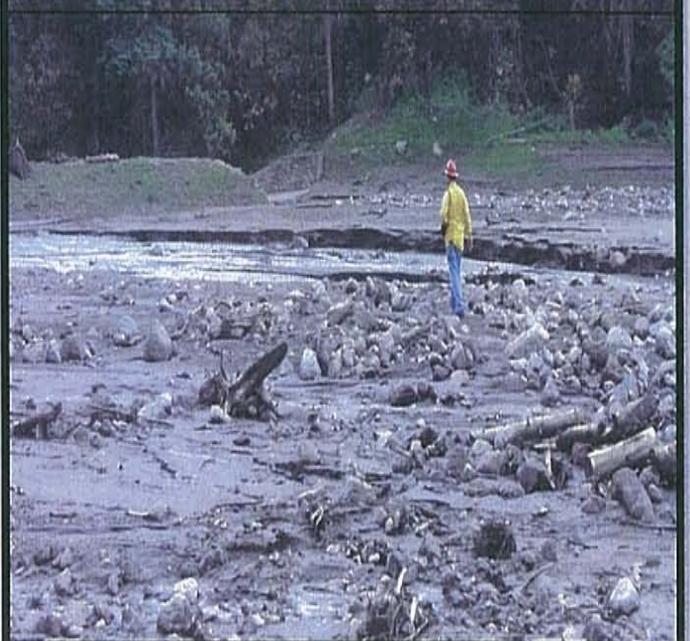
**On the ground assessment of the 2<sup>nd</sup> water control facility - full of sediment, woody debris, gravel, silt**

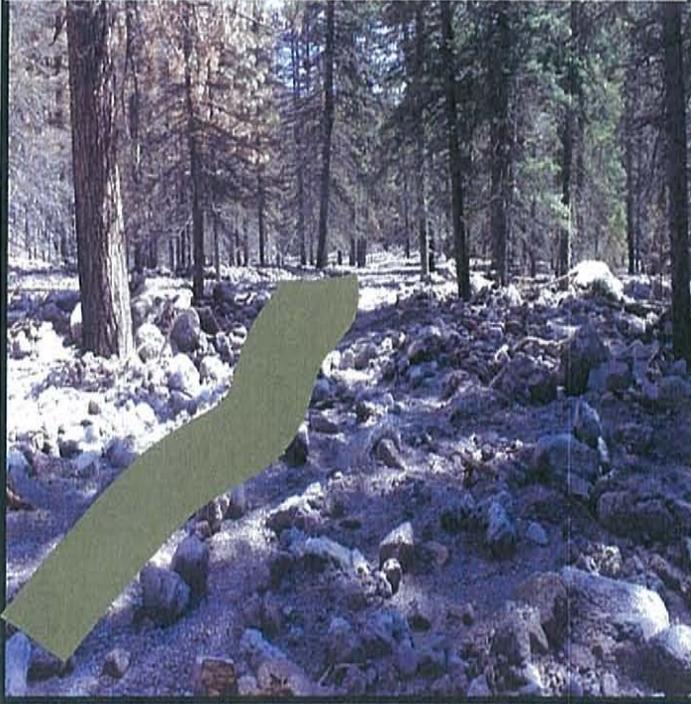
- Due to the Flooding events that the Pueblo has been experiencing, there is roughly 20.3 miles of road that has been damaged and destroyed. The Pueblo has recently completed a road project and the estimates to fix one mile of road equaled to roughly \$500,000 per mile to repair. Recent assessments have determined that the existing road may need to be abandoned and a new road may have to be created to reach the upper portions of the Santa Clara Canyon, which will escalate and inflate the cost of road construction.

**Road devastated by flood event.**

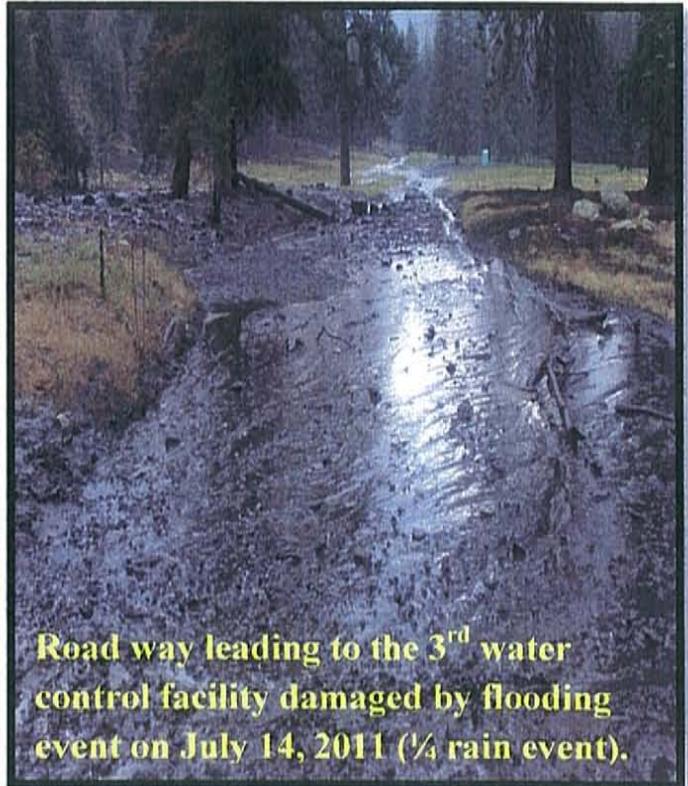
**Road way leading to the 3<sup>rd</sup> water control facility damaged by flooding event on July 14, 2011 (¼ rain event).**

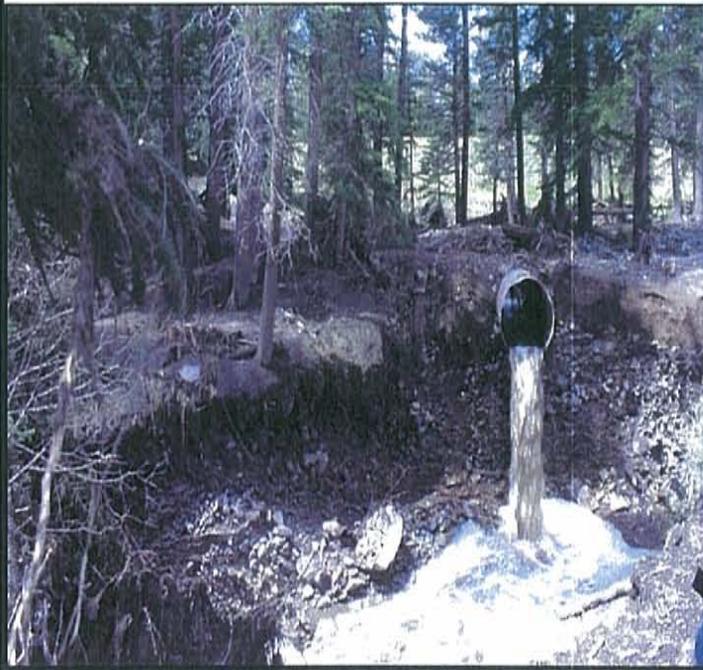
- Along with the damaged sustained to the roads there are roughly 40 culverts that have been impacted by the flooding events as well. The flooding events have altered the stream course and large amounts of floatable debris have clogged and ripped out many of the culverts.

**View of impacted Culvert from Aug. 21, 2011 Flood Event**

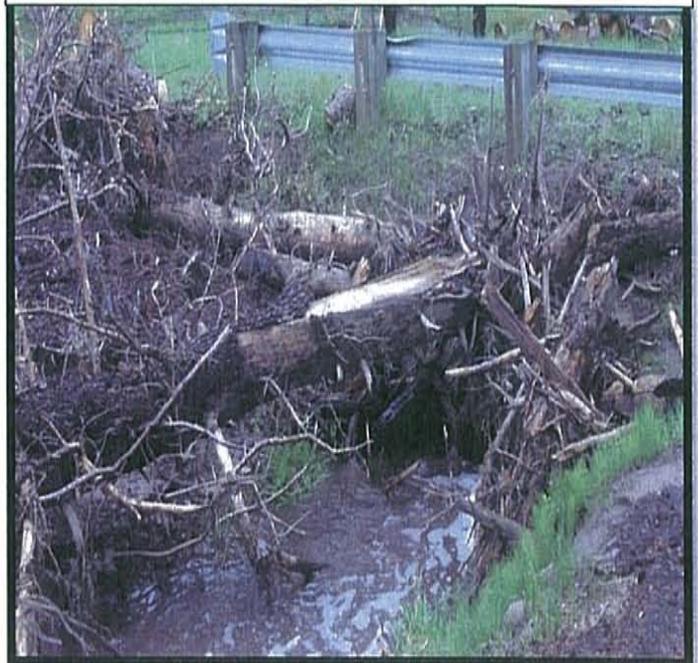
**An example of a culvert that is full of woody debris.**

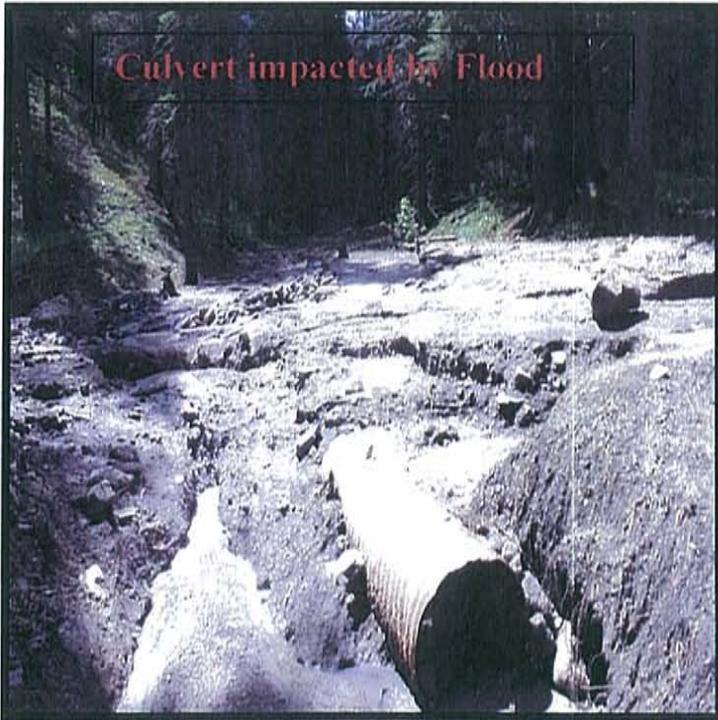
**Culvert impacted by Flood**

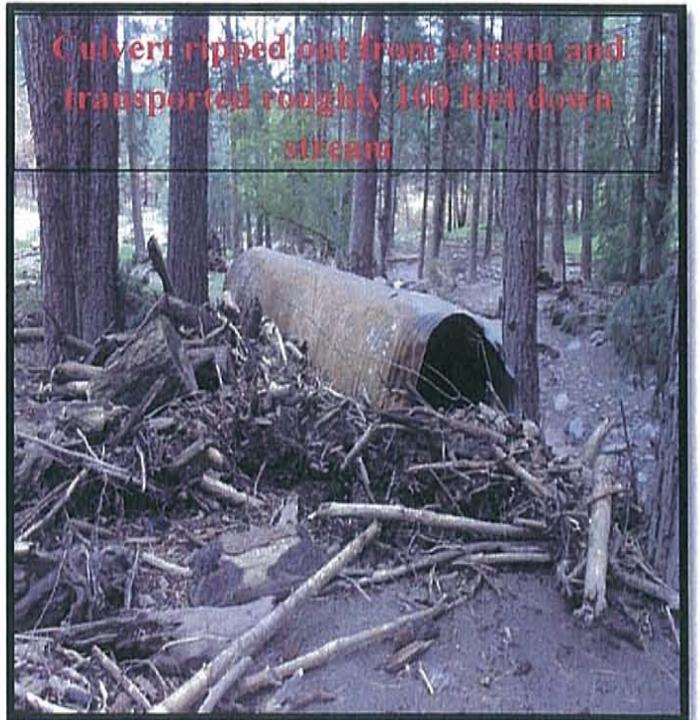
**Culvert ripped out from stream and transported roughly 100 feet down stream**

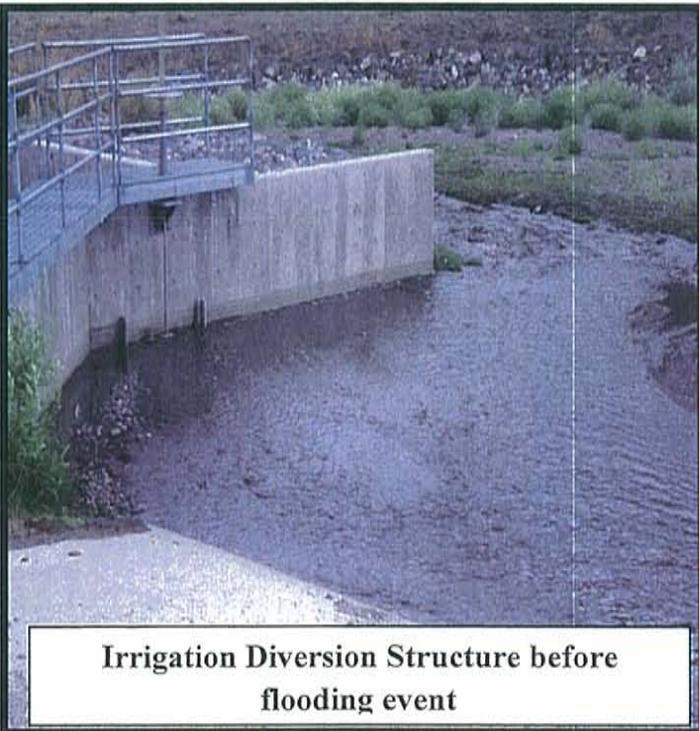
**Irrigation Diversion Structure before flooding event**

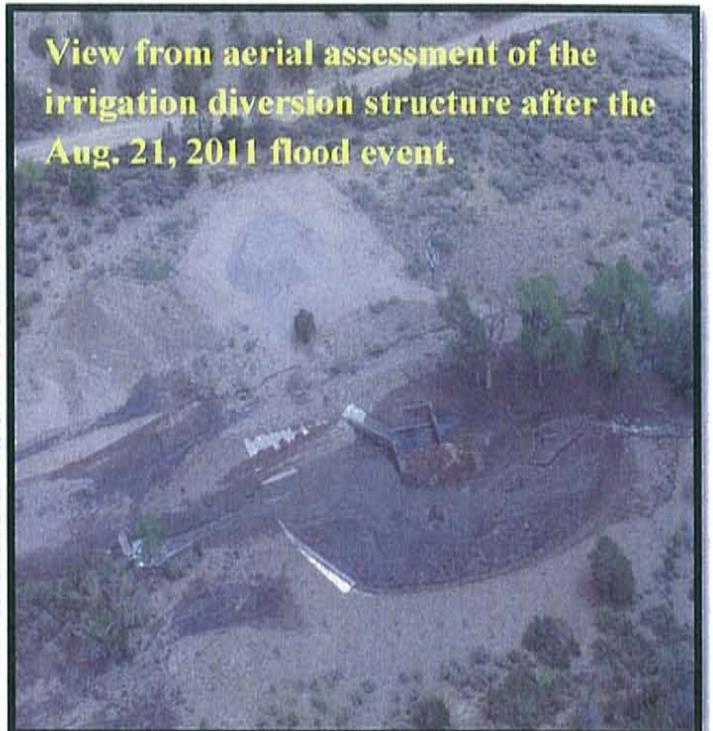
- The Pueblo constructed an irrigation diversion structure which has now been impacted by the flooding. The structure is currently full of sediment, woody debris, silt and gravel.

**View from aerial assessment of the irrigation diversion structure after the Aug. 21, 2011 flood event.**
