WIPP Recovery Update

Joe Franco, Manager
Carlsbad Field Office
U.S. Department of Energy

July 23, 2014

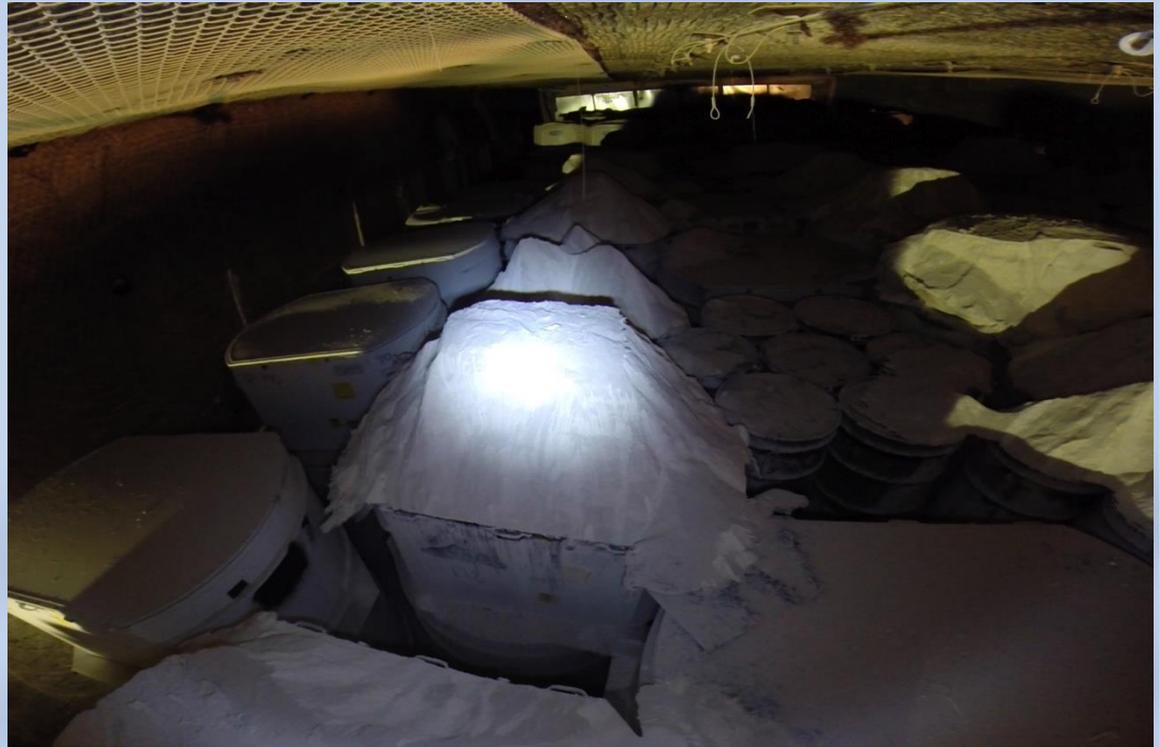
Source

Event scene
was Panel 7,
Room 7

The cause is
under
investigation

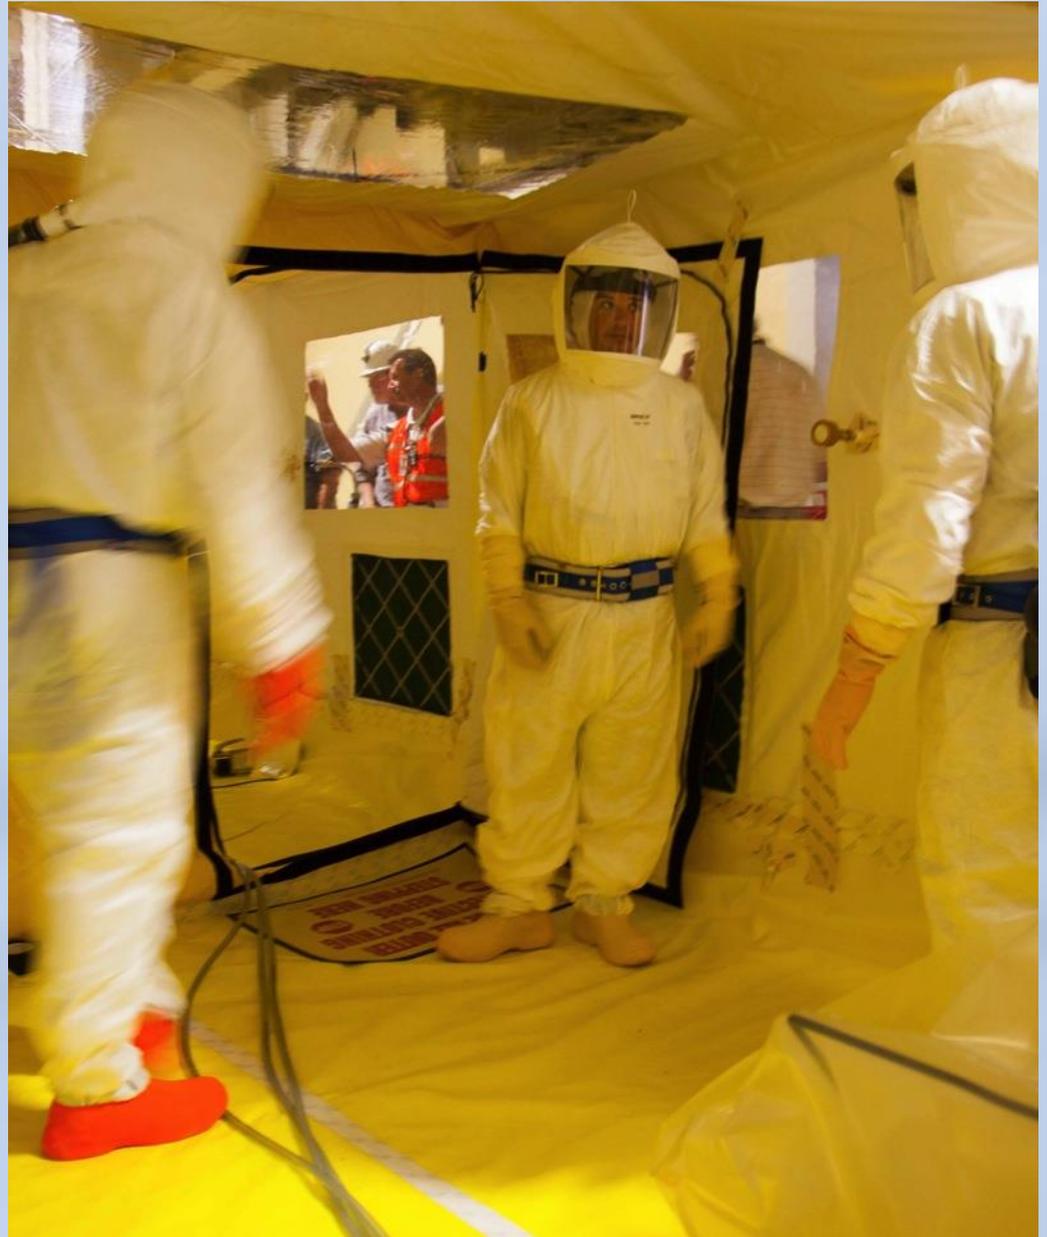
Filters changed

Moderate- and high-
efficiency filters
affected by smoke and
contamination were
changed

WIPP filtration system
continues to perform
well

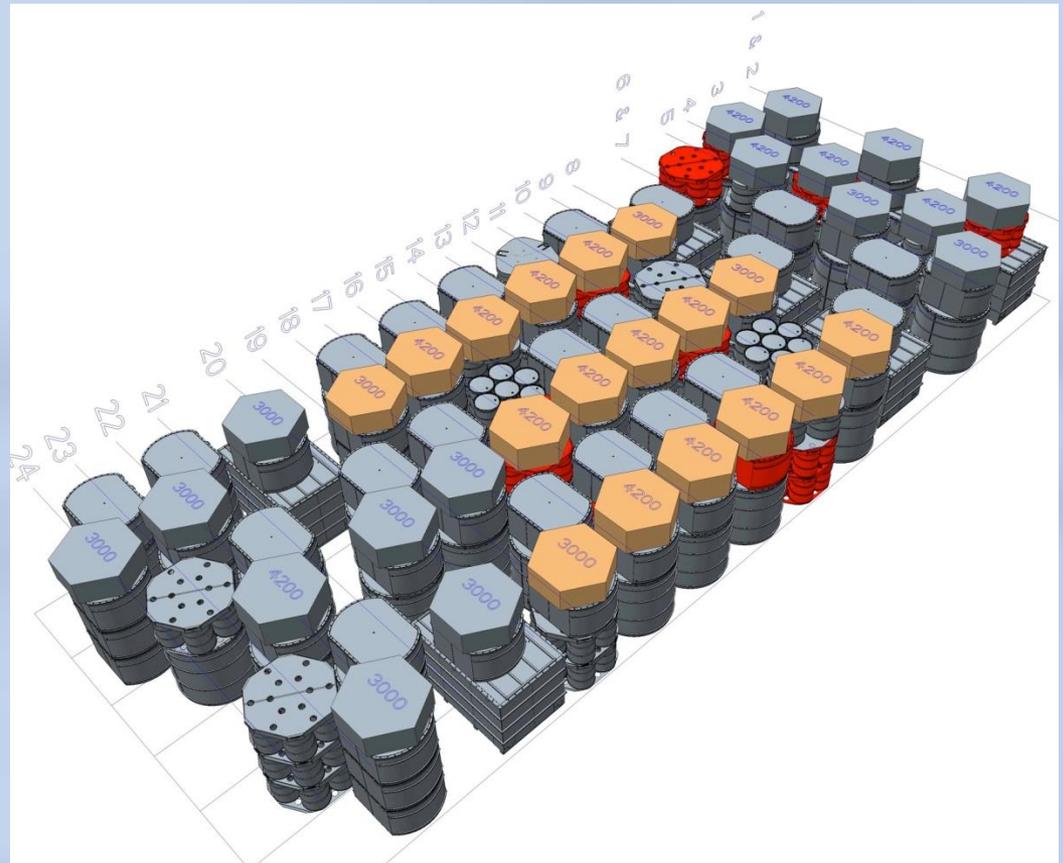
Current activities

- Implementing system to examine Room 7 from Row 1- 24, top to bottom
- Analyzing samples

A drum from the waste stream is suspected of causing heat-generating reaction

No definitive cause determined yet

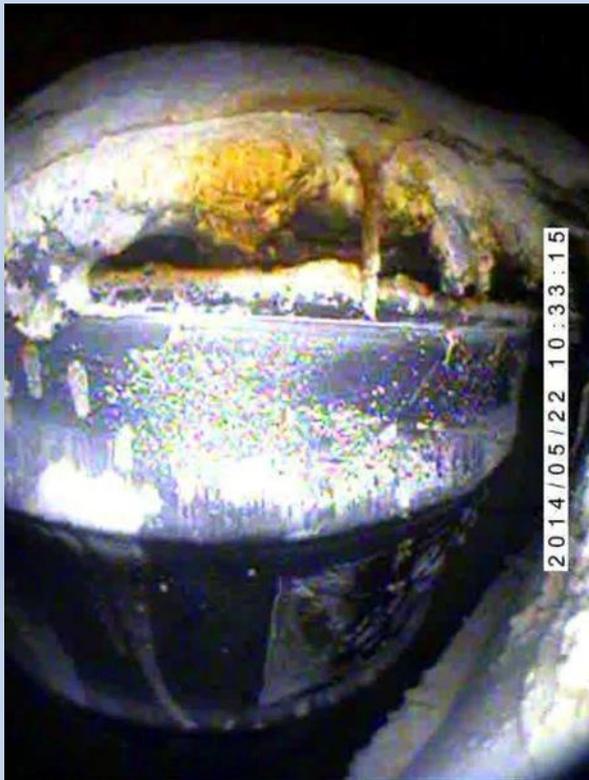
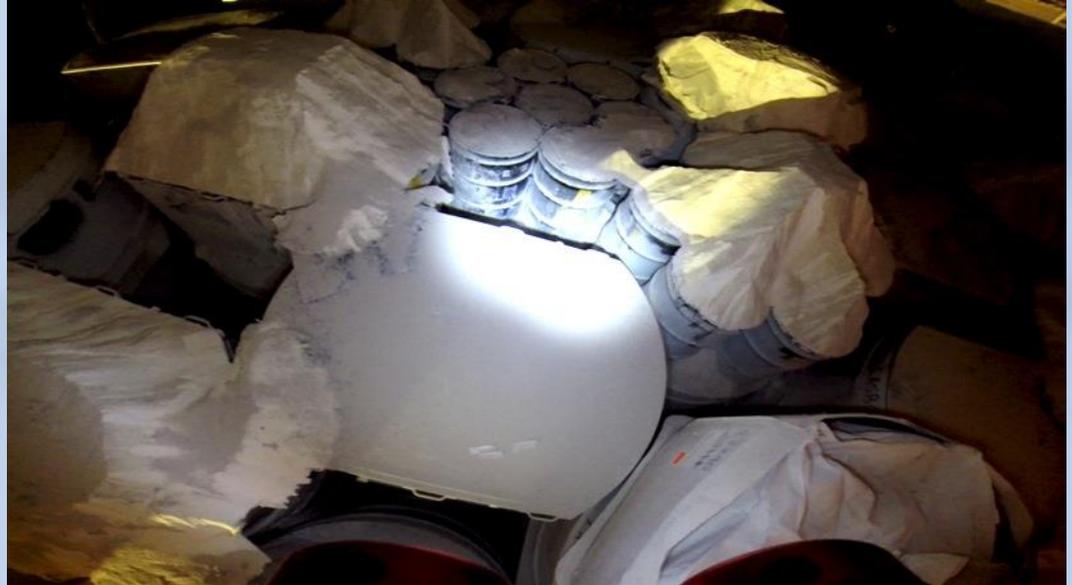
What we know

- The mine is stable
- Magnesium oxide sacks were disturbed by event
- Heat damage is evident
- At least one container is no longer intact
