COUNTY OF LUNA ROAD CONDITIONS

TRANSPORTATION INFRASTRUCTURE REVENUE SUBCOMMITTEE

July 15, 2016

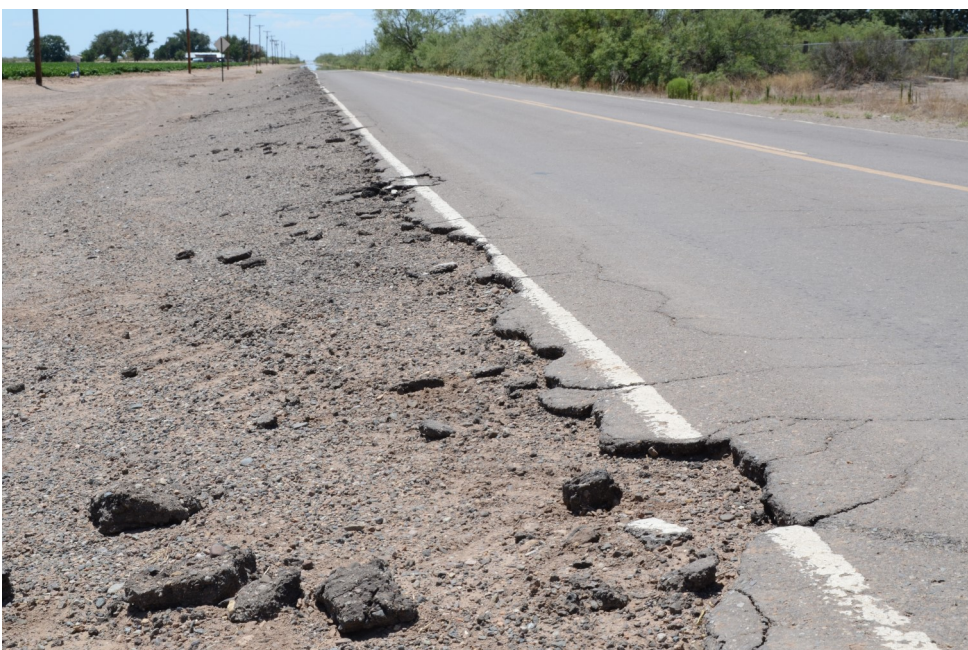
Country Club Road—2.75 miles; part of commercial truck bypass and industrial park area. Crack shown is from repair approximately five years ago

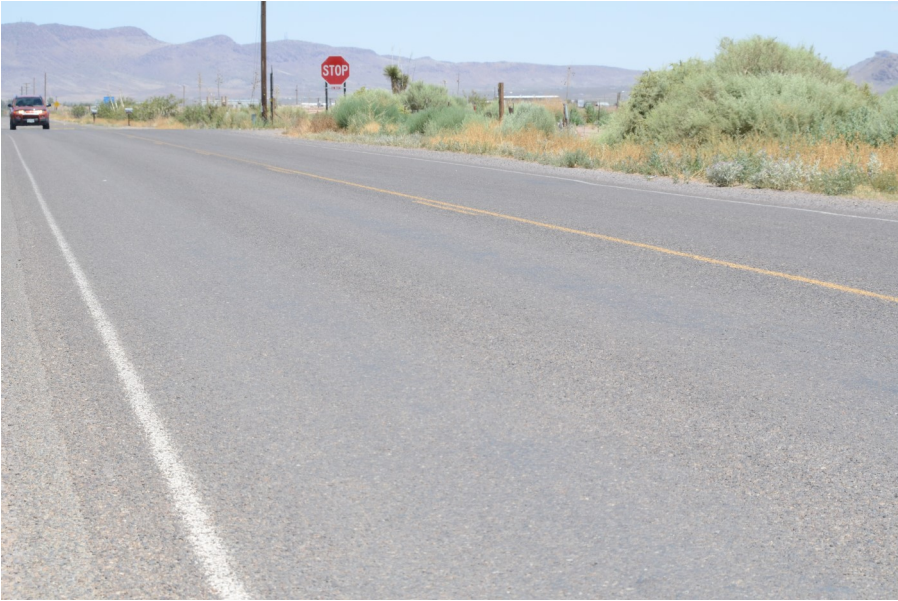
Solana Road is a former state highway and is approximately 6 miles long. Its travel lanes are 9 feet wide, instead of the recommended 10.5 feet. It sees heavy agricultural use, with tractor and semi tires causing shoulder damage

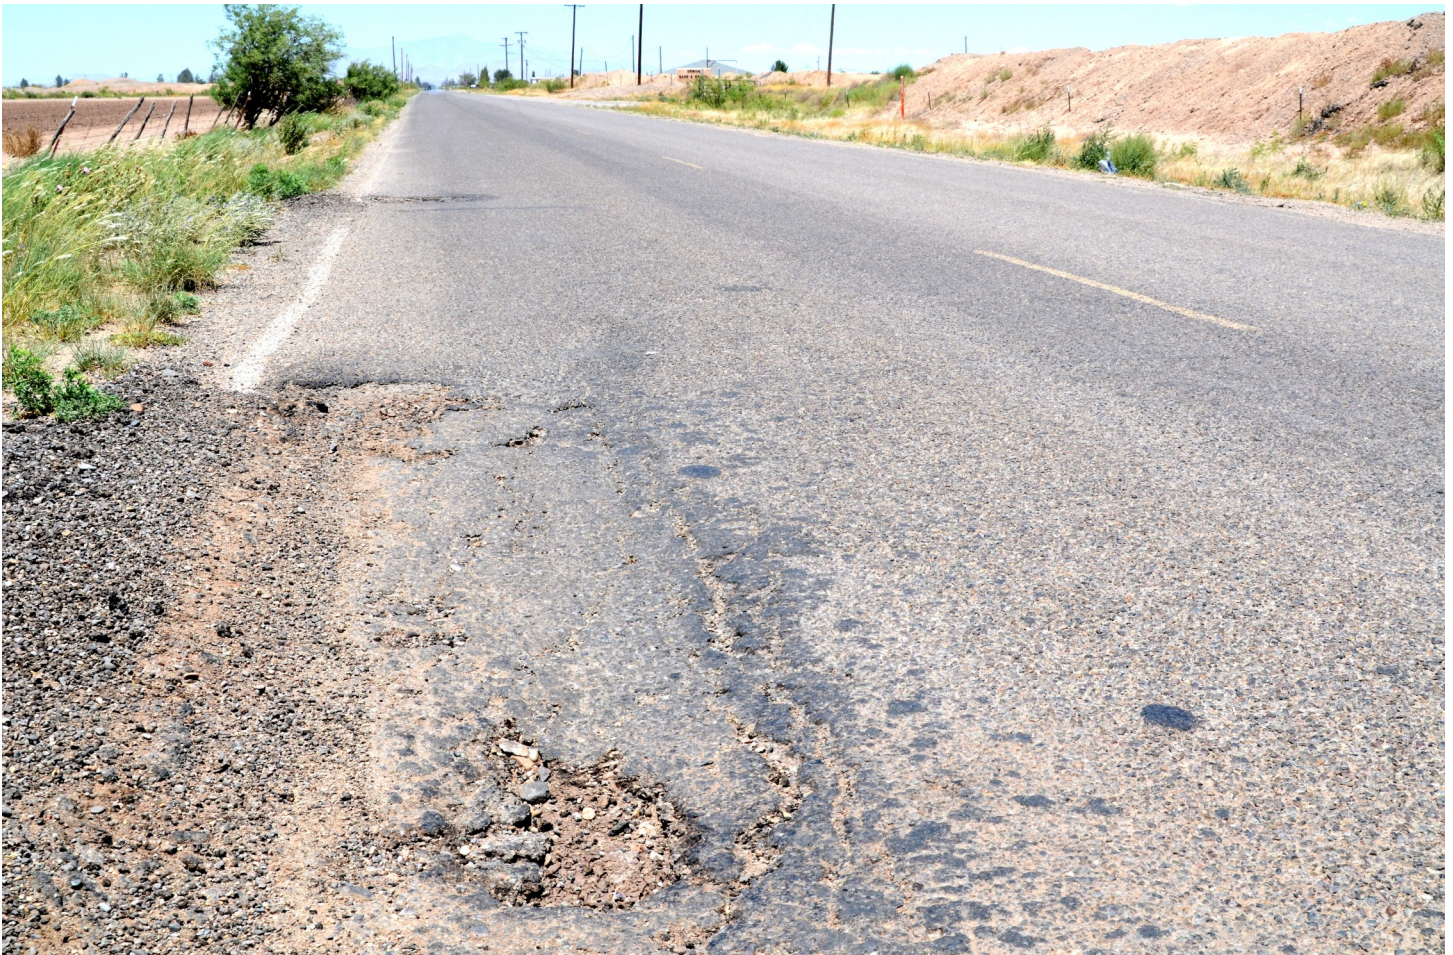
Below, a section of Country Club Road near farmland and a rock quarry shows the effects of heavy traffic over patching. The road is patched on a regular basis, with the last major maintenance project taking place five years ago. It is also part of the commercial truck bypass.

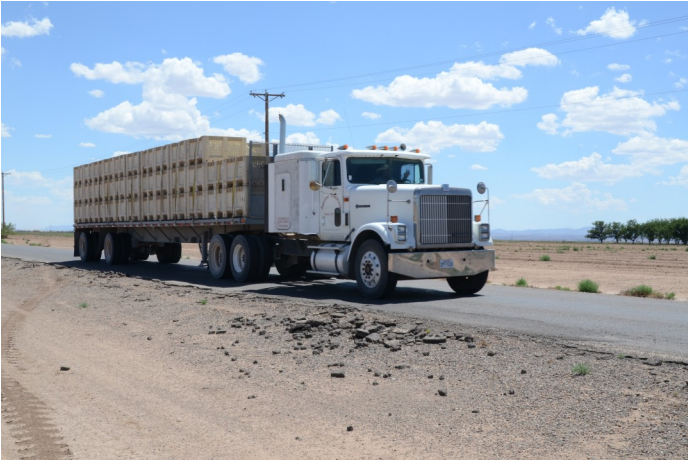
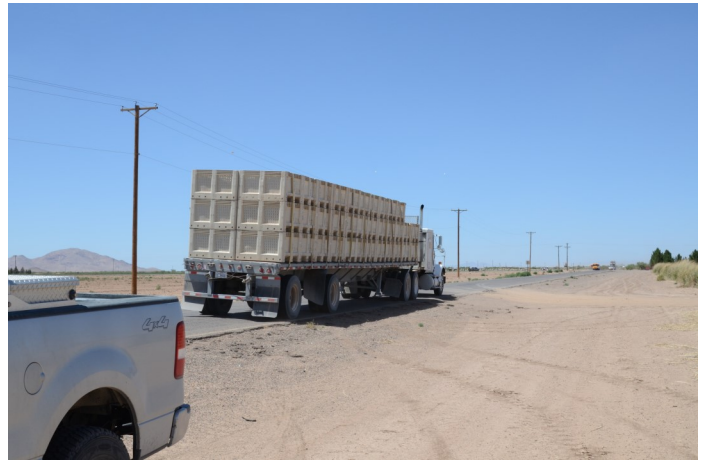
At the top, a truck loaded nearly 120,000 pounds of onions (estimated using the number of full boxes) is shown travelling Hermanas Road, which was built in the 1950s and is rated for 60,000 pounds. In the bottom photo, Road Department Director Marty Miller shows the bow in the road caused by heavy traffic from overloaded trucks.

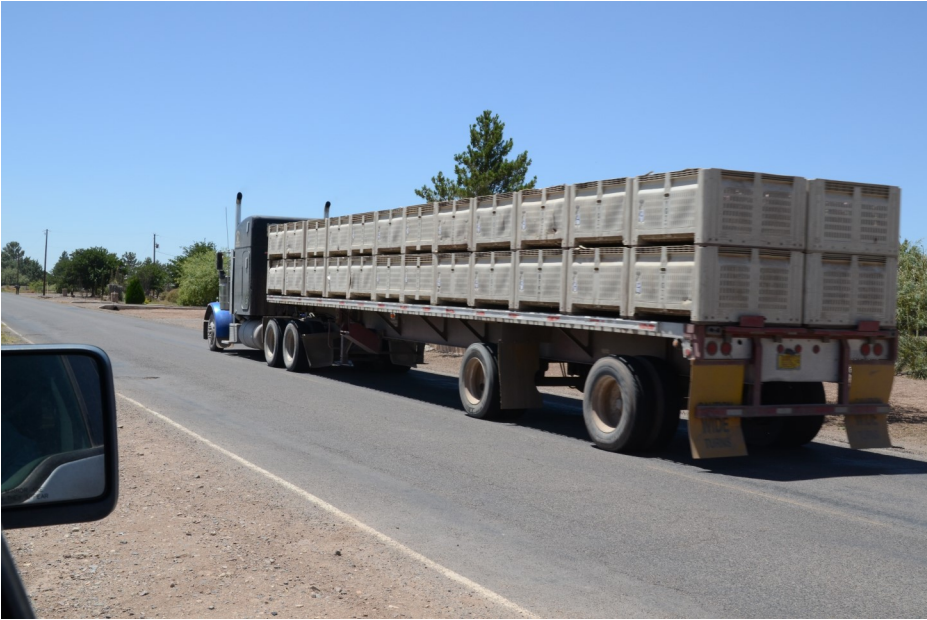
Pictured at left is a semi hauling an onion load estimated to be at least 90,000 pounds. It is traveling on Solana Road, which is plagued with pot-holes, shoulder issues and a rating of 60,000 pounds.

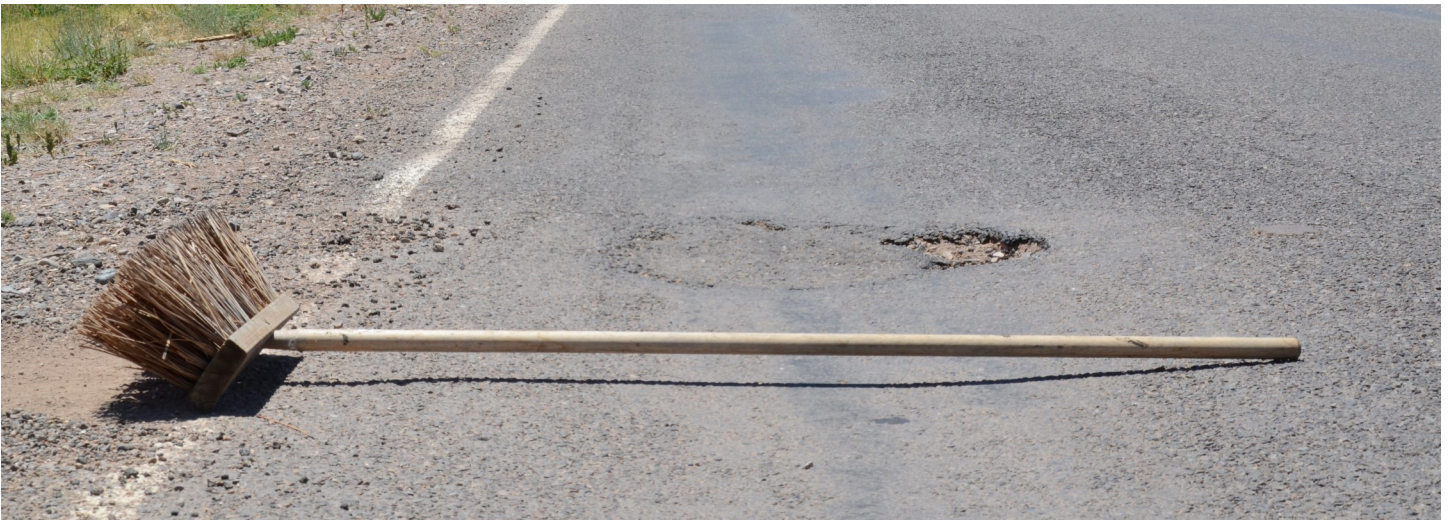
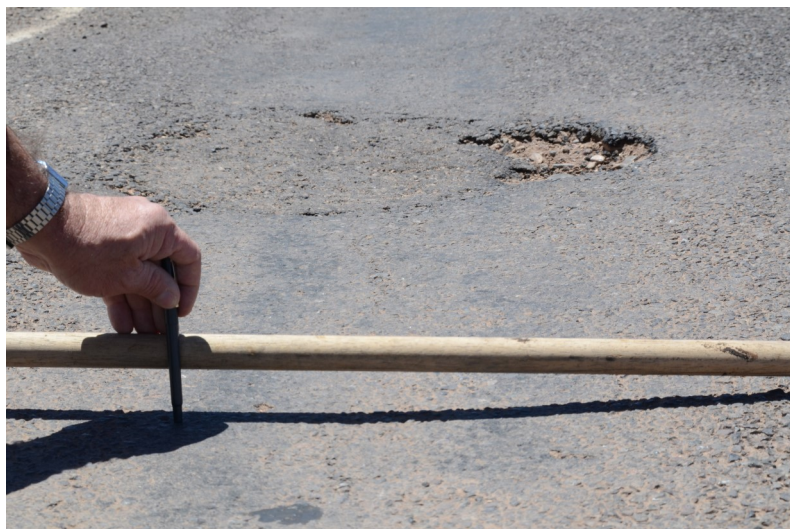
Below, a broom is again used to demonstrate the bow in the road caused by heavy traffic. This is the same section shown at left.
