Santo Domingo Pueblo Head Start and Early Head Start Complex

TIF Project Funding: \$115,000
Awarded 2010

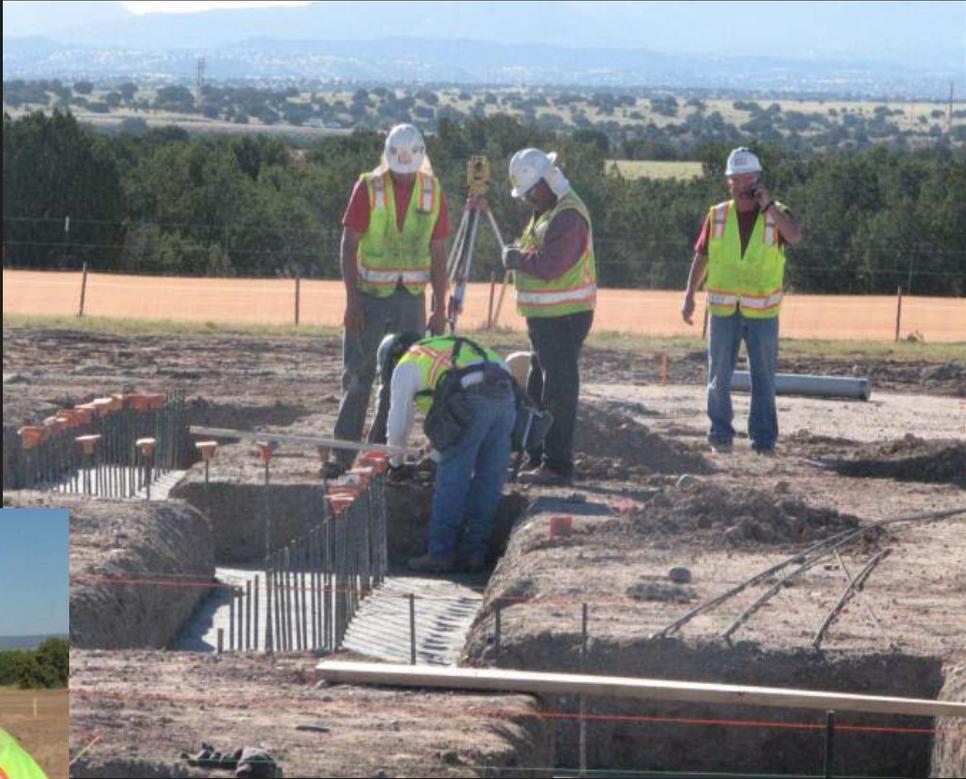
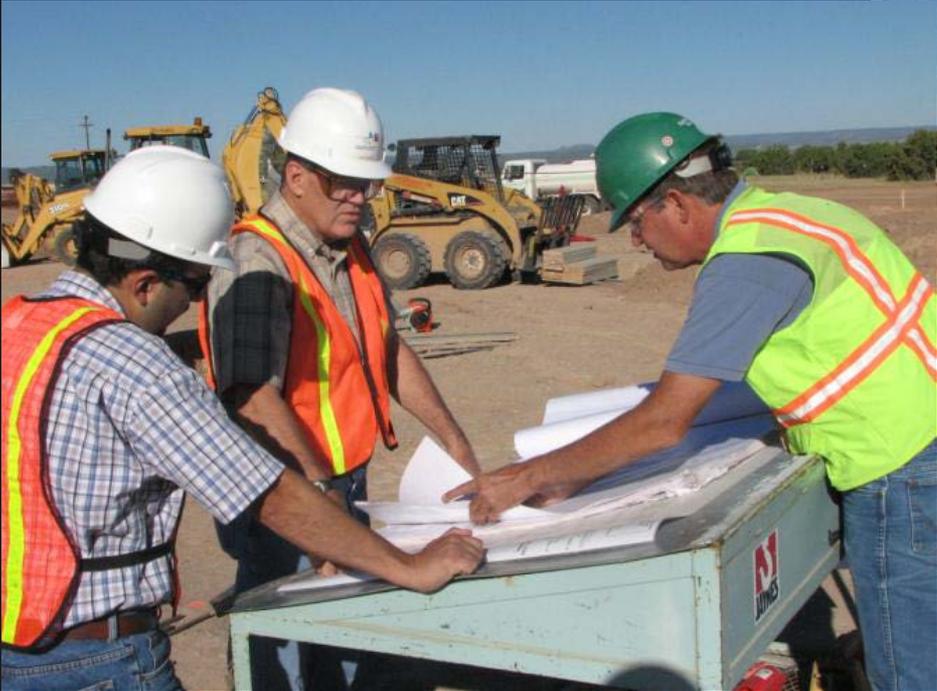
9/28/10- Architectural review
of foundation review

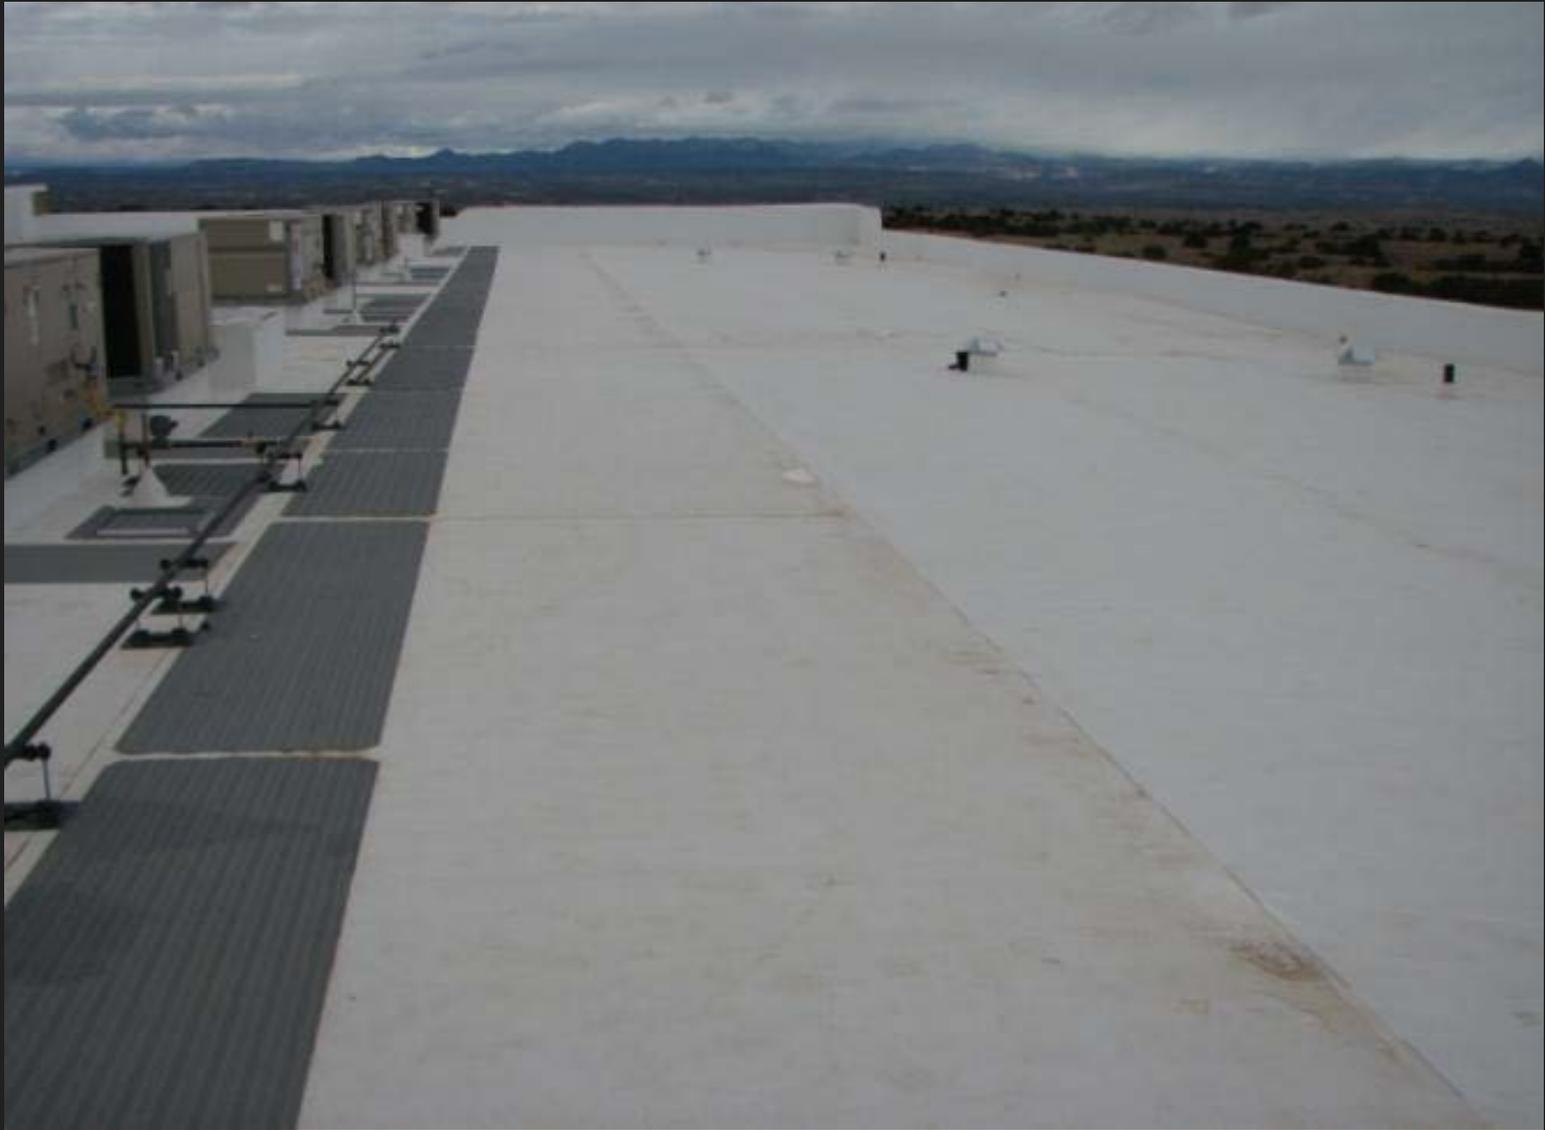
Roofing at HS (Head Start) wing

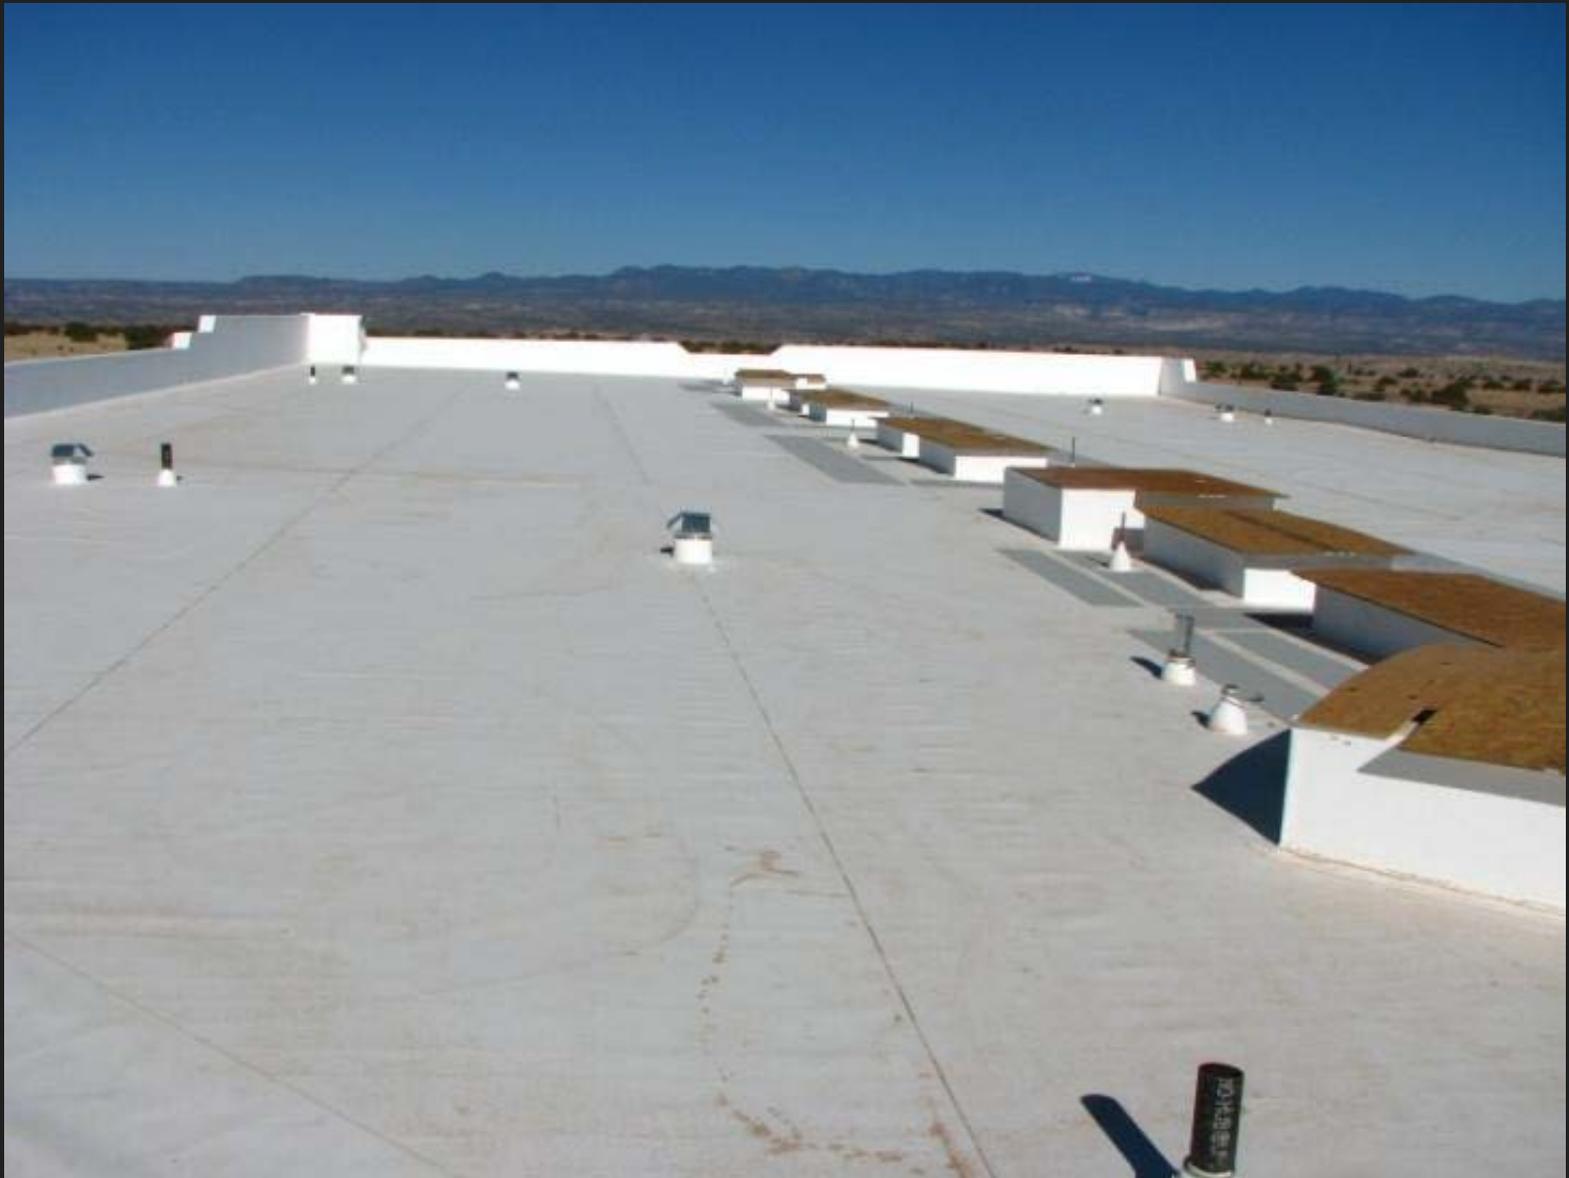
Roof on HS wing

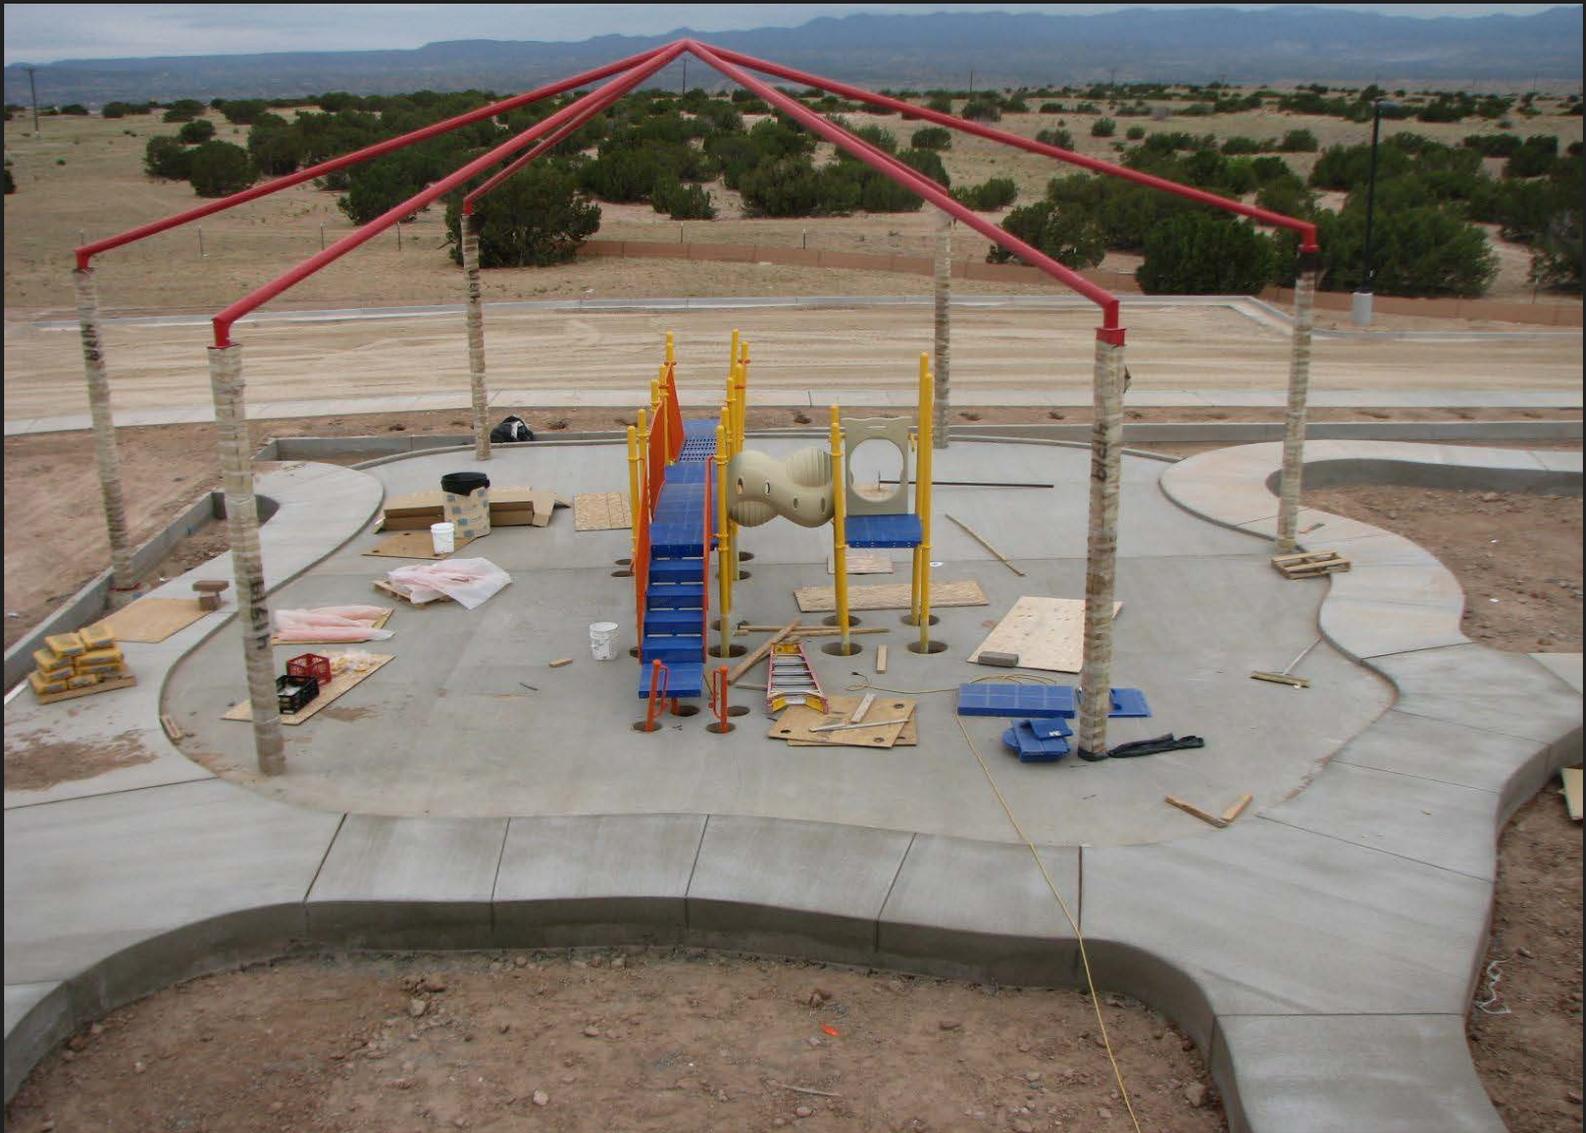
Much to be removed
