**Issues Associated with URI's Kingsville Dome
In-situ Leach Uranium Mine
Kleberg County, Texas**

George Rice
November 2, 2011

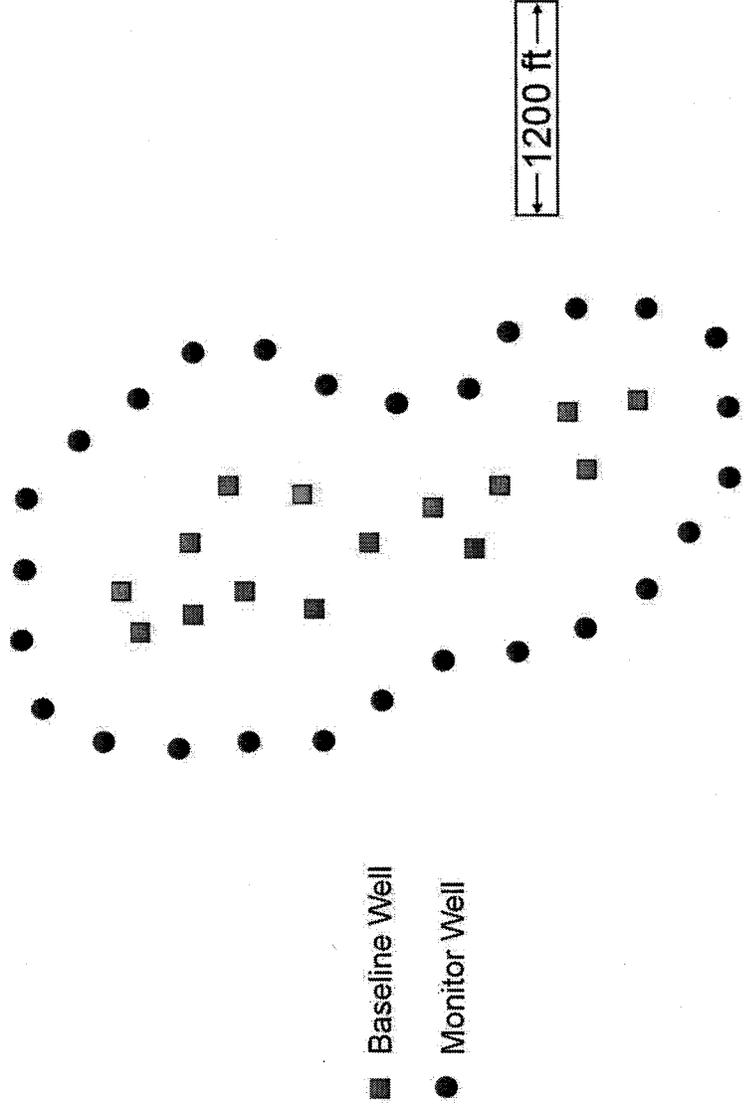
Figure 1
Schematic Representation of PAA-1
Kingsville Dome Mine

This bias can be seen when pre-mining concentrations in baseline wells are compared with pre-mining concentrations in monitor wells. Like baseline wells, monitor wells are on mine property and they are screened in the same aquifer as the baseline wells (see figure 1). However, monitor wells are usually not screened in or near an ore body. As shown in table 1, groundwater from baseline wells is much more likely to contain high concentrations of uranium and radium than is groundwater from monitor wells.

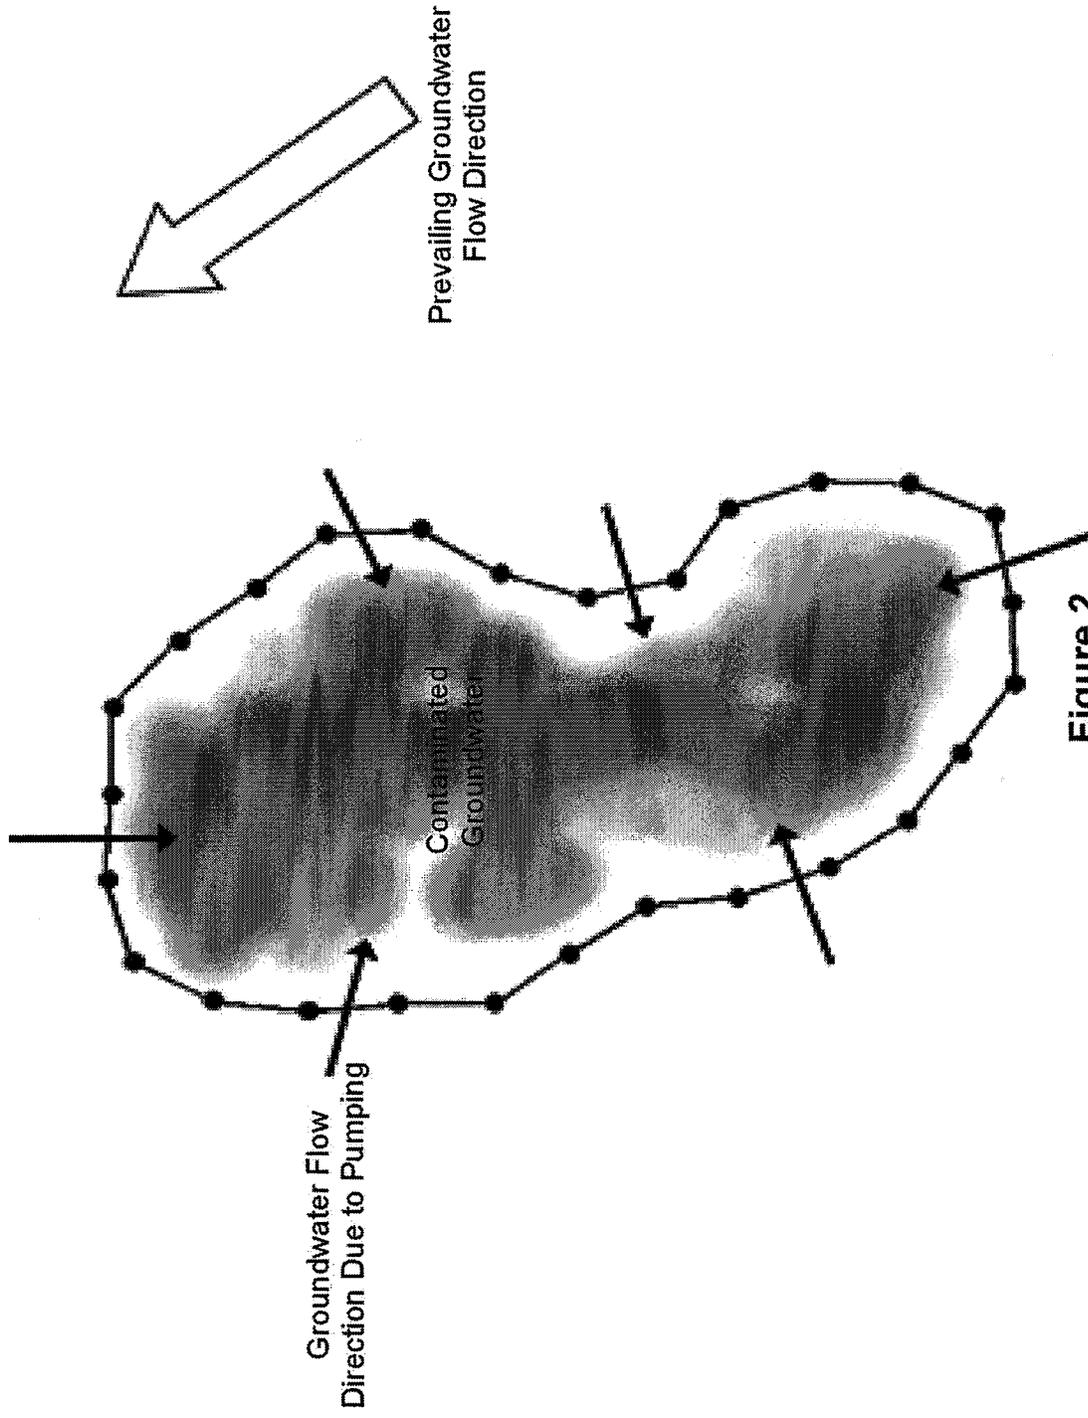
Figure 2
Groundwater Flow Directions During Restoration

During active restoration, groundwater flows toward pumping wells in the production area. This condition is schematically illustrated in figure 2. However, once pumping (restoration) stops, the prevailing hydraulic gradient in the vicinity of the mine will be reestablished in the production area. Then, groundwater in the production area, and the contaminants it contains, will flow beyond the mine boundary. This is schematically illustrated in figure 3.

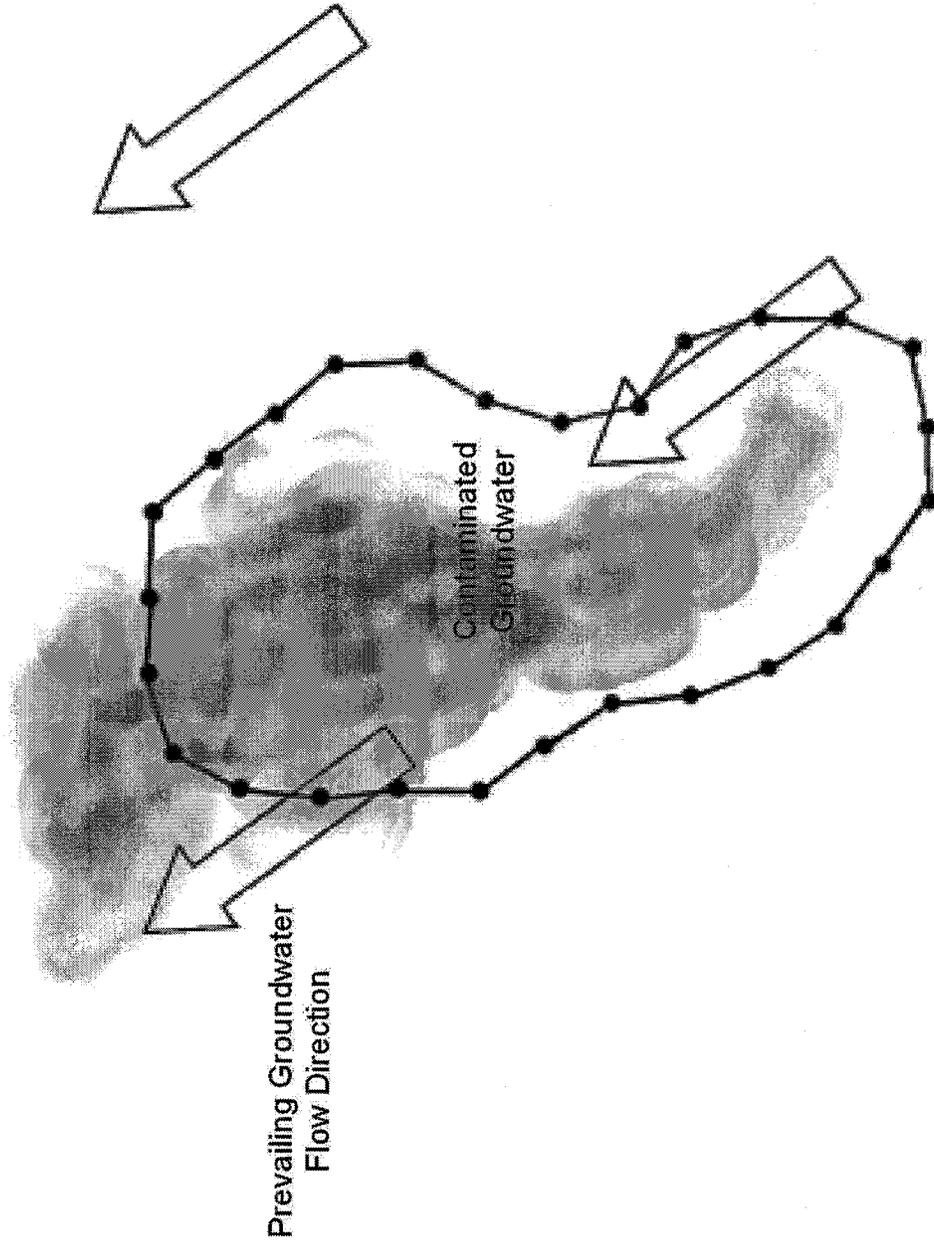
Figure 3
Groundwater Flow Direction After Restoration Stops

If restoration is stopped while high concentrations of contaminants remain in the aquifer, the contaminants may migrate beyond the mine boundary.
