## **Status Update**

### **Remediation of Unstable Brine Cavern in Carlsbad, New Mexico**

by Energy Minerals & Natural Resources Department (EMNRD)  
to Transportation Infrastructure Revenue Subcommittee

October 16, 2019

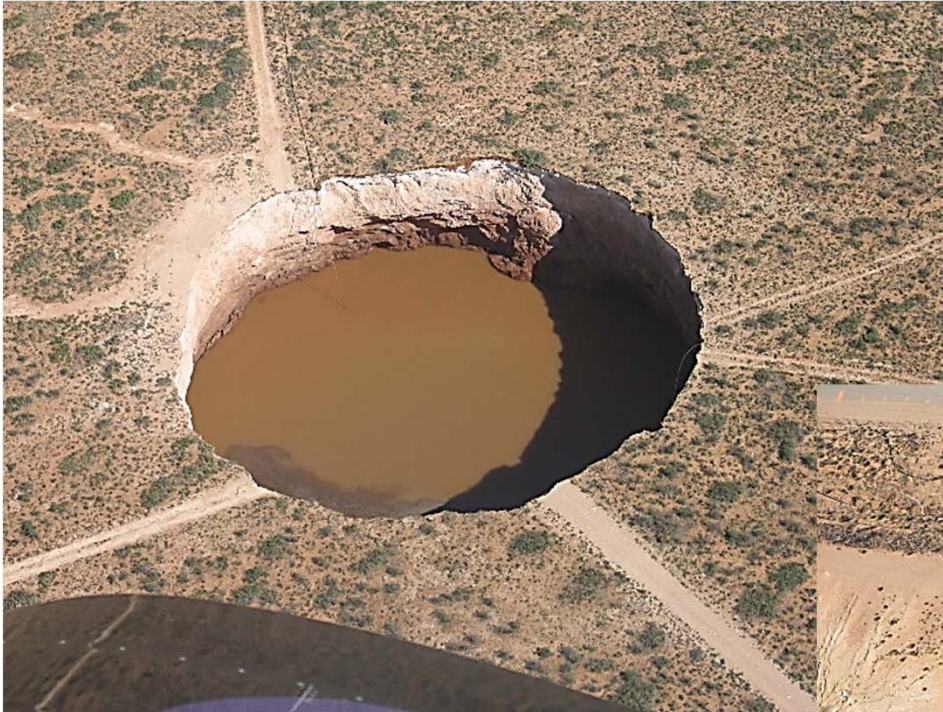
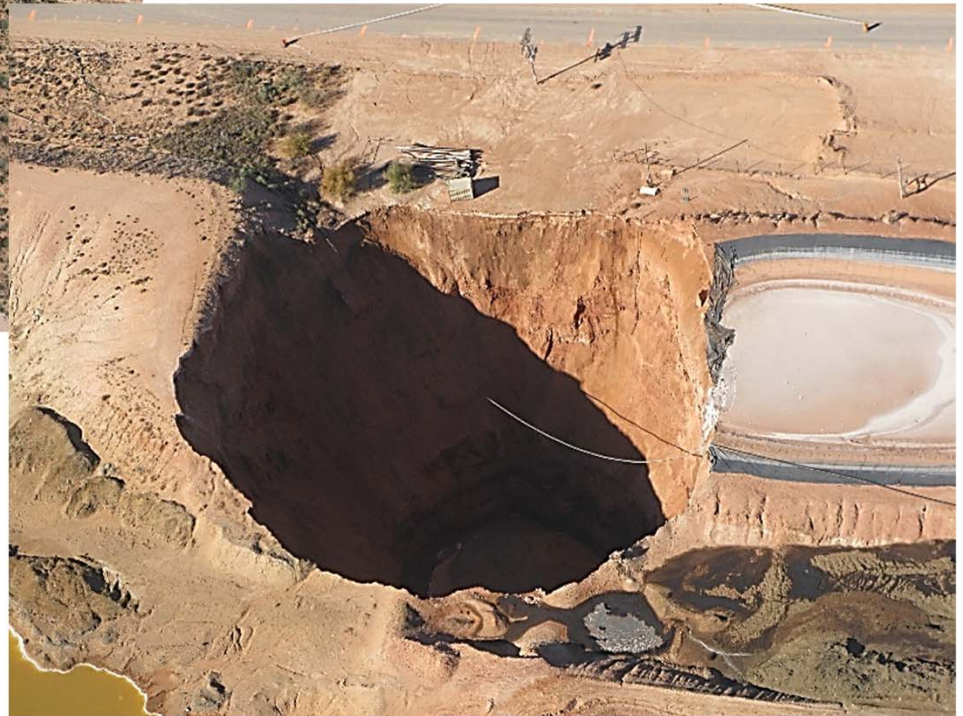
Jim's Water Service – July 2008

Loco Hills Disposal – November 2008

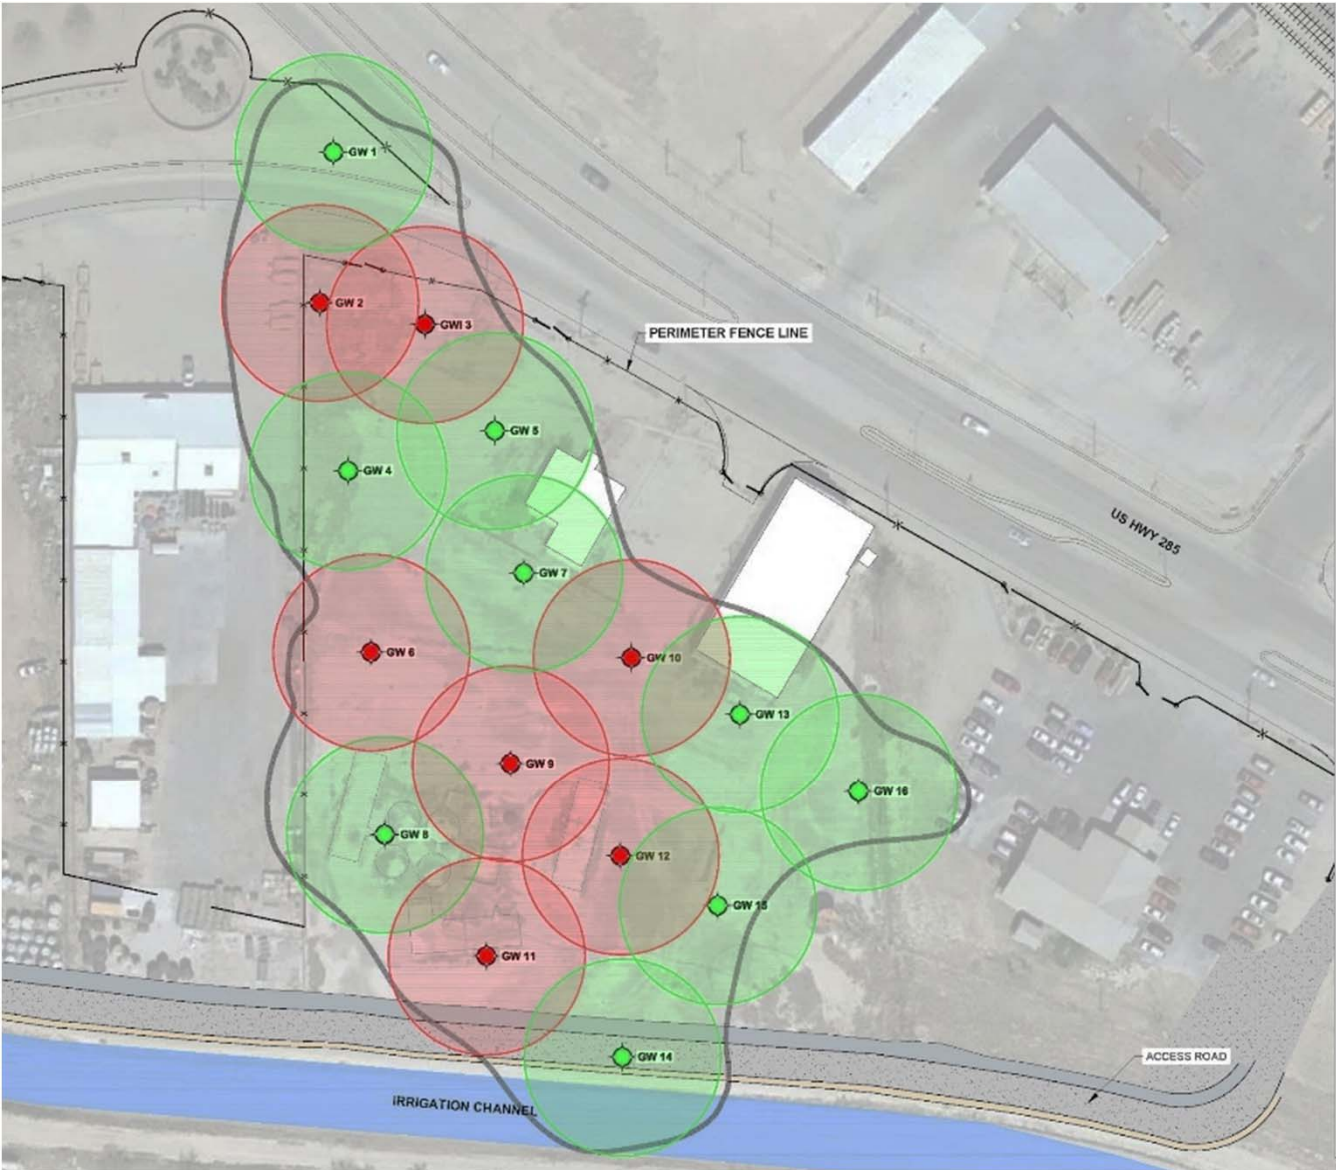
**GROUT WELL DRILLING PLAN & GROUTING SEQUENCE**

GROUT SEQUENCING	
PHASE	GROUT/BRINE RECOVERY WELL
1	1 (GW 9)
	2 (GW 6)
	3 (GW 10)
	4 (GW 12)
	5 (GW 11)
	6 (GW 3)
	7 (GW 2)
	8 (GW 1)
2	9 (GW 14)
	10 (GW 15)
	11 (GW 16)
	12 (GW 13)
	13 (GW 8)
	14 (GW 7)
	15 (GW 5)
	16 (GW 4)

**16 WELLS, 2 PHASES  
125-FT SPACING**

- Install a series of wells to sequentially pressure inject grout in two phases while simultaneously extracting brine
  - Maintain cavity pressure
  - Balance volume of brine removed with volume of grout injected
  - Injection Phase 1 - Establish a subsurface cap using high mobility grout materials to support the existing weakened cavity roof
  - Injection Phase 2 – Consolidate the existing partially dissolved cavern rubble using low mobility grout to structurally support the new grout cap
