R.A.D.O.N.

Radiological Assessment, Detection, Observation, and Notification
for the NTU Crownpoint Campus

Navajo Technical University

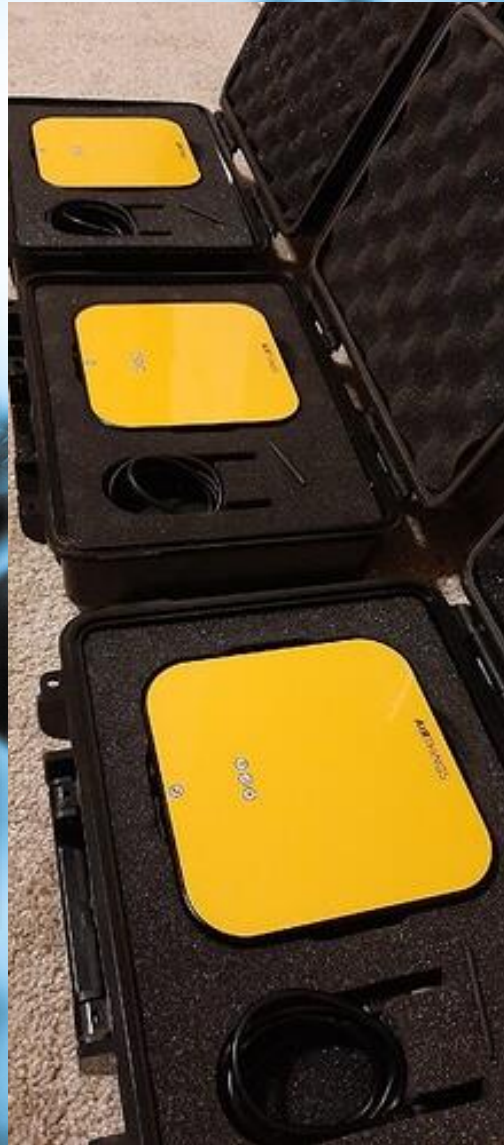
Methods

- Corentium radon detectors
- 48-hour sampling periods
- Multiple campus locations
- Results reported in **pCi/L**

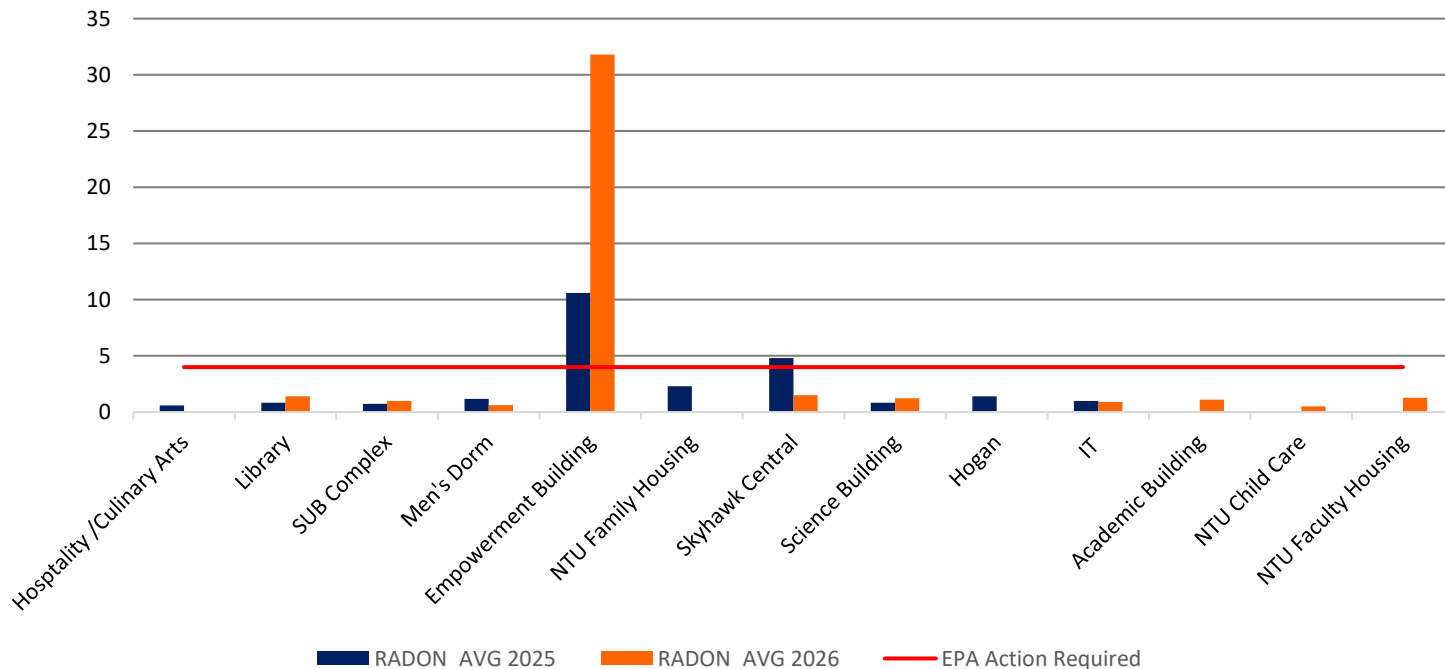
Comparison (2025 vs 2026)

- Most monitored locations remained below the EPA action level (4 pCi/L).
- Empowerment Building average increased from 10.59 to 31.8 pCi/L.
- Skyhawk Central decreased from 4.8 to 1.5 pCi/L.
- Highest readings were observed in basement environments.
- Additional monitoring is underway to evaluate elevated readings.
