# Carlsbad Brine Well Update

Radioactive and Hazardous Materials Interim Committee meeting in Clovis, NM

NEW MEXICO ENERGY, MINERALS AND NATURAL RESOURCES DEPARTMENT

August 2022

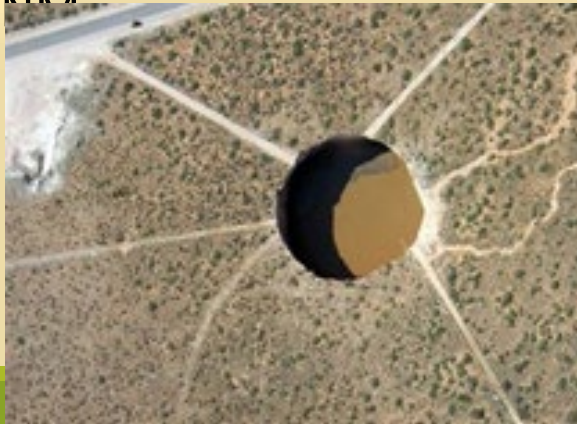
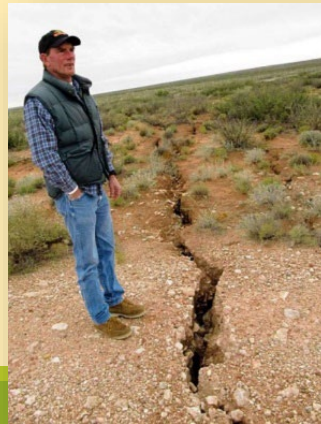
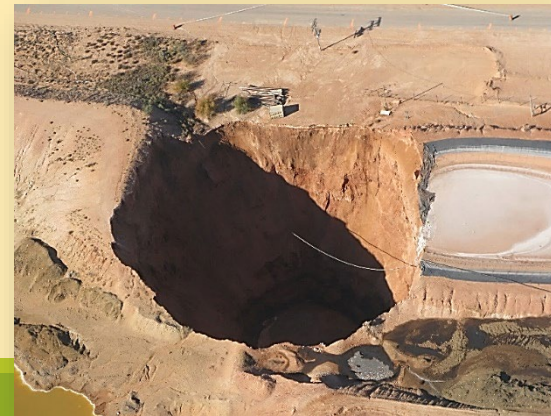
- 7/16/2008: Brine well southeast of Artesia catastrophically collapsed forming a 100-ft deep sinkhole.
- 7/22/2008: Brine production at the site was terminated at OCD's direction.
- 11/3/2008: Second brine well collapse occurred north of Loco Hills, NM.

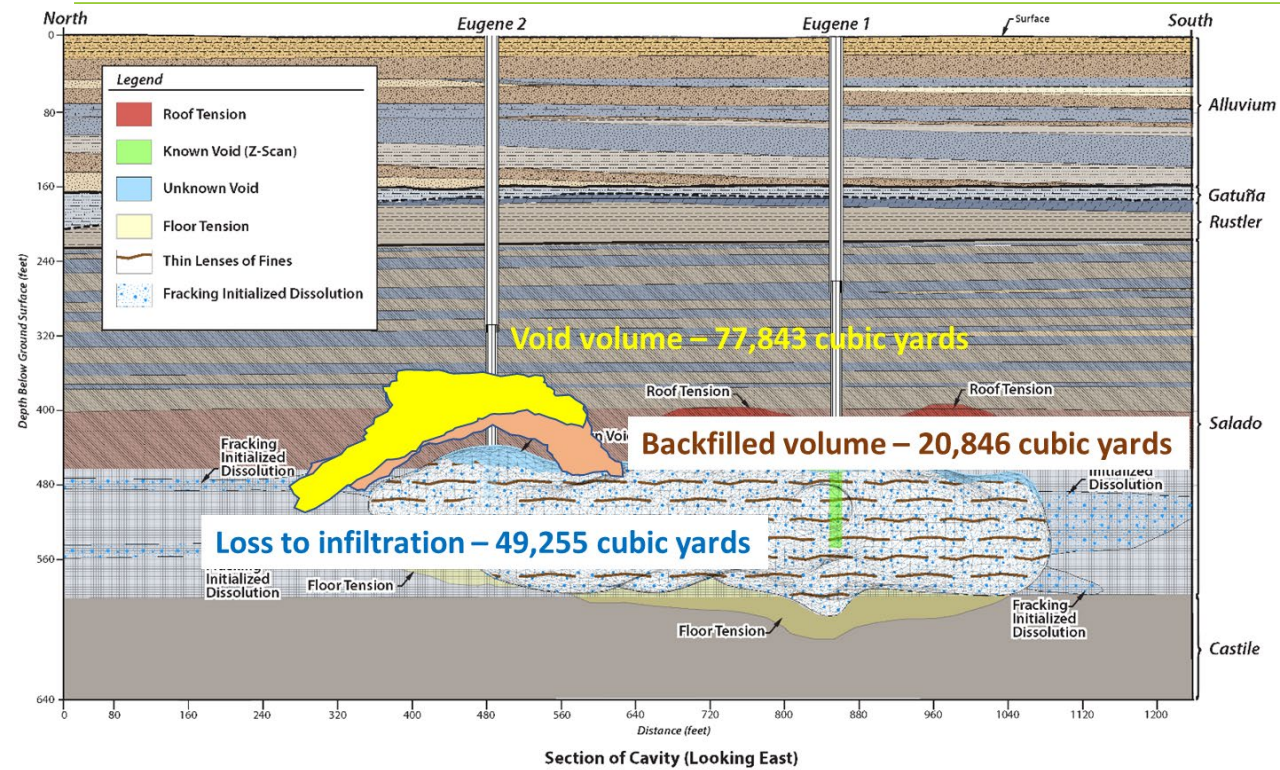
Sonar log of May 2020 after injecting 70,101 cubic yards of sand

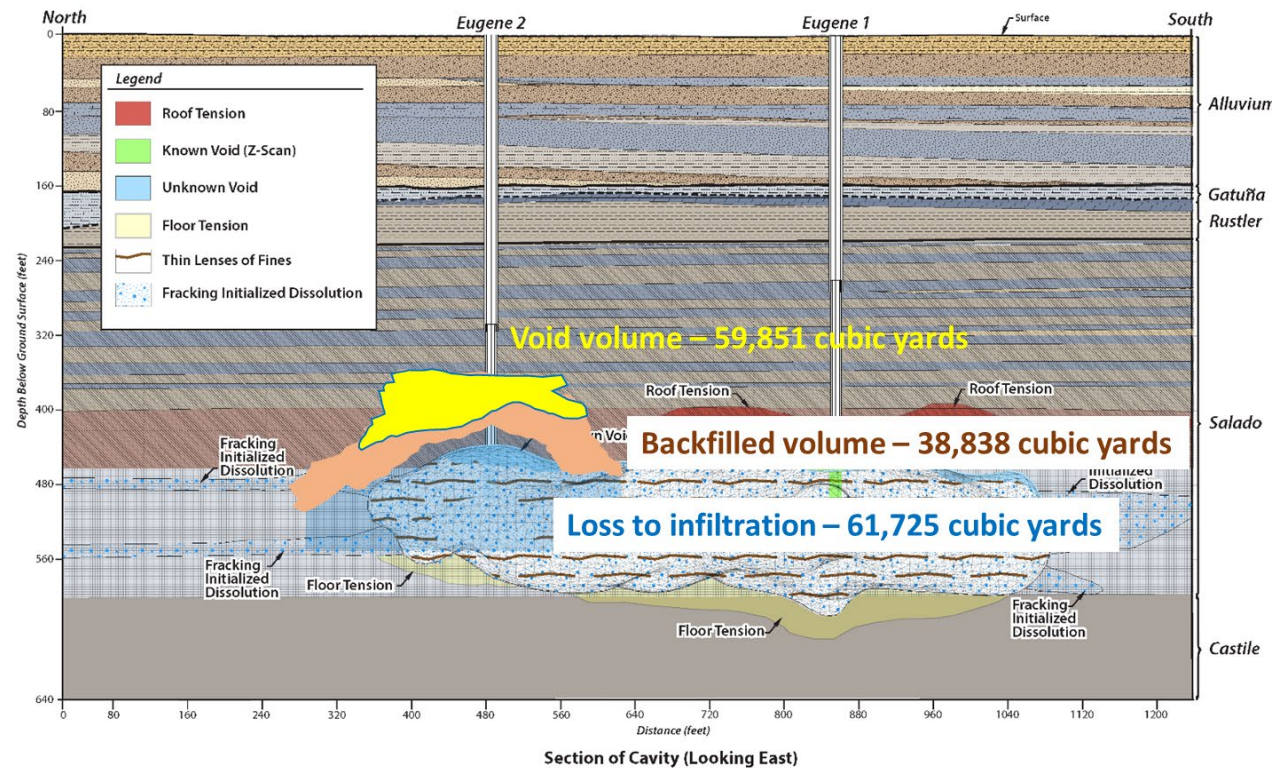
Sonar log of July 2020 after injecting 100,563 cubic yards of sand
