Erosion and sedimentation in the Cañon Largo watershed, southern Jicarilla Nation, New Mexico

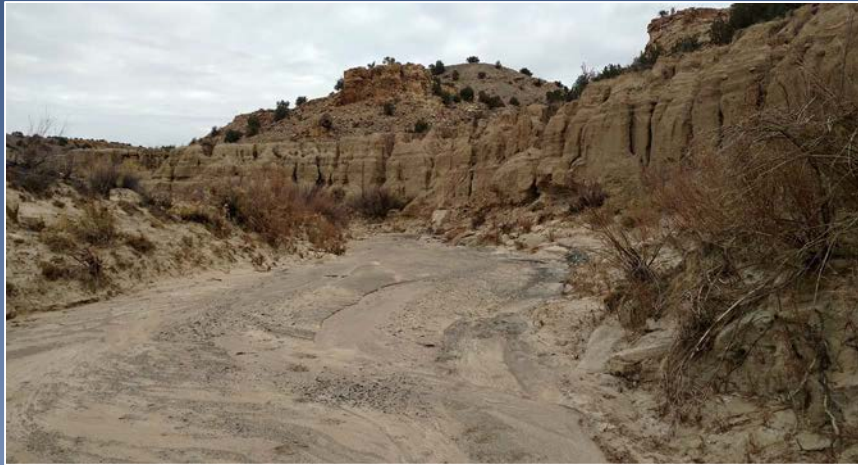
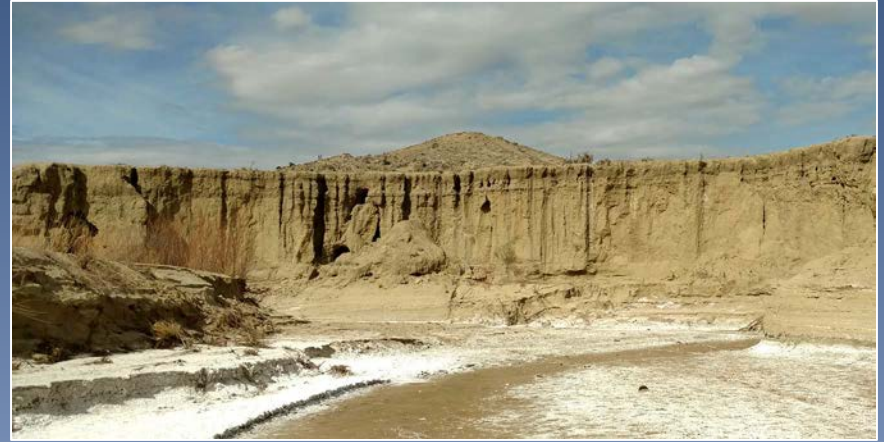
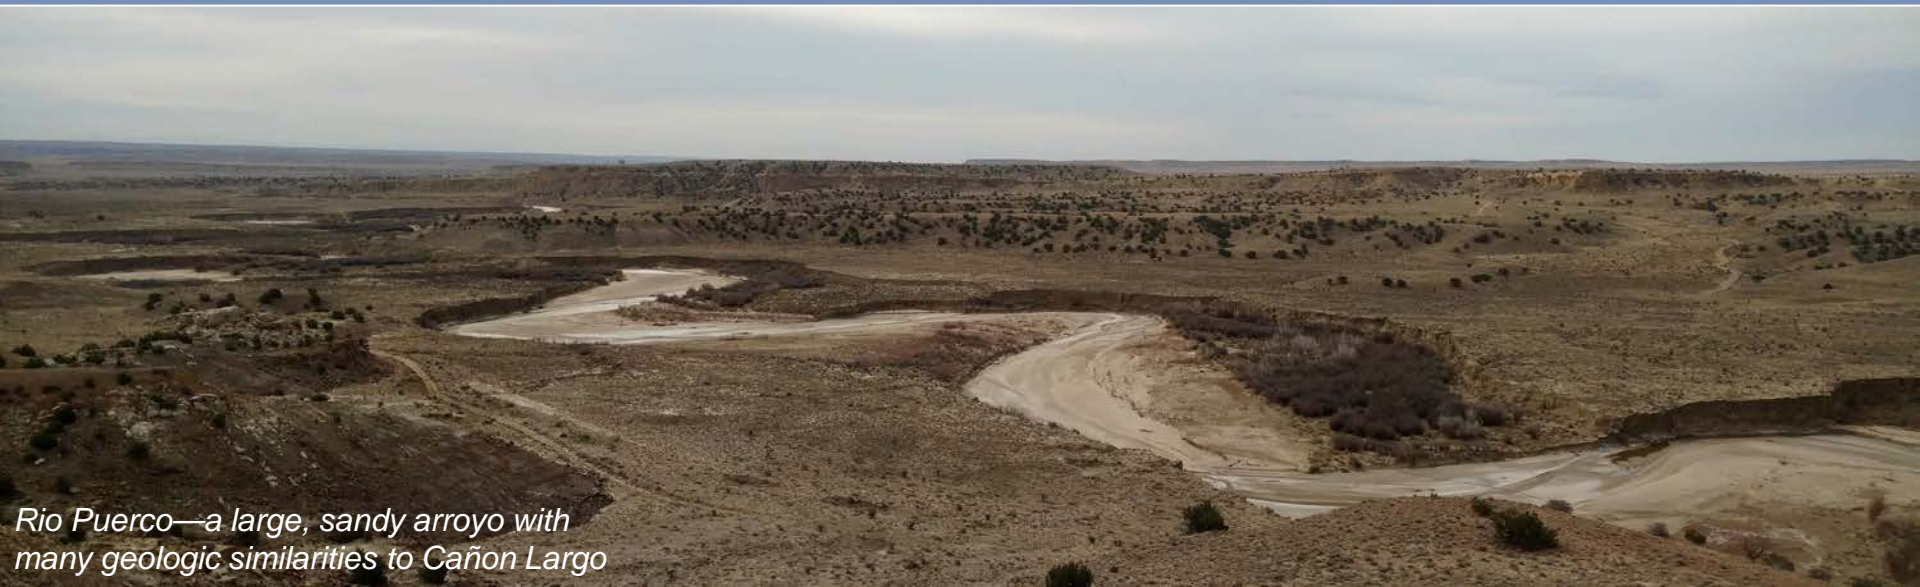
Rio Puerco—a large, sandy arroyo with many geologic similarities to Cañon Largo

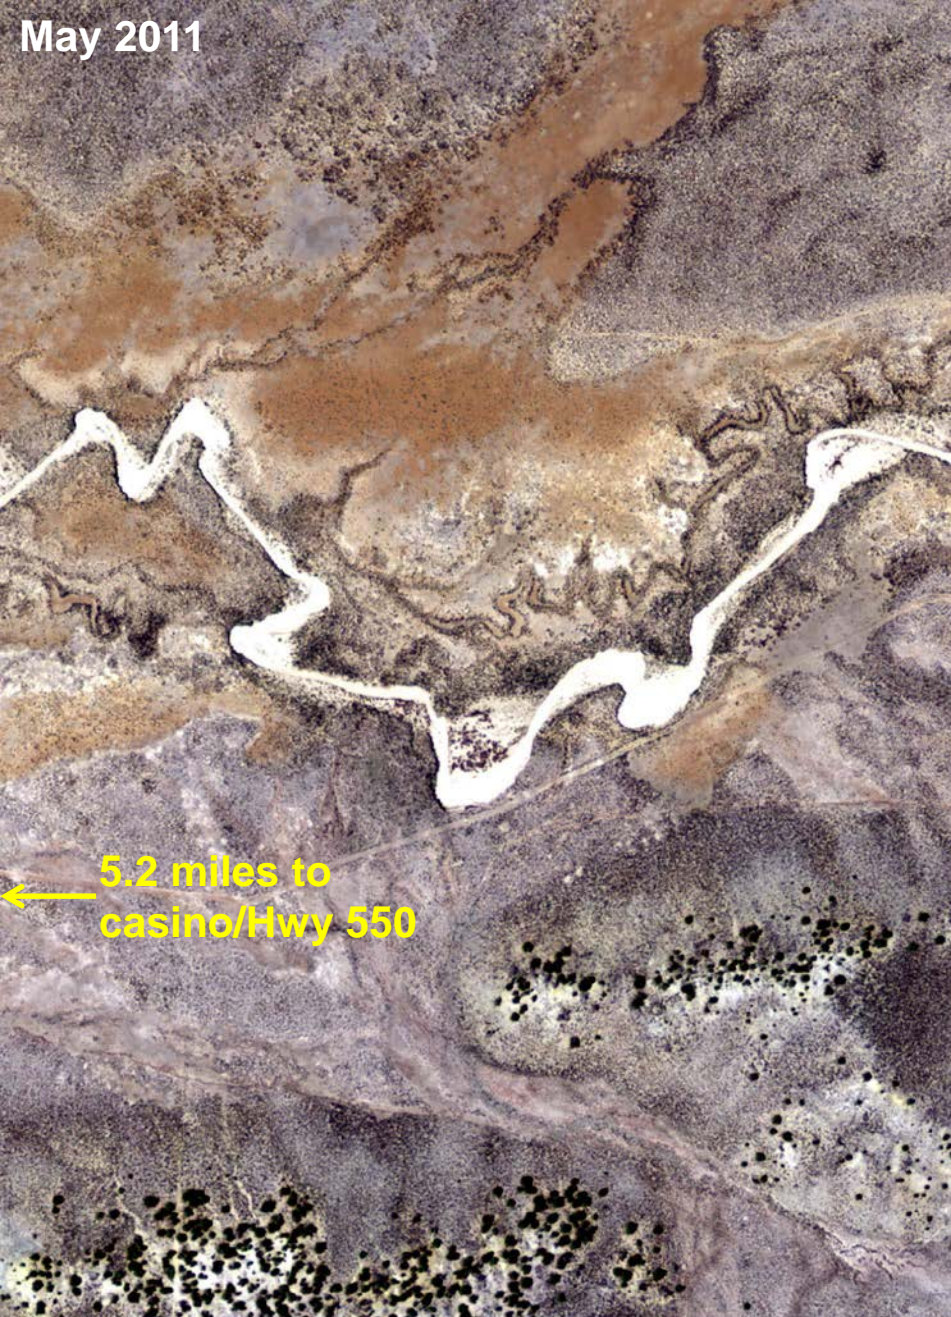
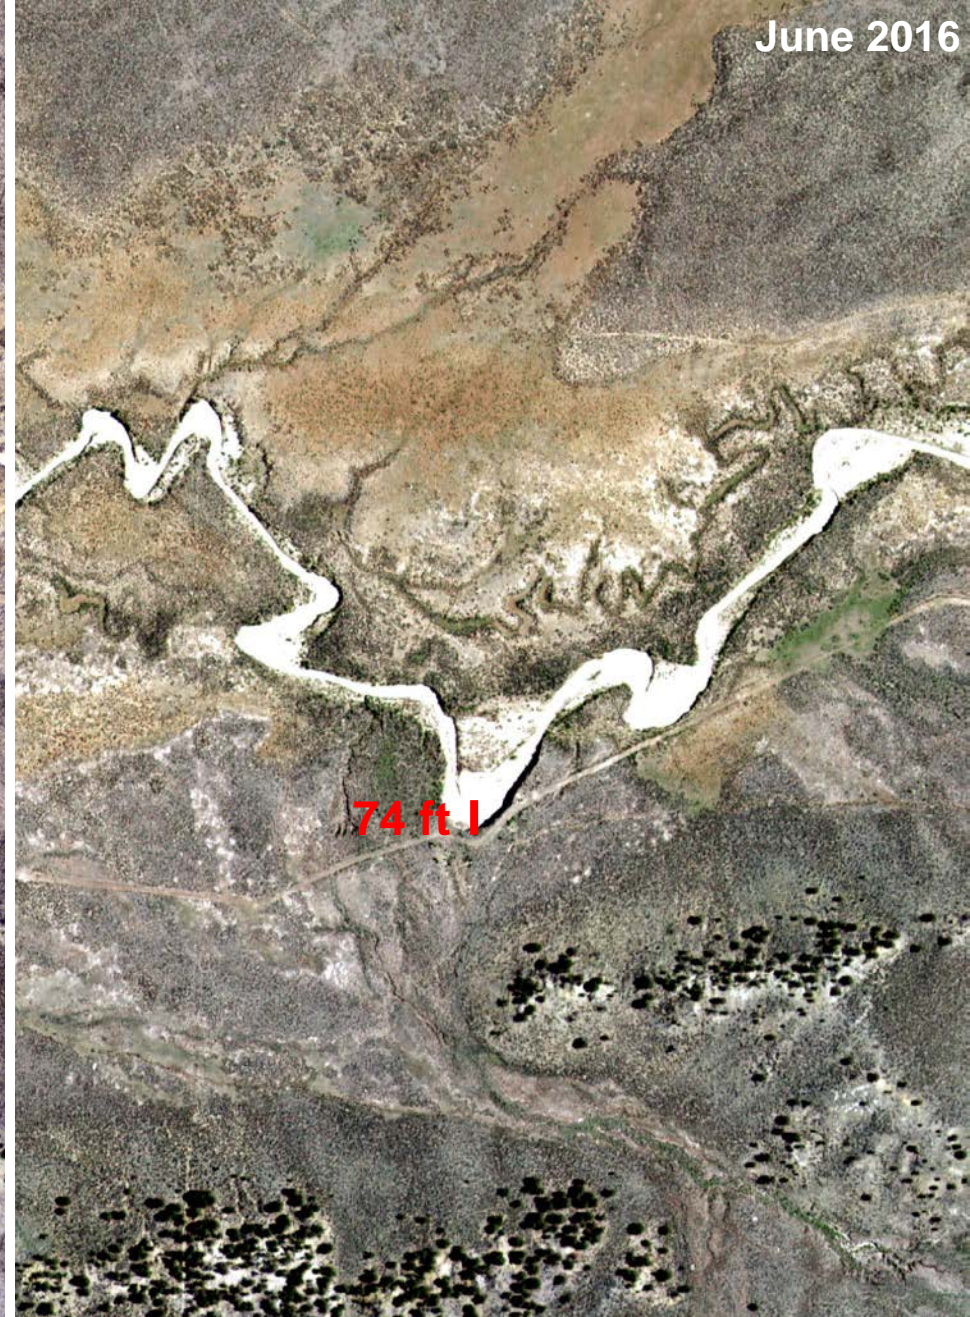
May 2011

June 2016

**Cañon Largo erosion
near Apache Nugget Casino**

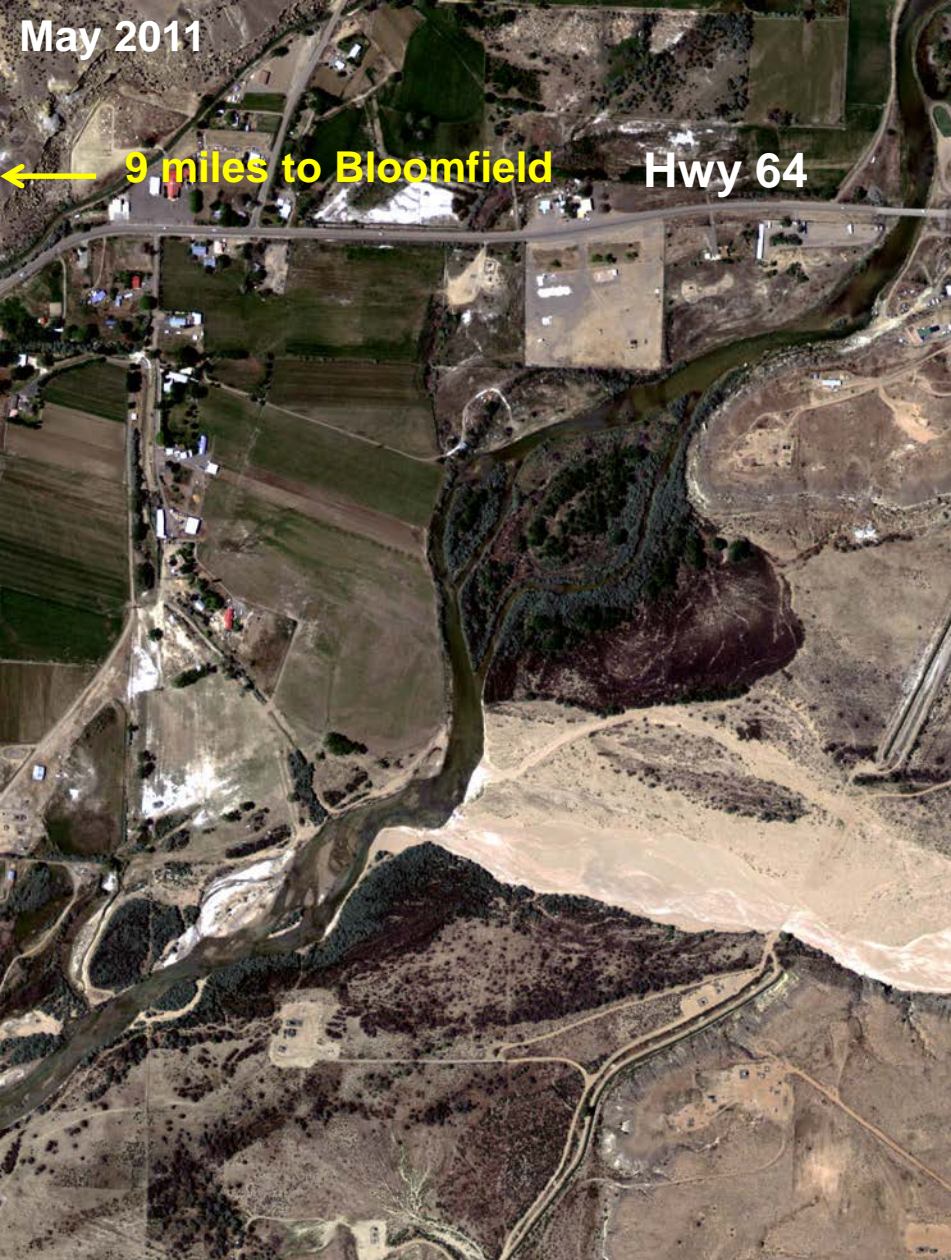
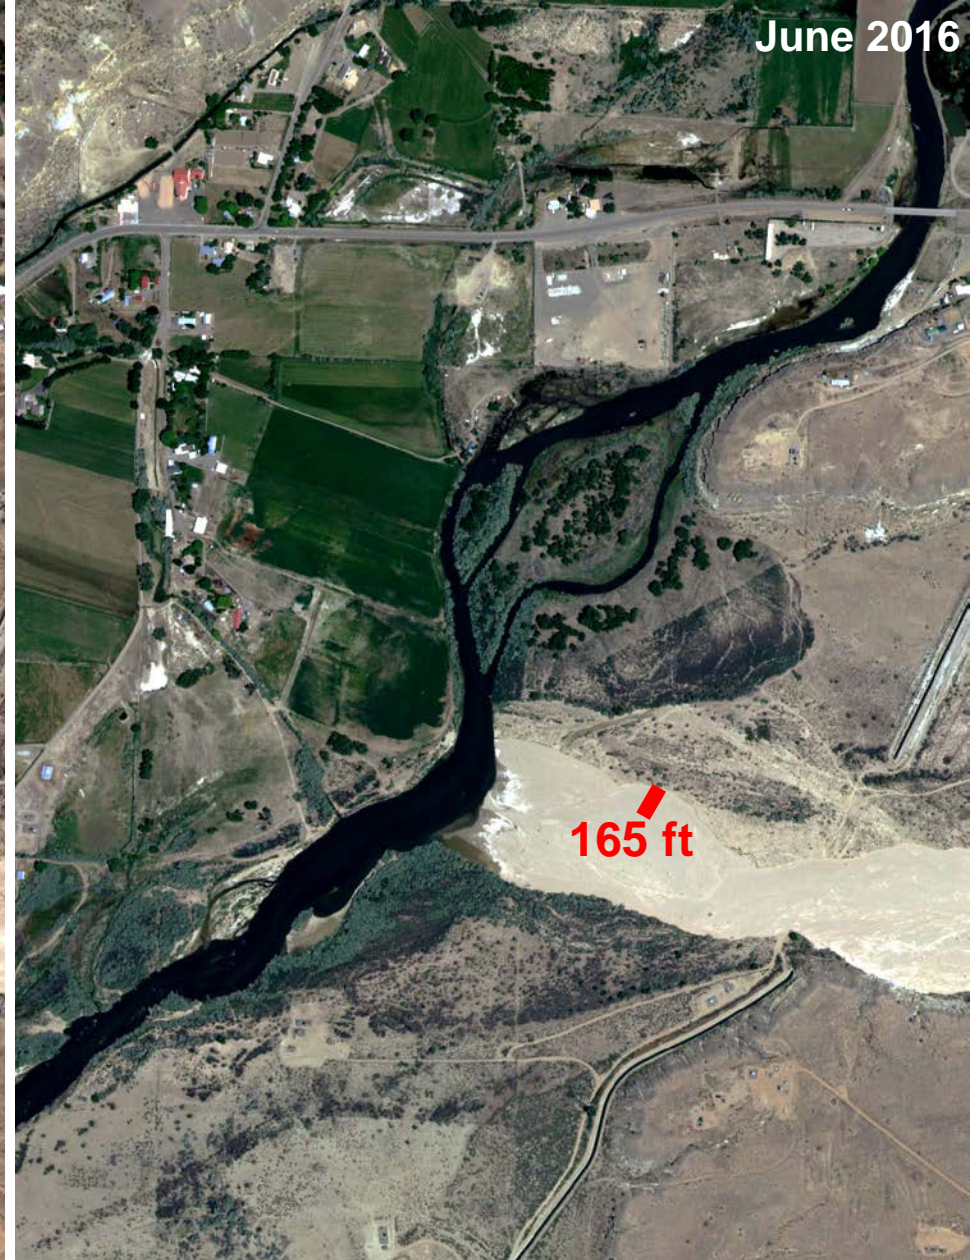
Cañon Largo sedimentation and erosion at San Juan River, Blanco, NM
