Carlsbad Brine Well Update

October 13, 2011

Jim's Water Service Brine Well Collapse

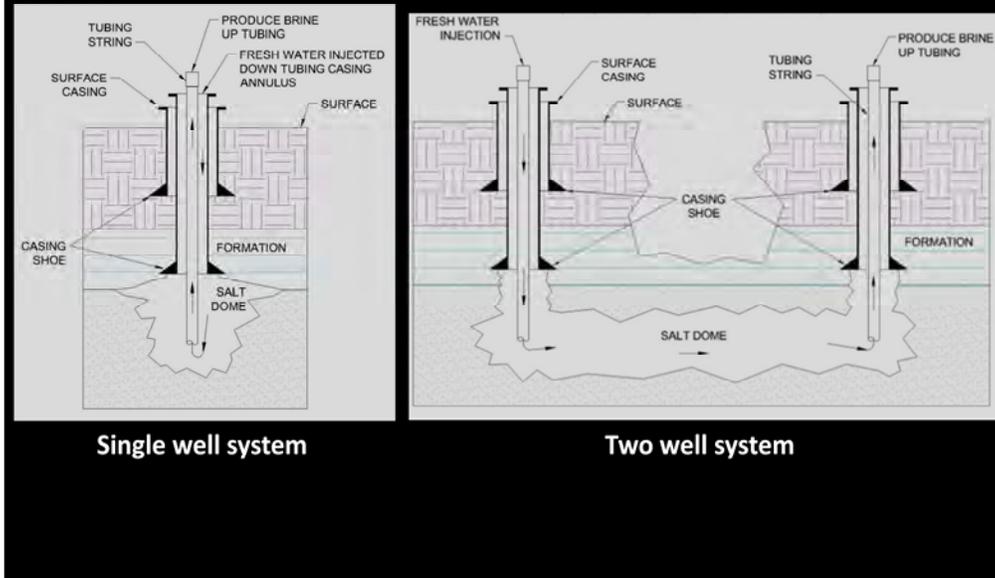
Brine well configurations

A “brine well” is a solution mining operation. Fresh water is introduced into the subsurface through a well casing or tubing, thereby dissolving the salt. The brine is then pumped out and trucked to wellsites for use.

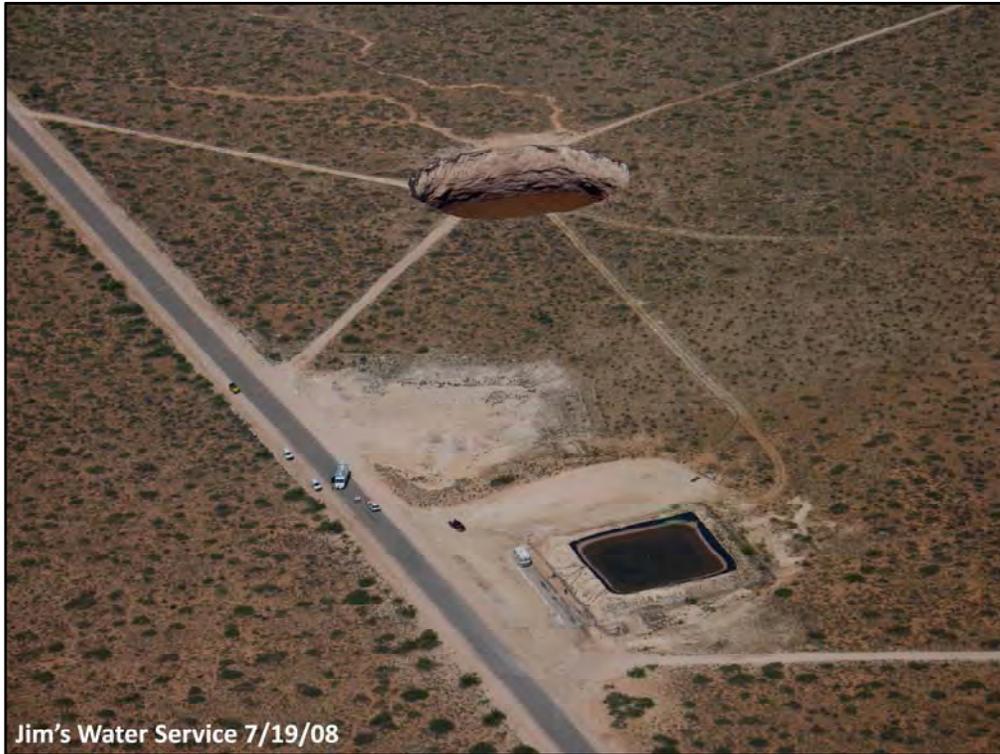
On July 16, 2008 the OCD received a phone call from a representative of Jim's Water Service of New Mexico (JWS) asking about the permitting process for a new brine well. During that conversation the OCD inquired as to the need for a new well as JWS already had an active brine well in Eddy County approximately 17 miles southeast of Artesia. Their initial response was to say they had "lost the well". After several more minutes of discussion, the OCD was informed that at approximately 8:15 that morning during a routine inspection an employee was approaching the well when he observed a significant amount of dust. He stopped, got out of his truck, and immediately noticed severe ground movement and a crack propagating toward him. Within minutes he observed a sinkhole centered on the former location of the wellhead.

The site is located on State Trust land otherwise used for grazing. The area was fenced by JWS and is monitored to see if subsidence is adversely affecting the adjacent roadway (NM 217). This brine well first came into production in March 1979 under the ownership of Permian Brine Sales. The well was constructed by re-entering a former oil well. Depth to salt in the area is 397 feet below surface. Production records are incomplete, but an estimate of total brine production is in excess of 5 million barrels resulting in a mined cavern greater than 750,000 barrels in volume.

On July 23rd, 2008, then EMNRD Cabinet Secretary Joanna Prukop requested a state-wide review of all brine wells including an internal OCD audit and daily well inspections by all operators of active facilities. What precipitated the cavern collapse at the JWS facility is not definitively known. Based on the diameter of the surface hole, the subsurface cavern was at least 300 feet across. Thus, the ratio of cavern diameter to overburden thickness is $300/397$ or 0.76. A general "rule of thumb" in rock mechanics and solution mining says that caverns appear to be stable if this ratio is less than 0.67 (two-thirds).

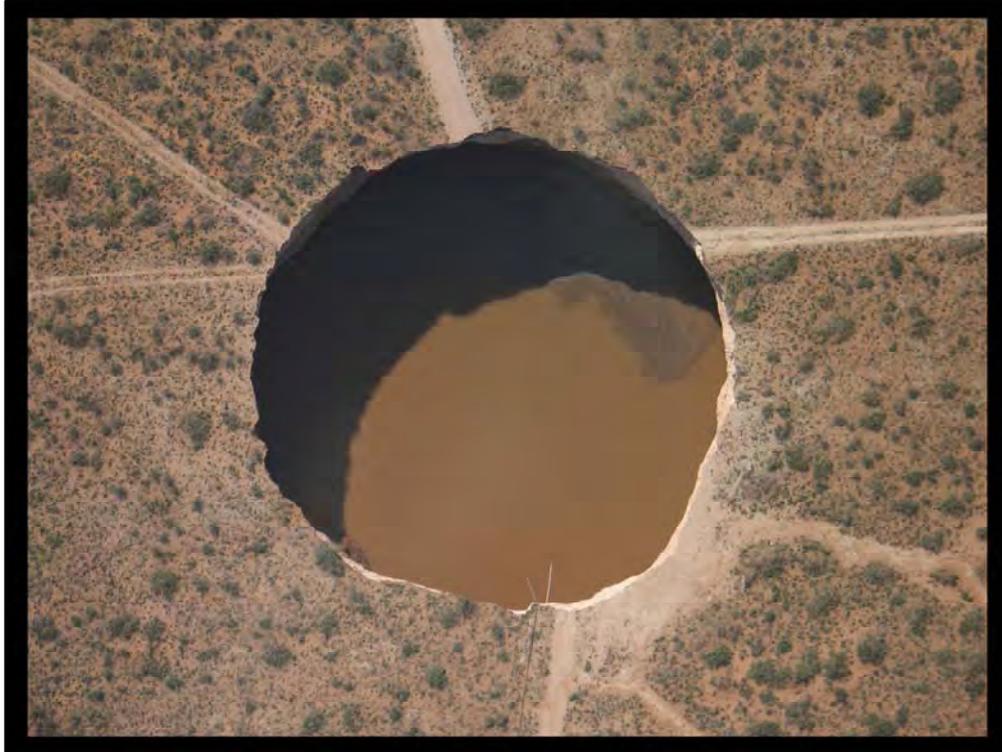
Jim's Water Service Brine Well Collapse - July 16, 2008. The sinkhole contains brine that migrated upward from the cavern as the roof and overburden moved down. There is no significant groundwater in this area.

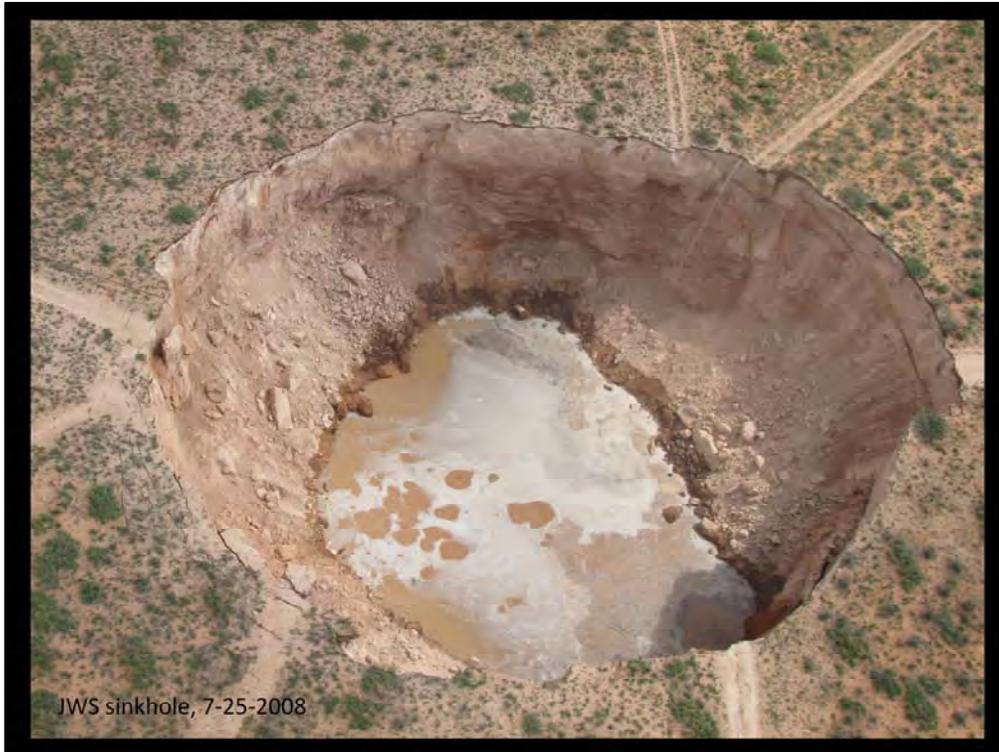
Jim's Water Service Brine Well - July 25, 2008; nine days after collapse. Brine has begun to drain into the surrounding soil and the sidewalls are eroding to a natural angle of repose.

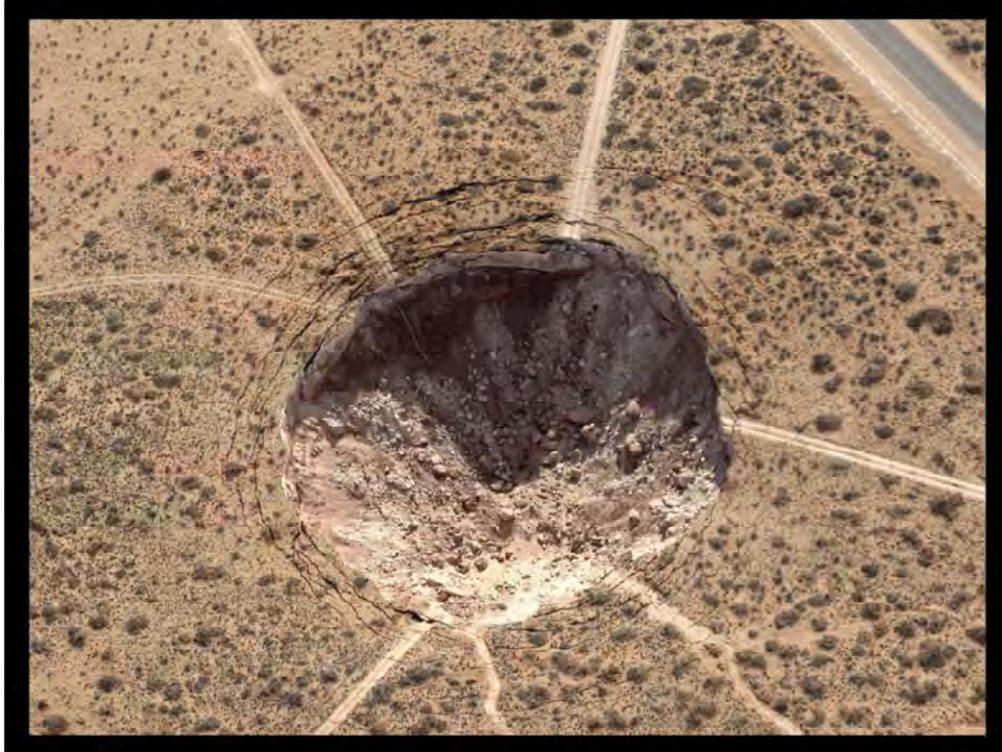
Jim's Water Service Brine Well Collapse -This sinkhole has since grown to a diameter of about 400 feet with a depth greater than 100 feet. Numerous concentric surface cracks appeared immediately after the collapse and identified as far as 300 feet away from the sinkhole's edges.

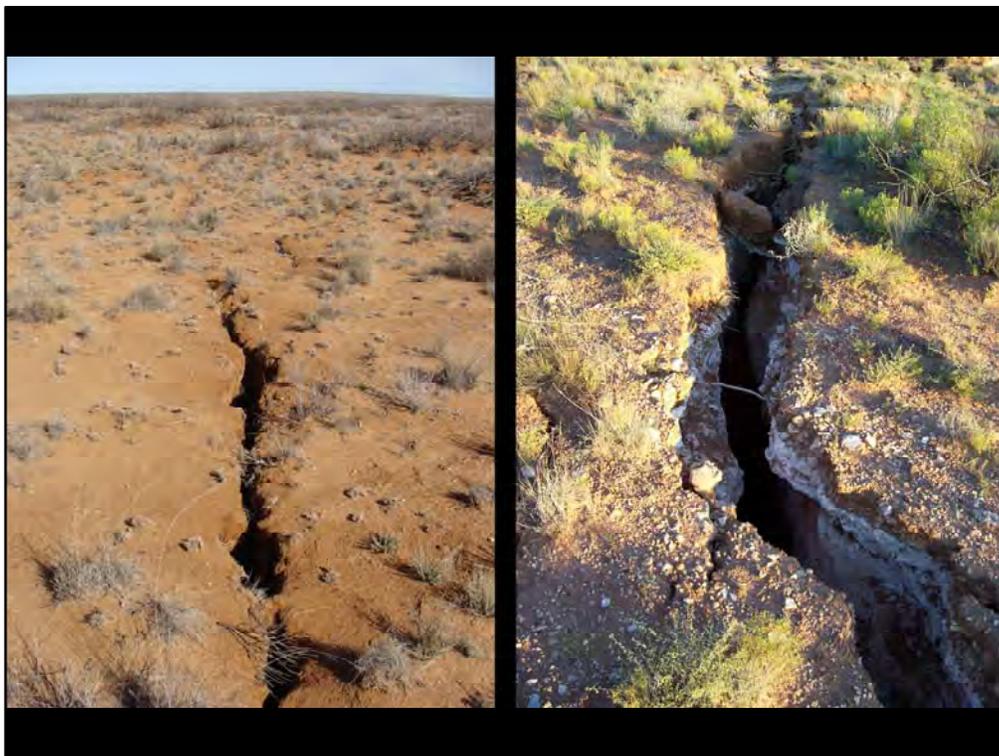
Jim's Water Service Brine Well Collapse –These cracks can be more than 80 feet in length, more than one foot in width, and of an unverified depth.

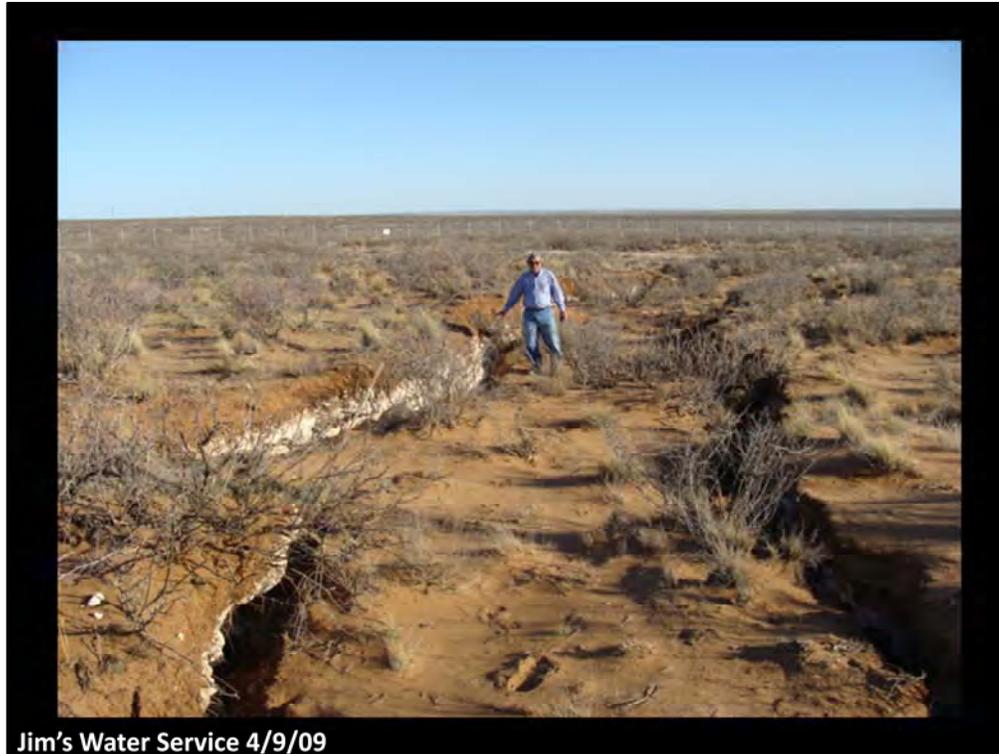
Jim's Water Service Brine Well Collapse – Cracks nine months after collapse. This picture was taken on the northeast side of the sinkhole approximately 60 feet from the edge. The central block has fallen about two feet vertically.

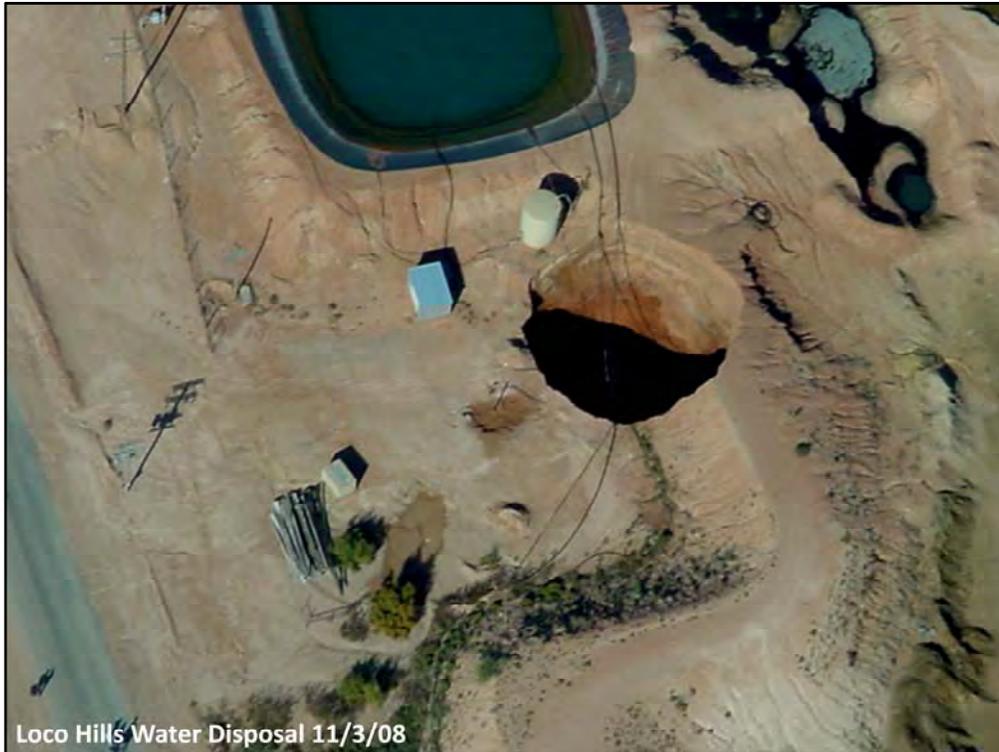
Loco Hills Water Disposal Co. Brine Well Collapse

In June of 2008, a brine well failed a casing integrity test located at the Loco Hills Water Disposal facility immediately north of the town of Loco Hills, in Eddy County east of Artesia (also on State Trust land). The well was thereafter plugged. This brine well had been in operation since late-1985, depth to salt in the area is 470 feet, and produced approximately 8 million barrels of brine throughout its lifetime. This would have resulted in a cavern nearly 1.2 million barrels in volume.

On November 3rd, 2008 as one of the owners of the Loco Hills facility was returning from lunch, he saw what he thought was a dust devil in the vicinity of the plugged brine well. As he got closer he noticed the dust particles were not swirling, but rather traveling vertically. The brine cavern was collapsing.

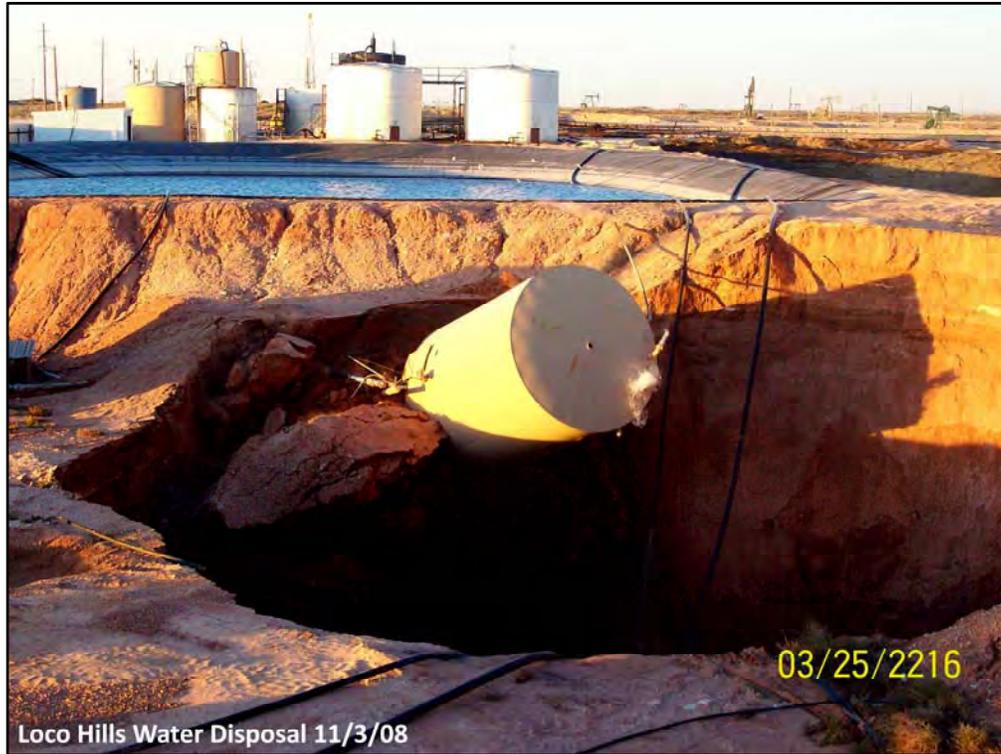
Loco Hills Water Disposal Co. Brine Well Collapse

This picture was taken during the evening of November 3rd, 2008.

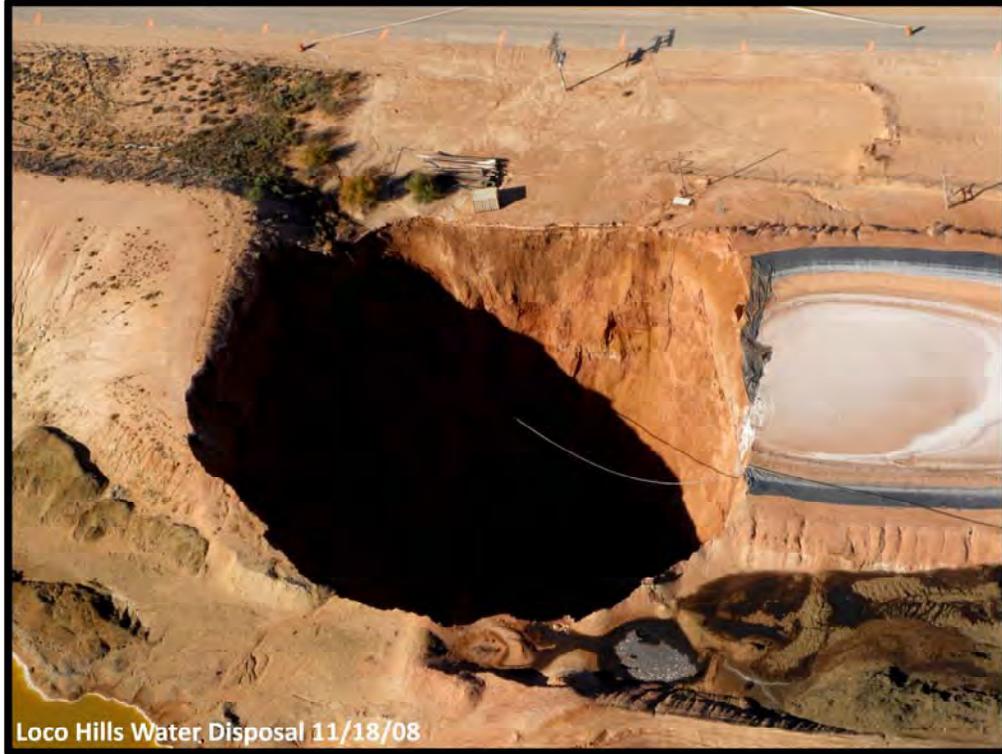
Loco Hills Water Disposal Co. Brine Well Collapse – 15 days after collapse, and still growing eventually to over 300 feet in diameter.

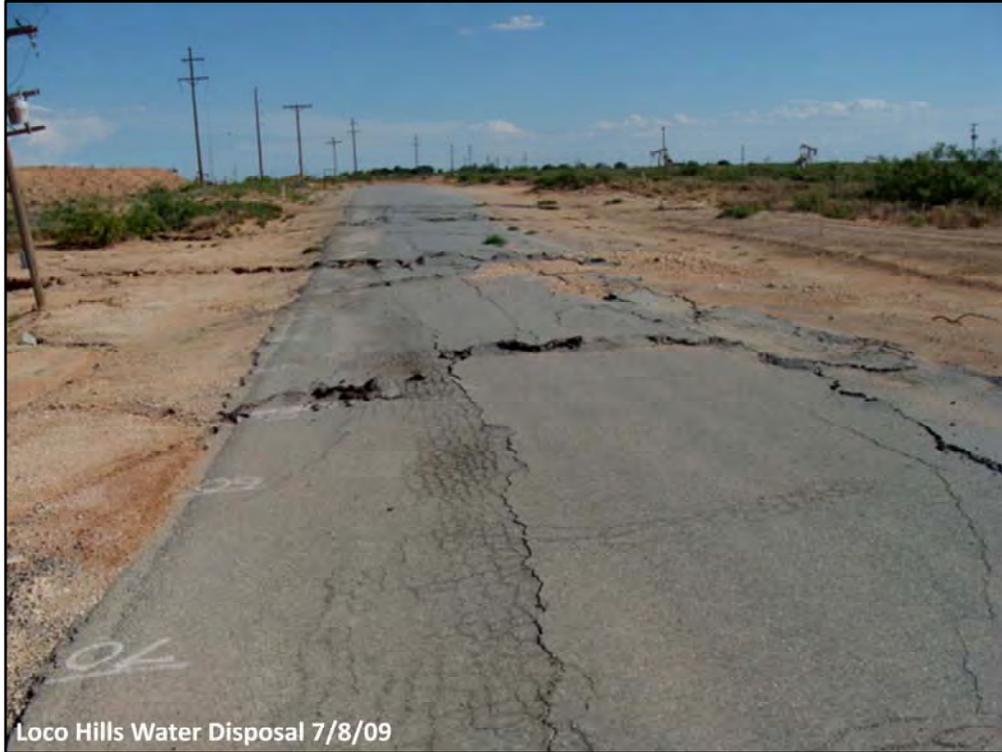
Loco Hills Water Disposal Co. Brine Well Collapse – Cracks formed in outlying areas as also occurred at the JWS sinkhole. These cracks immediately decimated the adjacent public roadway and eventually placed future operation of the disposal facility at risk.

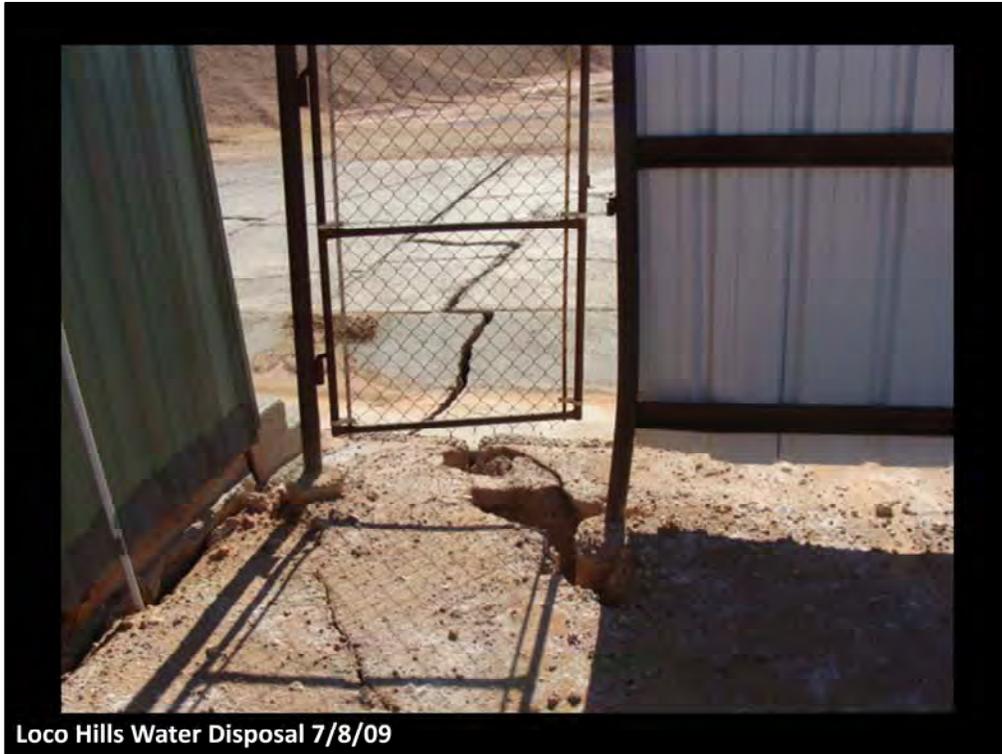
Loco Hills Water Disposal Co. Brine Well Collapse – This crack broke a 4-inch thick reinforced concrete slab.

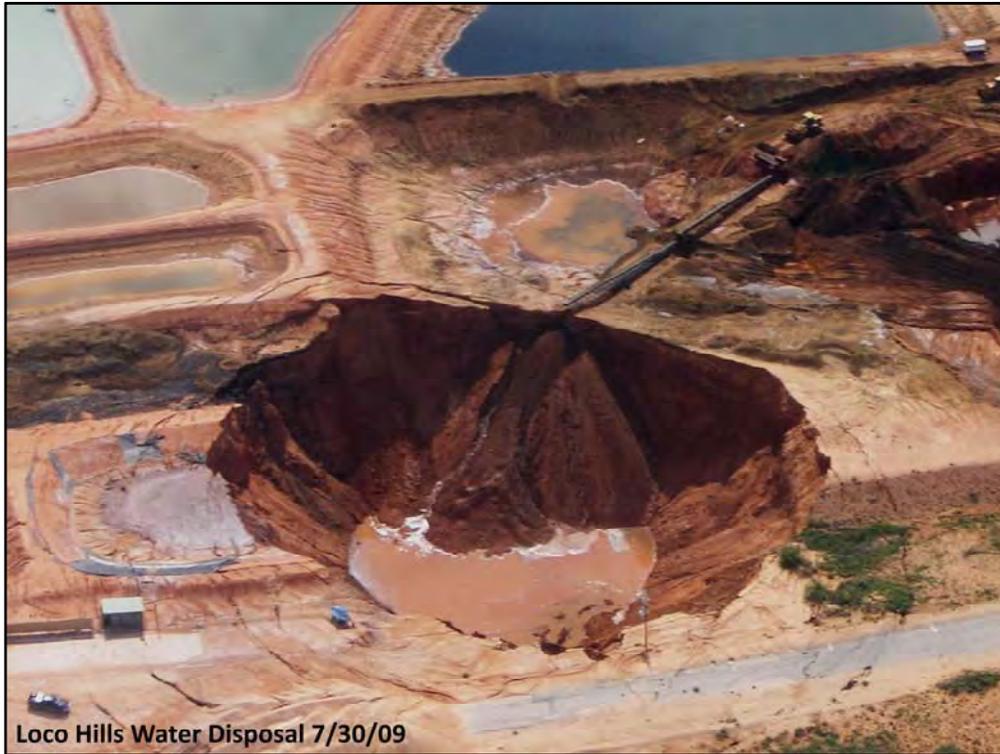
Loco Hills Water Disposal Co. Brine Well Collapse – Due to the continued risk to operations at the water disposal facility in Loco Hills, the operator decided to backfill the sinkhole. This endeavor took several months to complete and cost approximately \$1.3 million. Based on sonar logging of the brine cavern undertaken in February of 2001, the maximum cavern diameter was 310 feet. This placed the ratio of diameter to overburden thickness at $310/470$ or 0.66, right at the “rule of thumb” limit discussed previously.

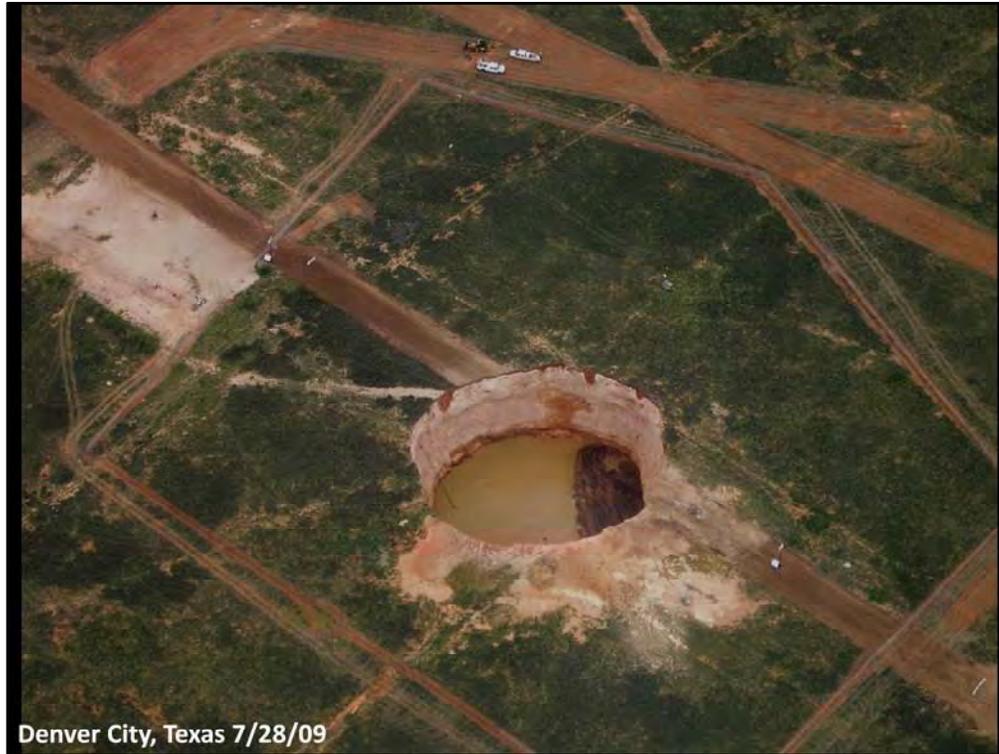
Denver City, Texas Brine Well Collapse

On July 27th, 2009 just over one year after the JWS brine well collapse, another sinkhole associated with brine production appeared overnight in the Permian Basin. This time just east of Denver City, Texas in Yoakum County about 15 miles from the Texas/New Mexico border.

This brine well came into production in 1974 but was completed as a re-entry into an oil and gas well originally drilled in 1958 and mined salt from the same geologic salt formation (Salado) as all brine wells in New Mexico. The depth to this formation in that area is approximately 2,150 feet. Complete information on the well and associated activities is not yet available but the well did experience a casing failure at a depth of 700 feet in 1997 and began venting an estimated 25,000 cubic feet per day of natural gas. The gas was allowed to vent and was flared in hopes of depleting the gas zone, which never occurred. Solution mining of salt continued in the immediate area via adjacent brine wells. An estimate of cavern volume by the Texas Railroad Commission is approximately 885,000 barrels.

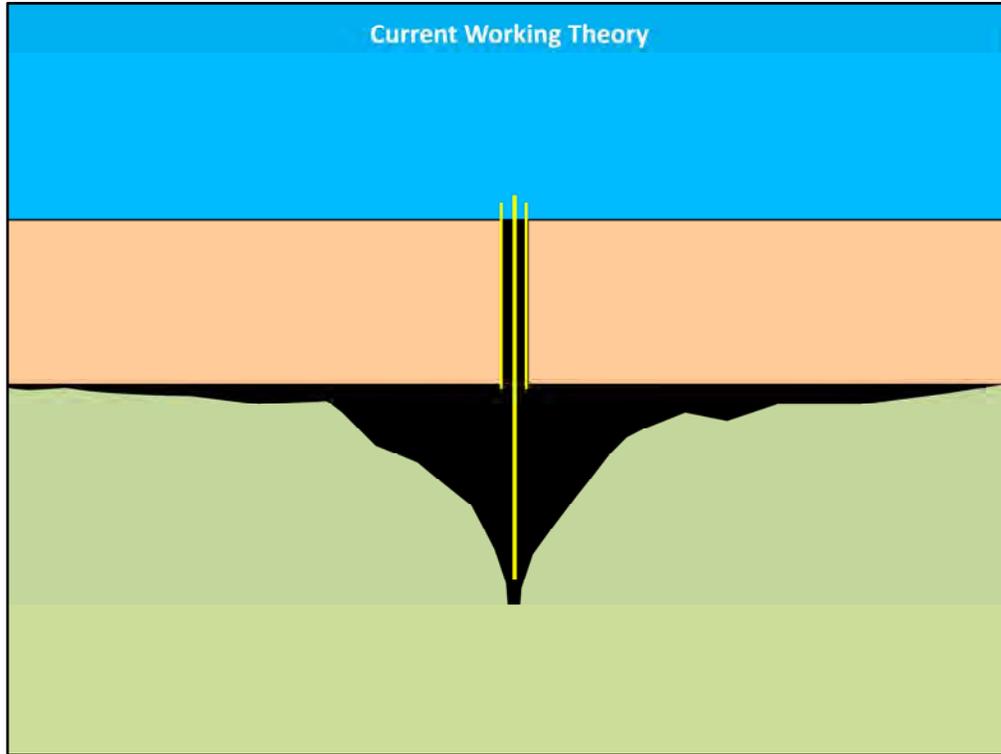
OCD's current working hypothesis is that due to historic setting of the casing shoe at or very near the salt/overburden contact, along with the federal requirement for fresh water injection thru the annular space, has resulted in laterally large solution caverns with deeper central cores in the area of the production tubing. This geometry is a recipe for structural failure and subsidence.

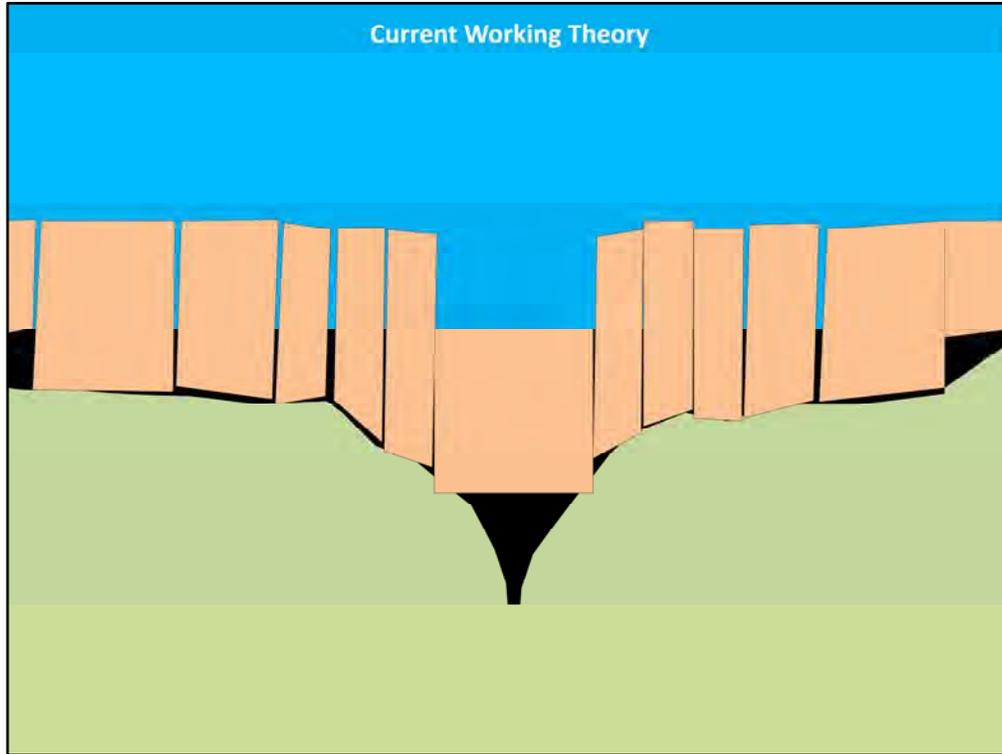
Consequently, when catastrophic failure occurs a deep sinkhole is formed in the immediate area of the well where the cavern height is greater, but the observed concentric fractures are indicative of broader roof collapse in those areas where the cavern height is substantially less.

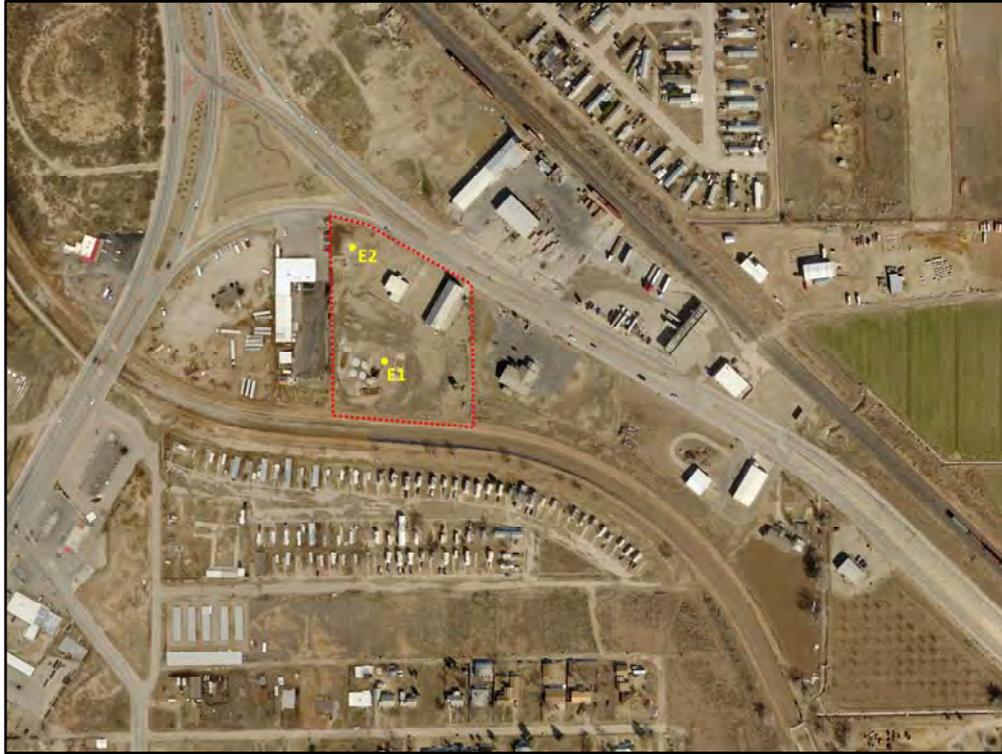
I&W, Inc. Brine Well in Carlsbad

Within days of the first brine well collapse at the JWS facility southeast of Artesia in July 2008 division personnel became concerned about an oilfield trucking operation in Carlsbad owned by I&W, Inc. which included an active brine well of similar depth and production history. This facility is located amidst two major roadways, a vital irrigation canal, a trailer park, a church, a feed store, an agricultural dry goods facility, a truck stop, and a railway servicing the potash industry.

On July 22, 2008 brine production from the remaining operational well was terminated at OCD's direction and the well was plugged in October of that year. On March 11, 2009 OCD recommended the operator consider shutting down remaining operations and submit contingency planning for a possible collapse including discussions with their neighbors. On March 26th and 27th of 2009, a gathering of the brine well working group was held in Santa Fe to discuss overall brine well safety during which a consensus developed that the brine cavern in Carlsbad had a high probability for collapse.

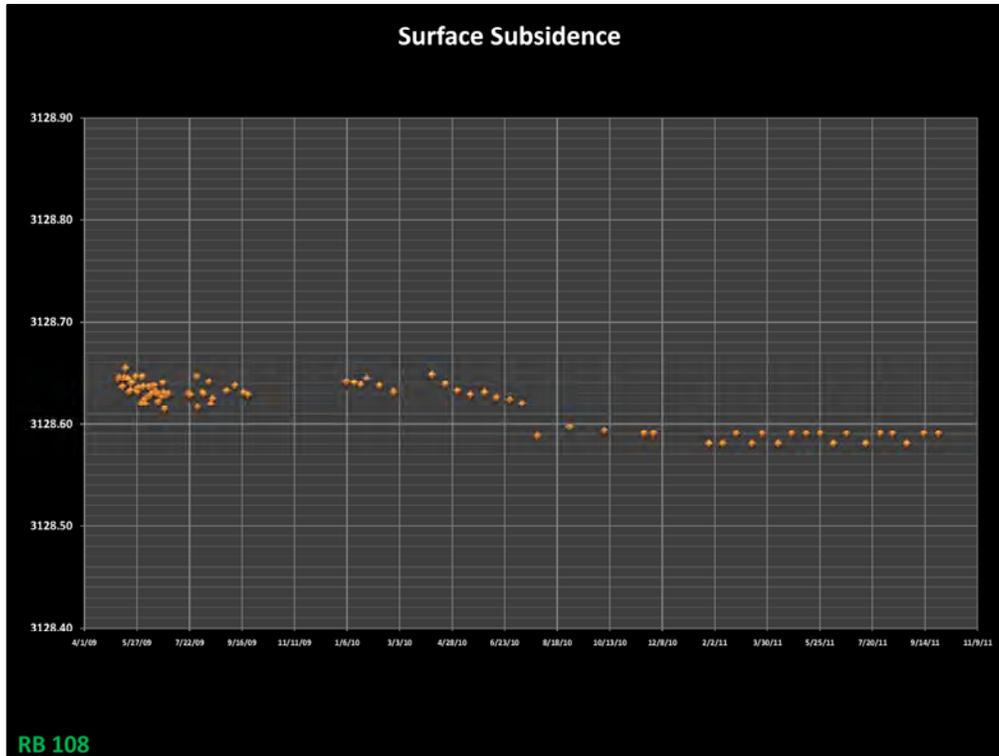
OCD also contracted with a knowledgeable engineering firm to undertake characterization of the brine cavern and install an automated system to detect ground movement. The graph above provides historic surface survey data for one of 71 benchmarks established atop the presumed brine cavern and surveyed on a regular basis. This particular location is above the center of the cavern and has subsided about three-quarters of an inch over the past two years. Approximately half that subsidence occurred during July of 2010 when less than one percent of the brine was allowed to flow from the cavern during a re-entry procedure.

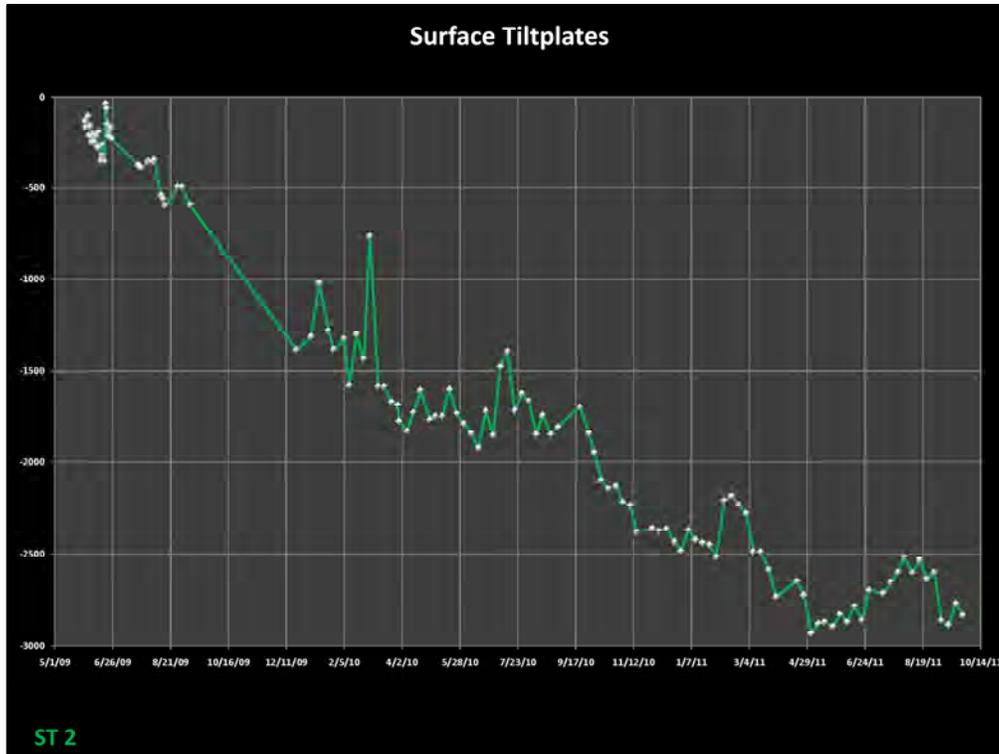
A group of X surface tiltplates were also installed in the area. The graph above presents data from one such plate located within a highway median along US 285 northeast of the I&W facility. The measured displacement indicates a change in tilt of not quite one-quarter of one degree.

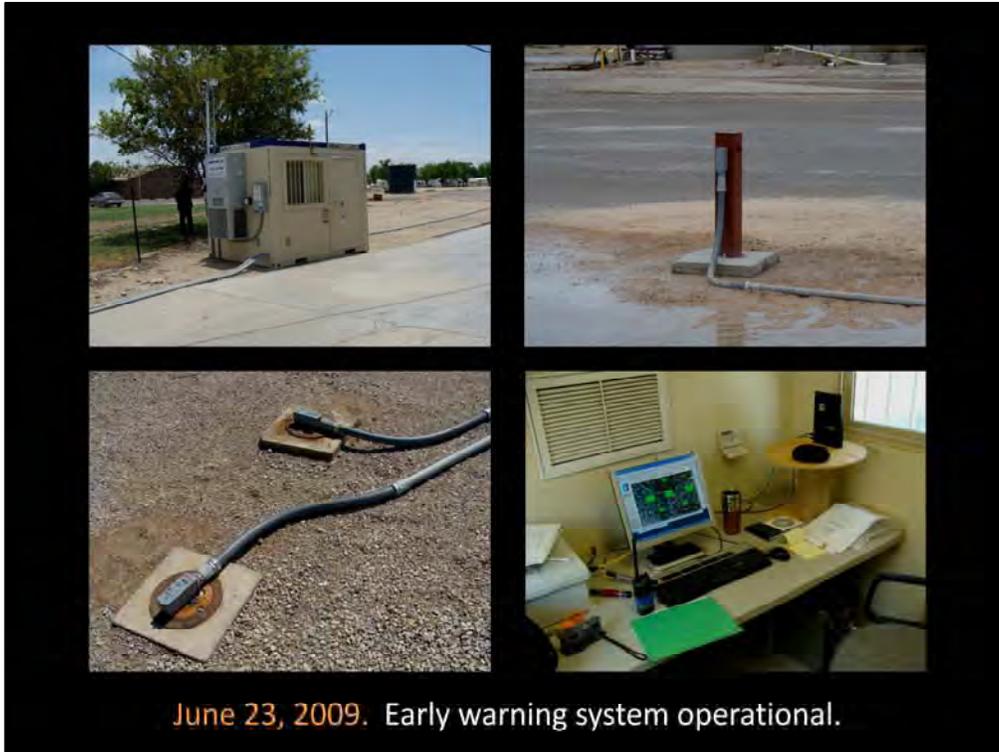
The early warning system became operational on June 23, 2009 and consists of four borehole tiltmeters, two pressure transducers monitoring groundwater levels, and two pressure transducers monitoring brine cavern pressure. Data is logged from all sensors every minute, uploaded to an offsite server every five minutes, and automatically checked against preset alarm levels. If an alarm condition is observed, the system digitally alerts the Eddy County Emergency Response infrastructure and the OCD.

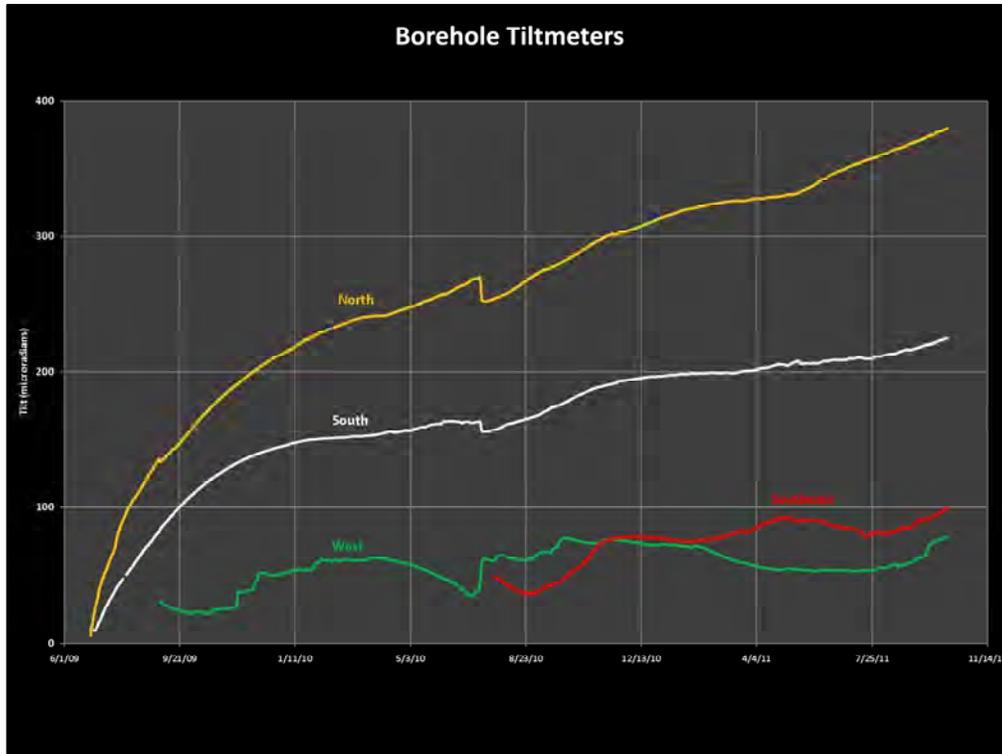
Data from the borehole tiltmeters has shown almost continual ground movement since July of 2009. The rate of movement accelerates during the irrigation season due to losses of water from the unlined canal. The distinct movement recorded in July of 2010 on 3 of the four meters is associated with brine flow from the cavern during re-entry for sonar logging.

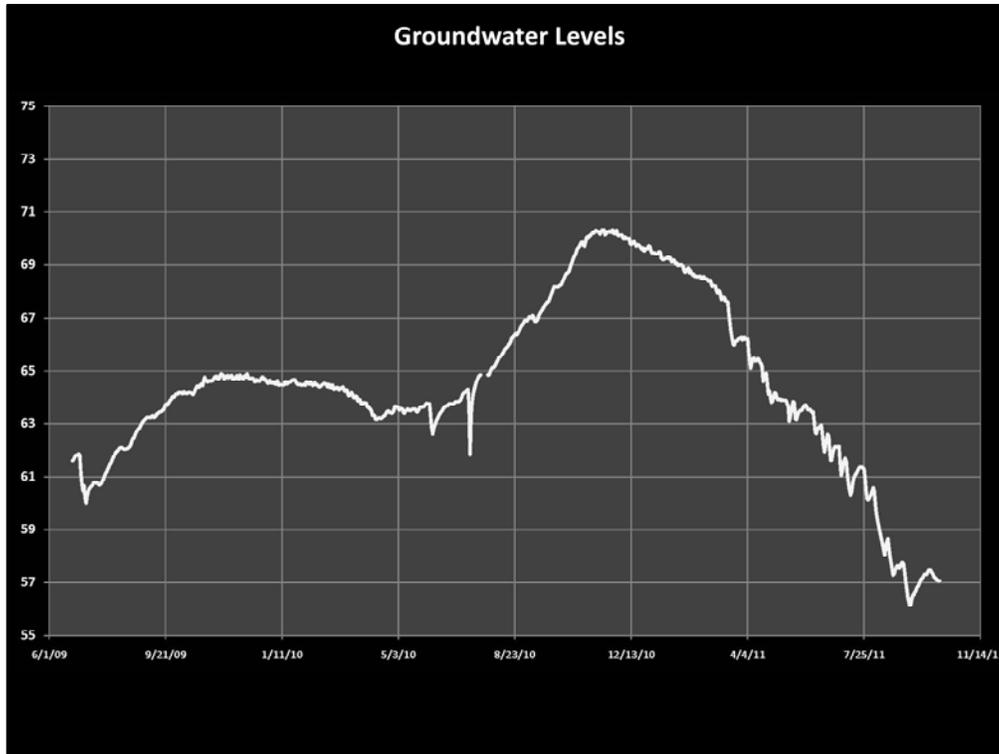
Groundwater levels in the aquifer situated several hundred feet above the brine cavern vary based on precipitation, regional pumping, and canal losses. If the brine cavern were to fail, upward movement of brine into this freshwater aquifer would render a large amount of the groundwater unusable.

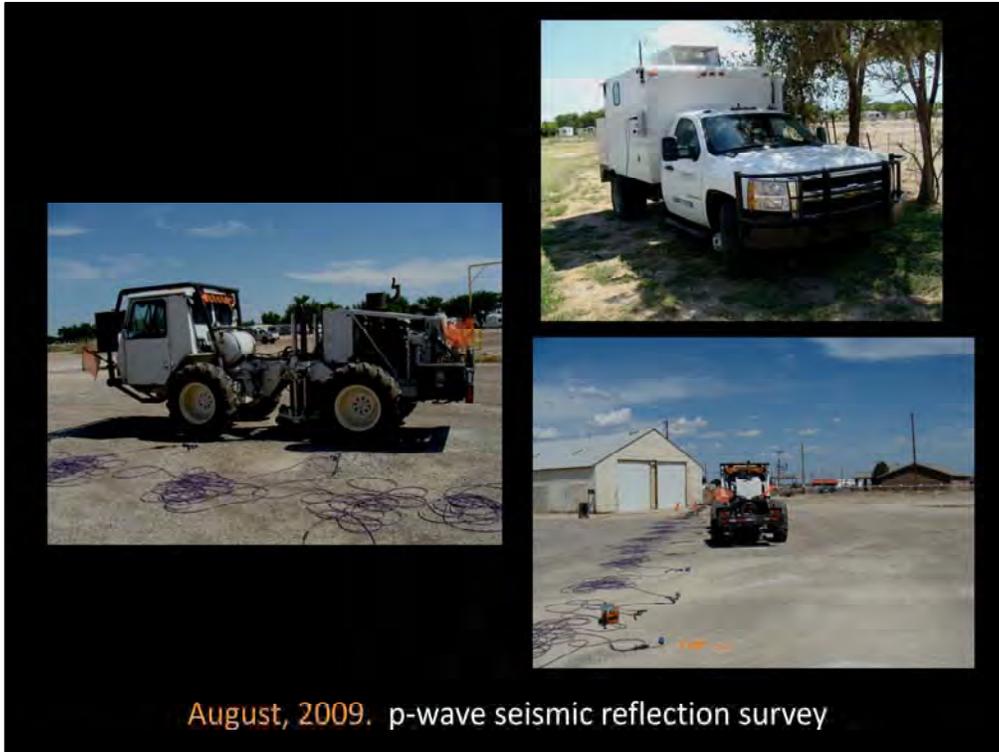
In August of 2009, a two-dimensional seismic reflection survey was completed to determine the lateral extents of the cavern.

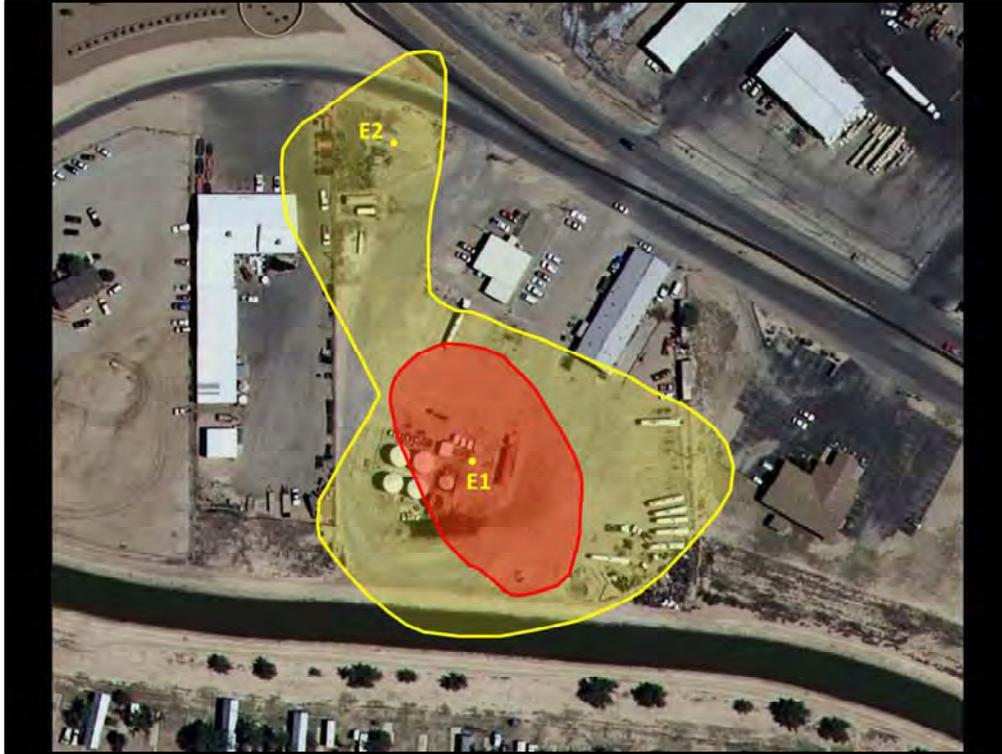
The area shaded in yellow represents an interpretation of the seismic data which likely indicates brine cavern heights in excess of 25 feet. The area shaded in red is indicative of the salt being completely removed.

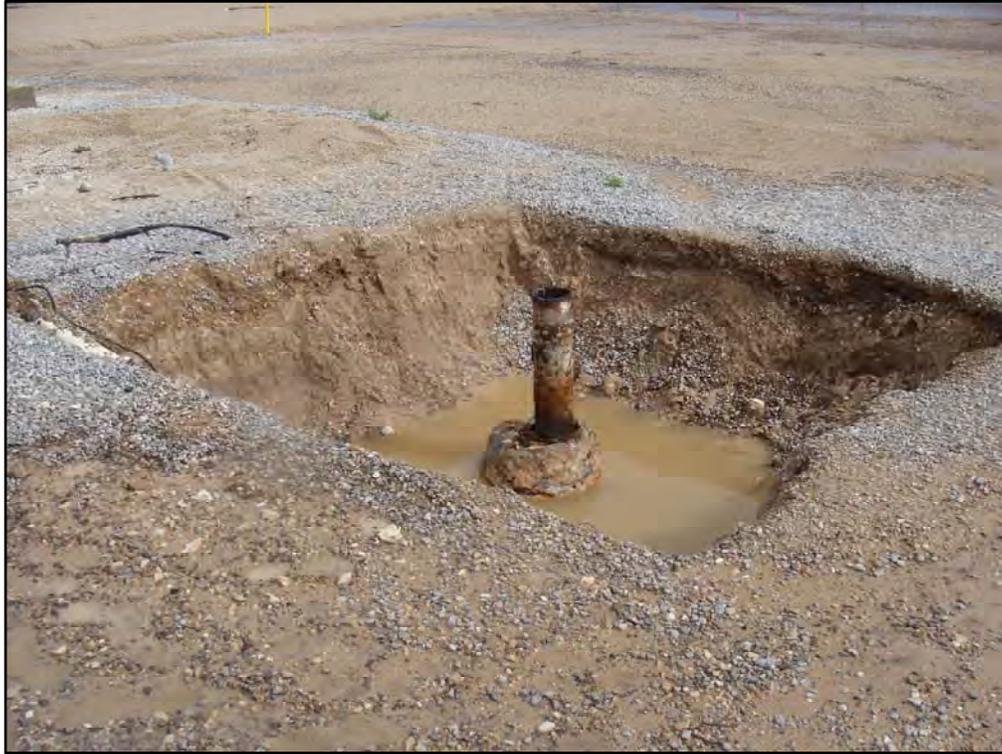
Re-entry of one of the brine wells for purposes of sonar logging was attempted by contractors for the city during July and September of 2010. This is a photo of the Eugenie #1 well with the P&A marker removed and a small pit excavated around the wellhead.

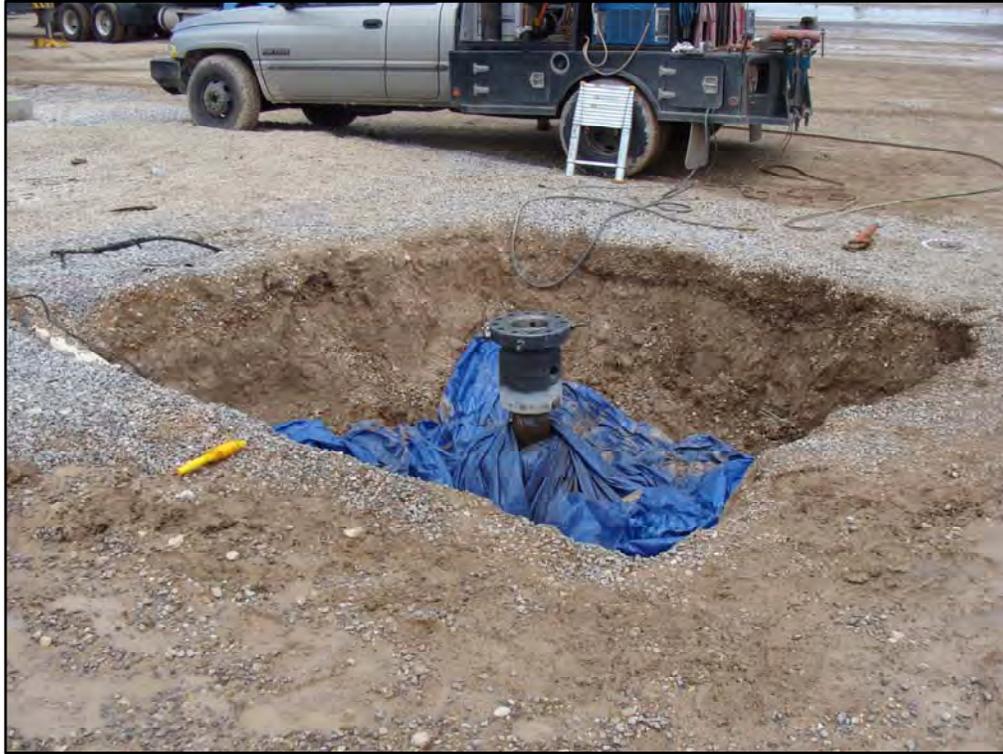
A bradenhead flange was then welded to the casing.
