Carlsbad Brine Well Update

October 13, 2011

Jim's Water Service Brine Well Collapse

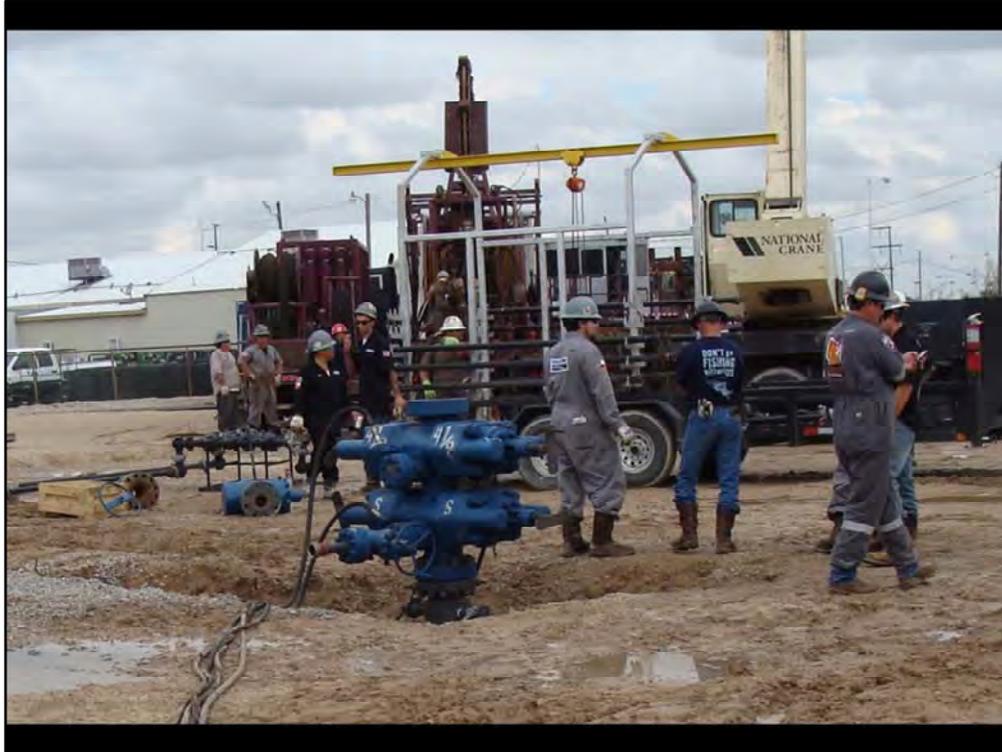
A blowout preventer was fastened to the bradenhead flange.

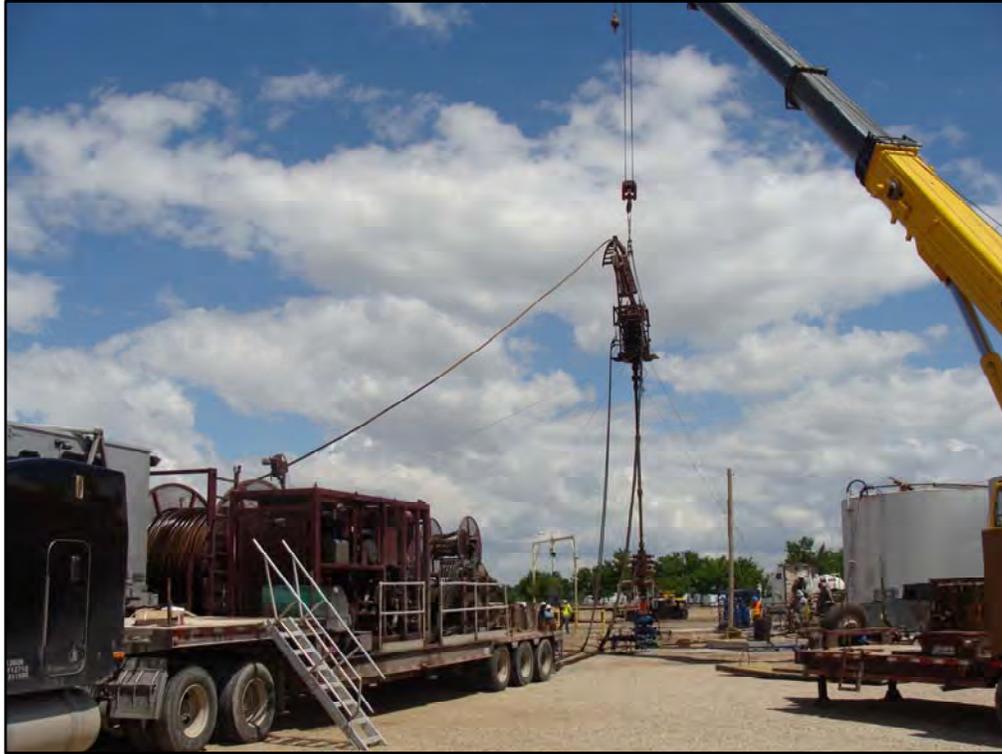
The previously cemented well casing was then drilled out using a coiled tubing system to prevent excessive weight being placed on the potentially fragile wellbore. Drilling thru the cement and cast iron bridge plug only took a few hours.

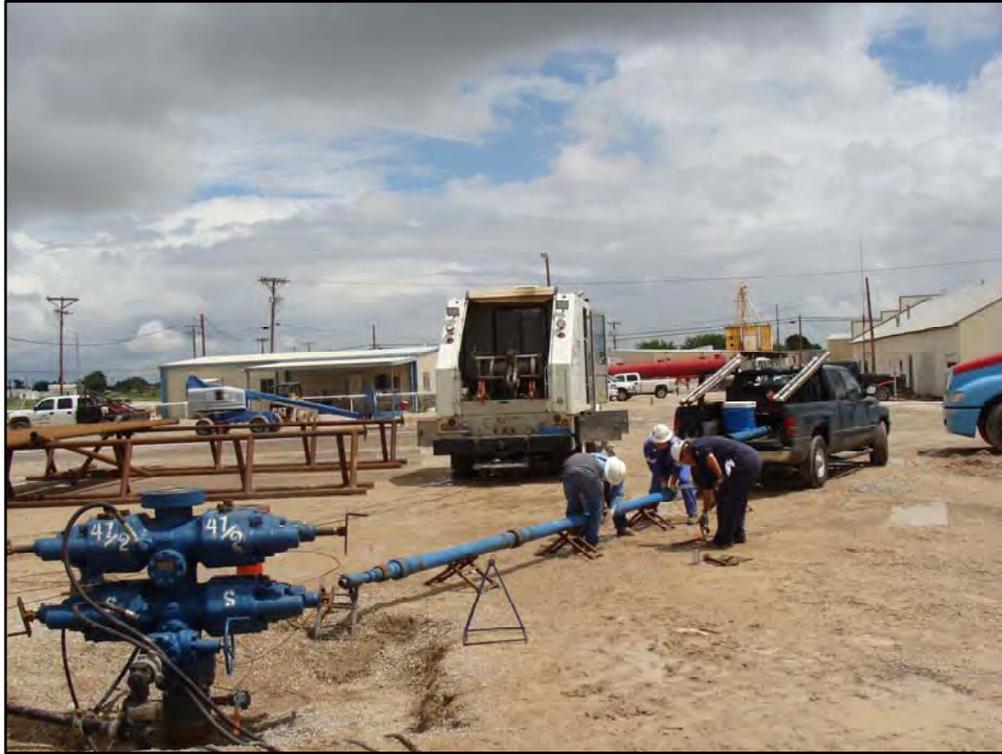
Once the cement and plug had been drilled out, the well was allowed to flow back brine thru the bradenhead and choke lines into on-site tanks while the upper cavern was logged using a sonar tool. This photograph shows the logging crew assembling a lubricator and the downhole sonar equipment prior to logging.

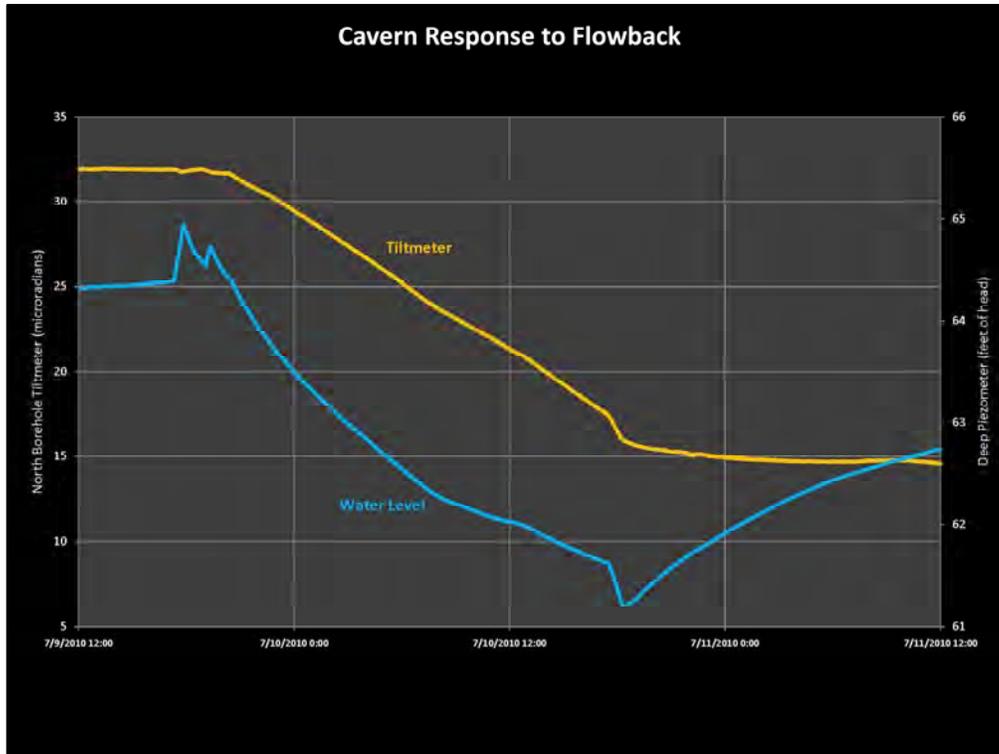
During the period in which brine was allowed to leave the cavern the borehole tiltmeters indicated ground movement and even the deeper water levels showed a response presumably due to an elastoporosity response in the overburden above the brine cavern. When the rate of flowback was temporarily increased, the earth movement and groundwater decline increased as well. When flow from the cavern was terminated, the ground immediately ceased moving and the water level began to return to its original state. This data is strongly indicative of an unstable cavern roof and the presence of brine within the cavern is likely the only remaining support.

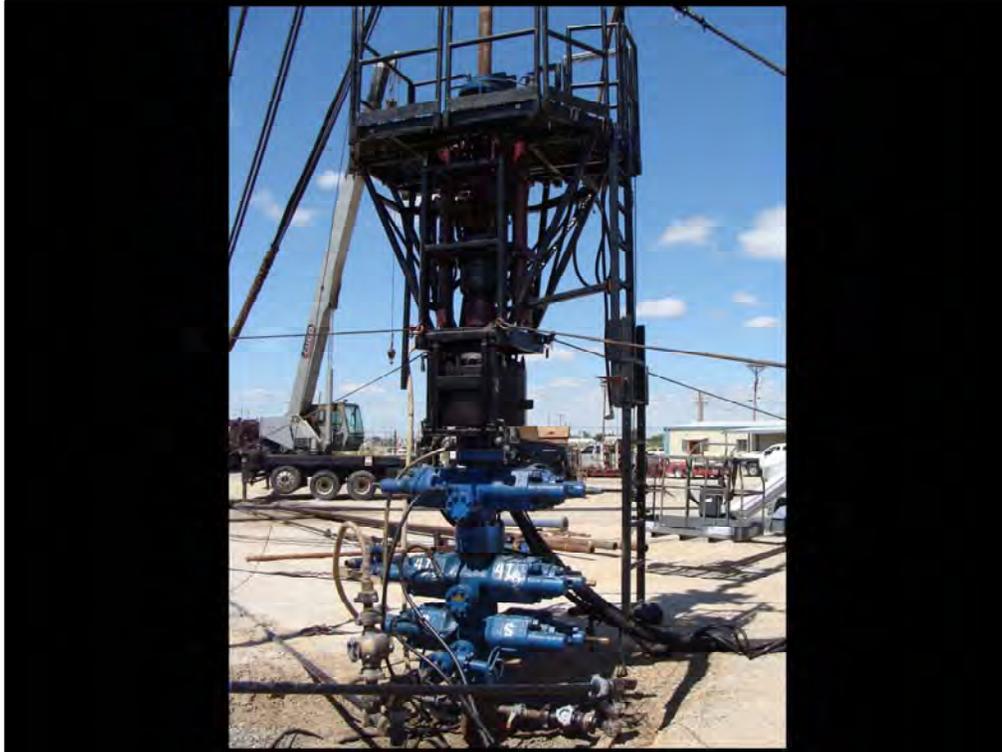
With a desire to still sonar log the cavern, the effort was put off until September of 2010 when a snubbing unit could be deployed to prevent loss of brine.

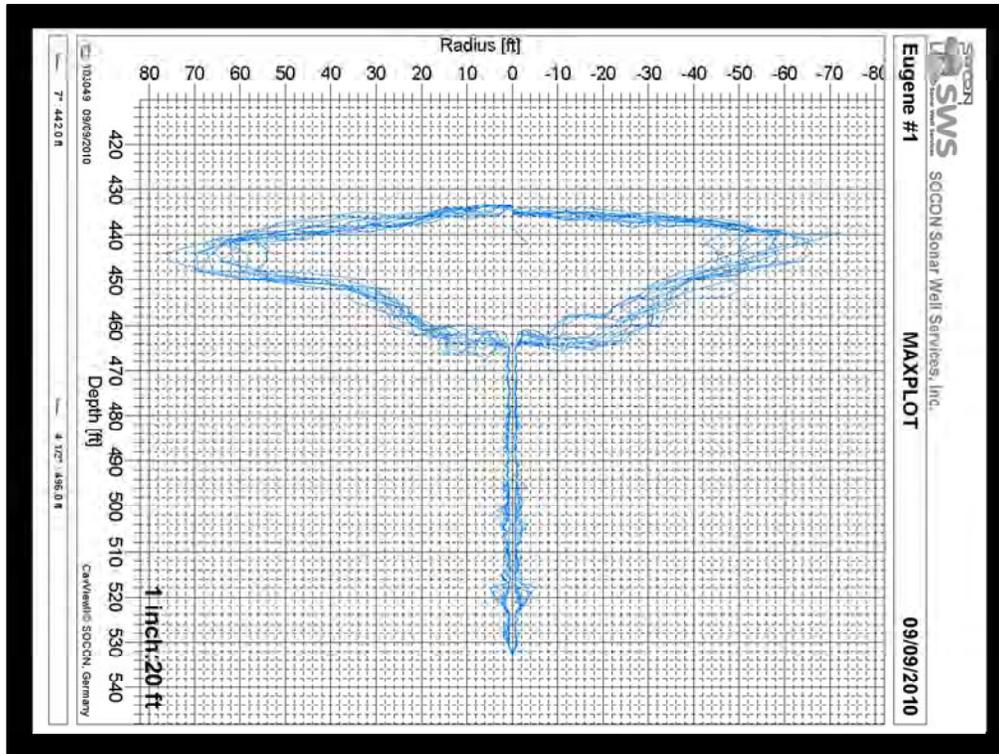
Those efforts did not yield a sonar picture of the larger cavern as had been hoped. A relatively small upper cavern was imaged, but what is most likely a rubble pile of broken material was observed at greater depth. Furthermore, those efforts in large part depleted available funding from the City of Carlsbad.

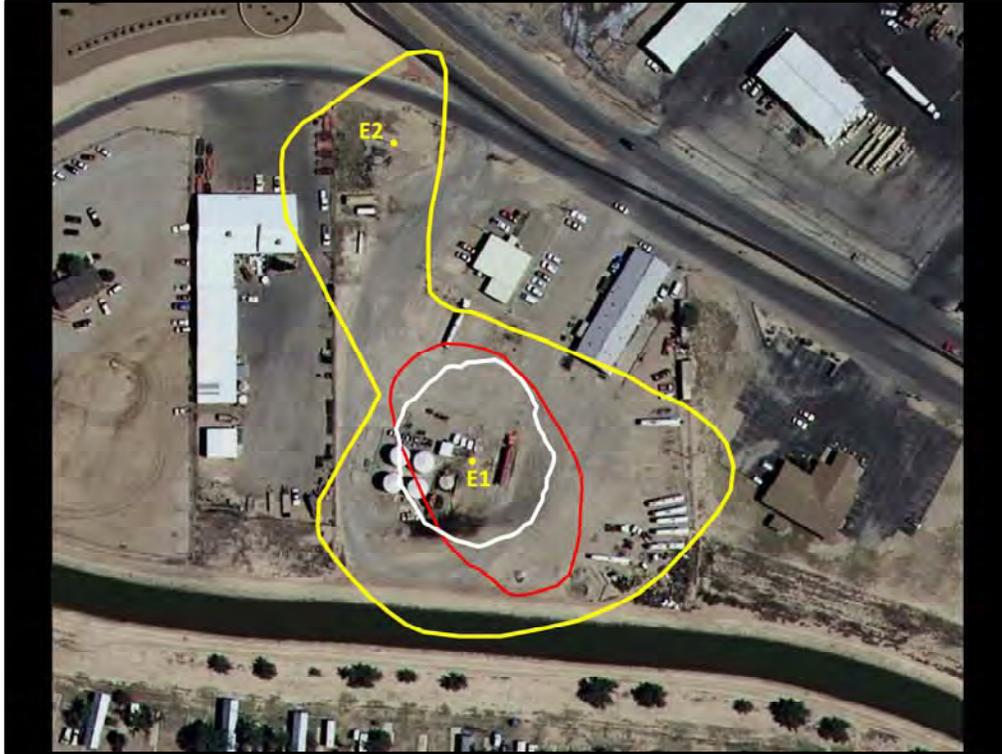
The image above provides the sonar footprint of the upper cavern (in white) overlain upon the seismic interpretation previously presented.

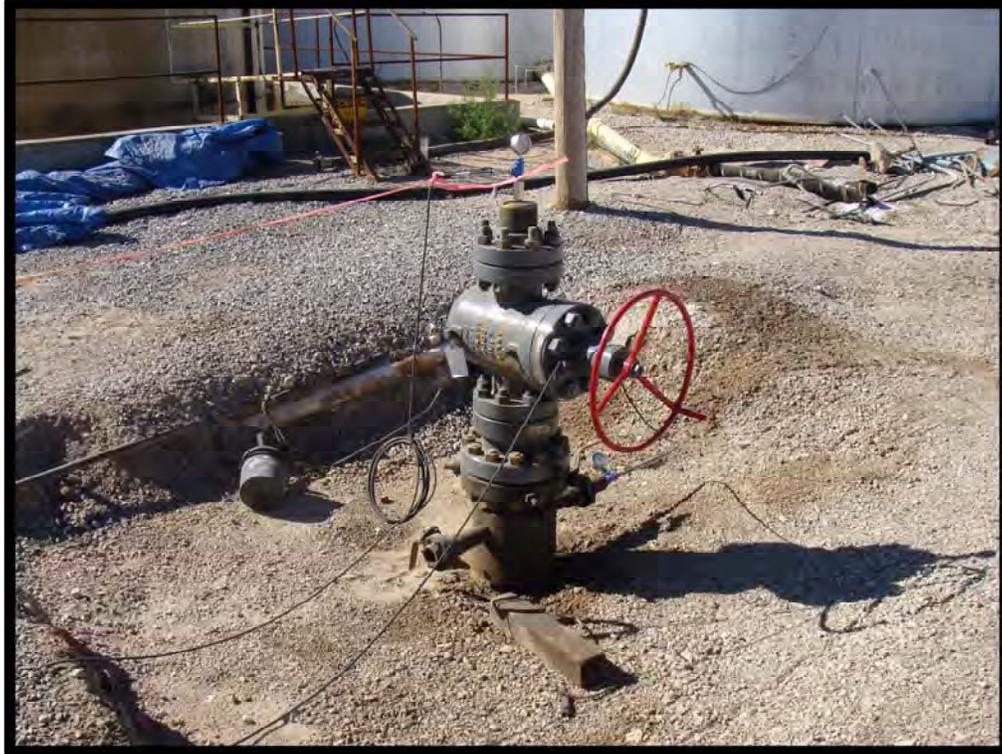
A master valve was fitted to the wellhead and integrated with pressure transducers to gauge the cavern pressure as part of the early warning system.

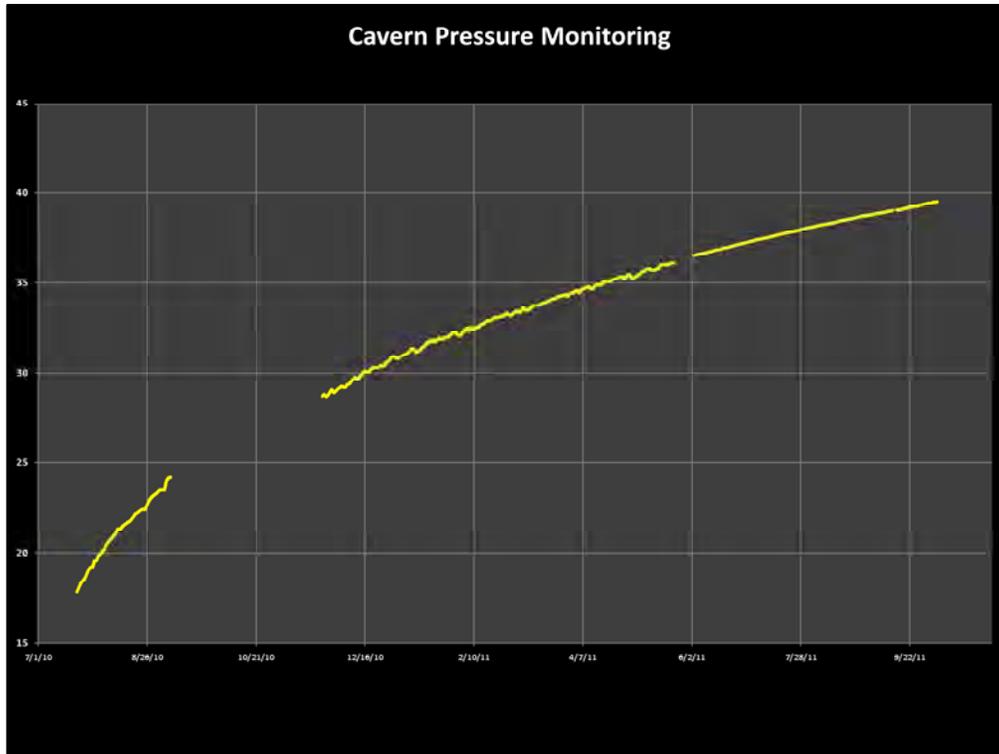
That pressure data shows a continuous climb in cavern pressure which indicates the cavern is hydraulically “tight” at present, but the observed increase could also be indicative of thermal instability, salt creep, and downward overburden movement.

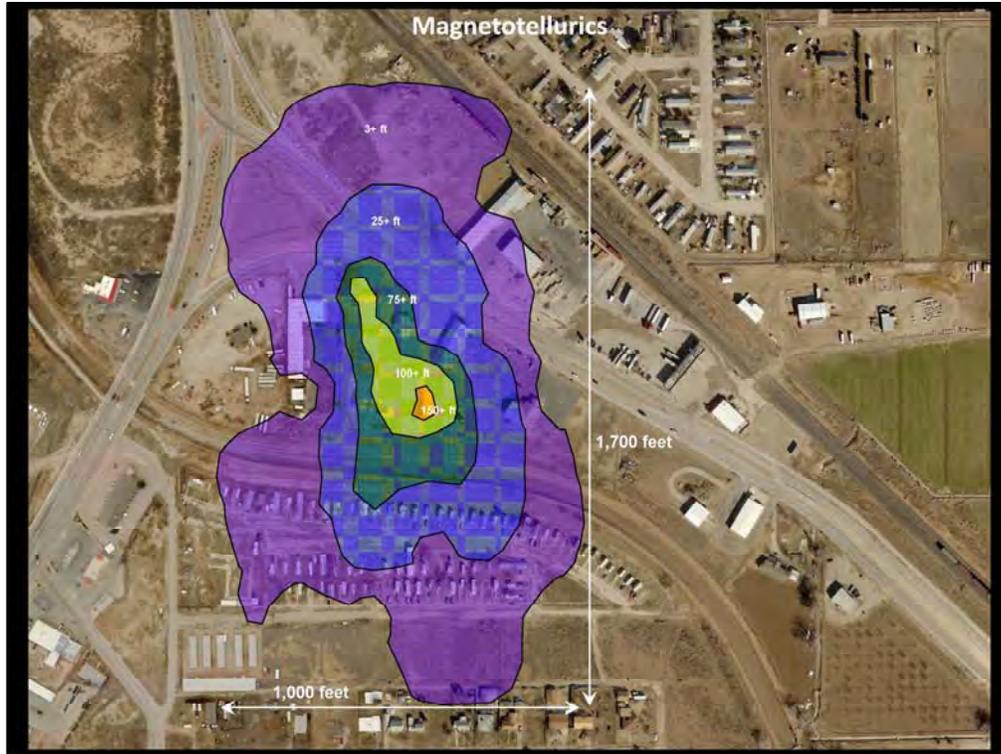
The OCD resumed fiscal and technical oversight of the characterization and early warning efforts in the winter of 2010 supported by the Reclamation Fund. Additional geophysical techniques have been used including digital magnetotelluric imaging. The image presented provides an overlay of the inferred cavern footprint atop an aerial photograph of the area. The area in purple defines disturbed salt and overburden thickness of at least three feet. The area in blue 25 feet. The dark green 75 feet. The lime green 100 feet and the orange greater than 150 feet in disturbed thickness. The potentially impacted zone spans about 1,700 feet North to South and 1,000 feet East to West.

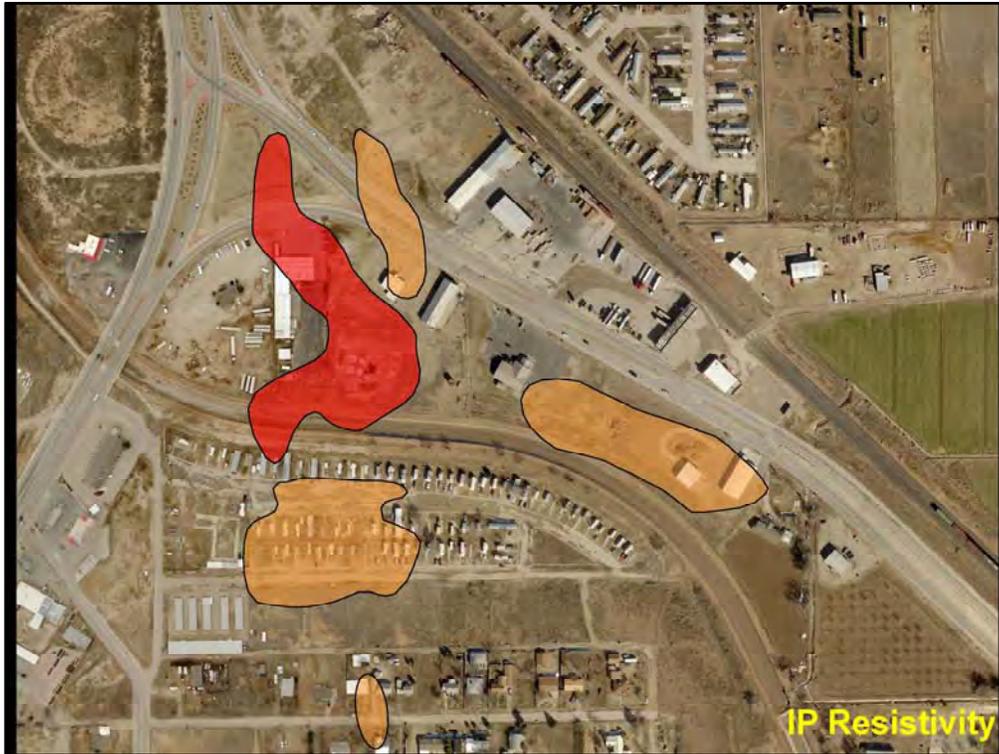
The National Cave & Karst Research Institute in Carlsbad was contracted by the OCD to undertake an induced polarization resistivity survey of the subsurface in the area and those results are partially presented above. The area shaded in red indicates low resistivity (brine) which is likely associated with the cavern. The areas shaded in orange represent low resistivity (brine and/or fresh groundwater) within the overburden.

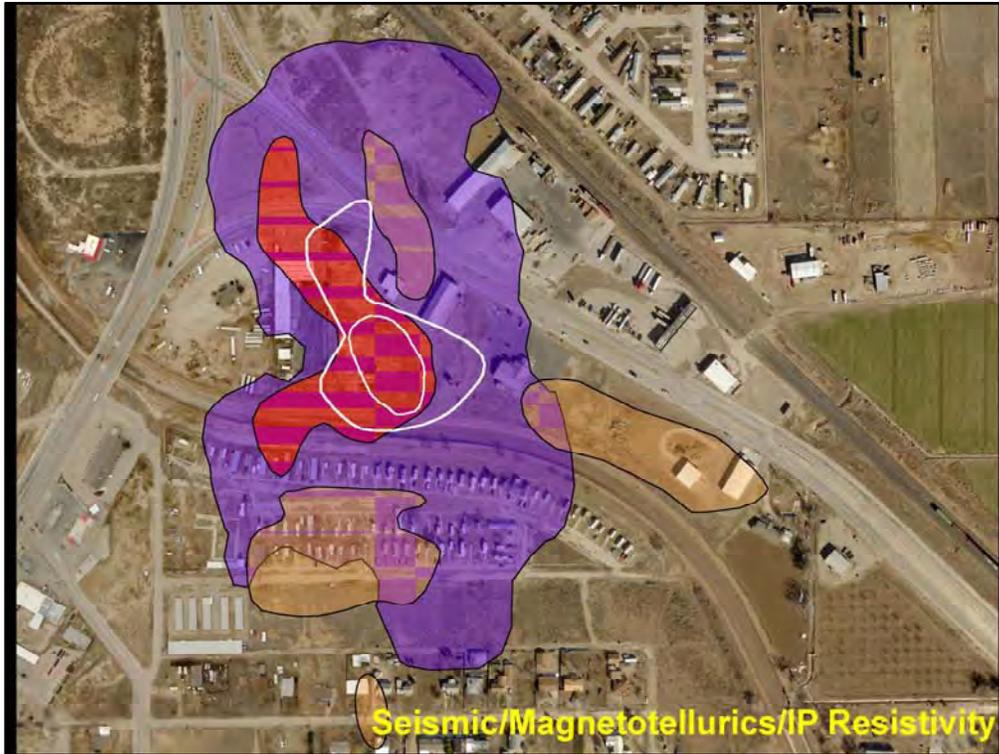
This image provides a combination of the seismic, magnetotelluric, and resistivity profiles. It may not look like it, but there is reasonable agreement between the techniques from a remote geophysical point of view.
