2014

Damage Assessment and Current Actions

Santa Clara Pueblo Canyon

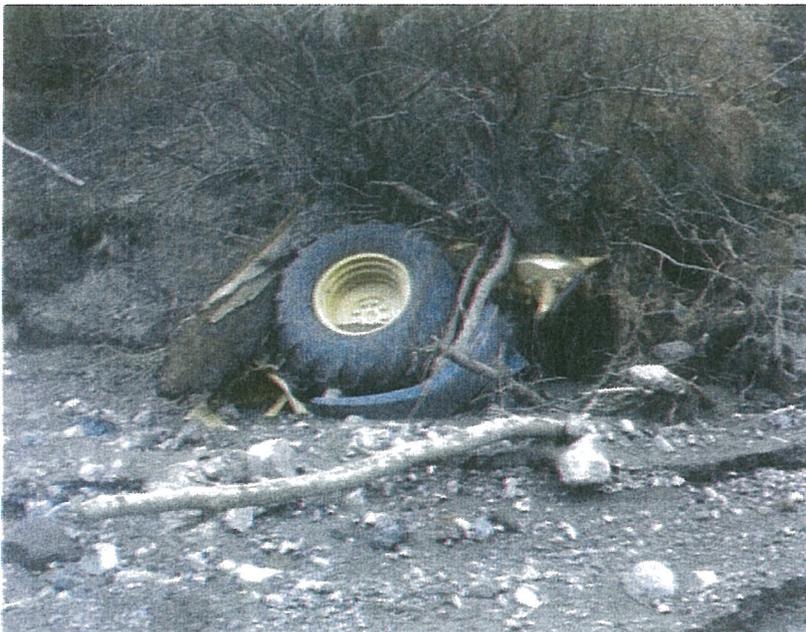
Additionally, after the 2011 event, efforts were made to clear the roadway by USACE maintenance workers from the Abiquiu Lake field office in an attempt to provide access to the ponds for rehabilitation and maintenance. During the operation, a flash flood swept through the work site. A rescue was required to remove the workers by helicopter and the equipment was lost.

USACE equipment lost after 2011 event

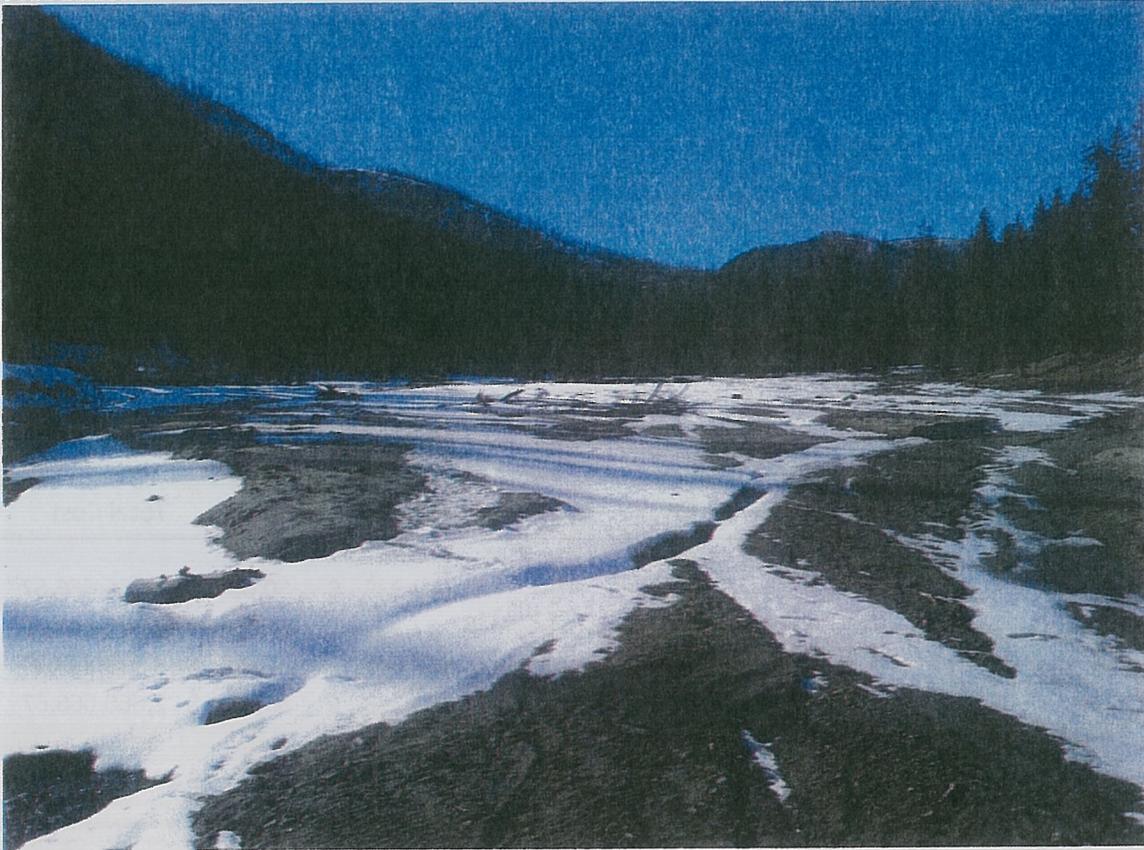
Pond number 4

This assessment finds the actual dimensions of the ponds to be indiscernible after the event of 2013. The areas that were once detention ponds now appear to be wide stream beds as siltation is again, complete.

Due to indiscernible debris in the retention ponds and complete loss of the retention ponds, it was decided to follow the previous methodology. It will be necessary to obtain quantification from the applicant showing the amount or percentage of the work completed in order to estimate

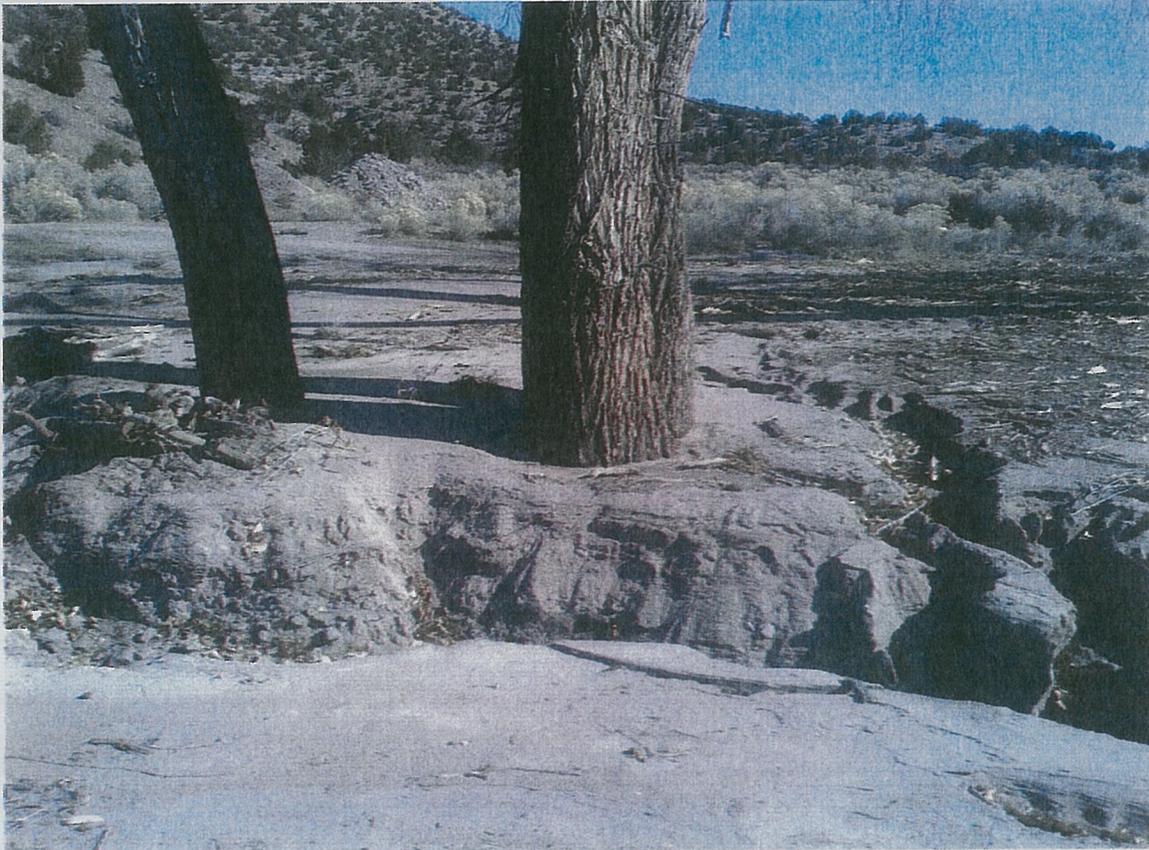
Trees were identified with as much as six feet of sediment deposited around them. If not removed, these trees will die and add additional debris to any future flash flood events. A project of this nature will be costly, as a true scope of work cannot be estimated. This R6 Debris SME recommends that a small section of the canyon that is representative of all areas be completed on a time-and-materials basis. From those incurred costs, an estimate could be compiled for possible bidding purposes if the applicant wishes to contract this project.

Sediment deposited on tree root system.

Beneficial use of resulting mulch and aggregate can be considered in the reduction of project costs. Fallen trees that are not suitable for lumber can be used to construct log weirs in strategic locations throughout the canyon to reduce the speed of runoff and allow the natural disposition of sediment.
