**Indian Affairs Las Conchas Fire  
Talking Points  
For  
Governor Walter E. Dasheno  
Prepared by: J. Michael Chavarria  
Forest Development and Restoration Manager  
Santa Clara Pueblo Forestry Department  
November 1, 2011**

# POST LAS CONCHAS FIRE IMPACTS SANTA CLARA PUEBLO

## Fire Altered Hydrology for Santa Clara Creek

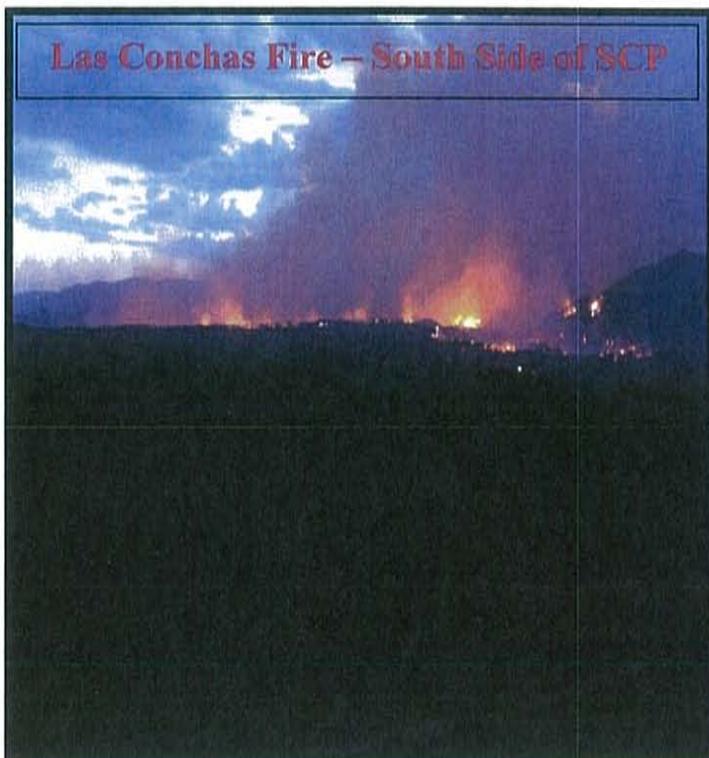
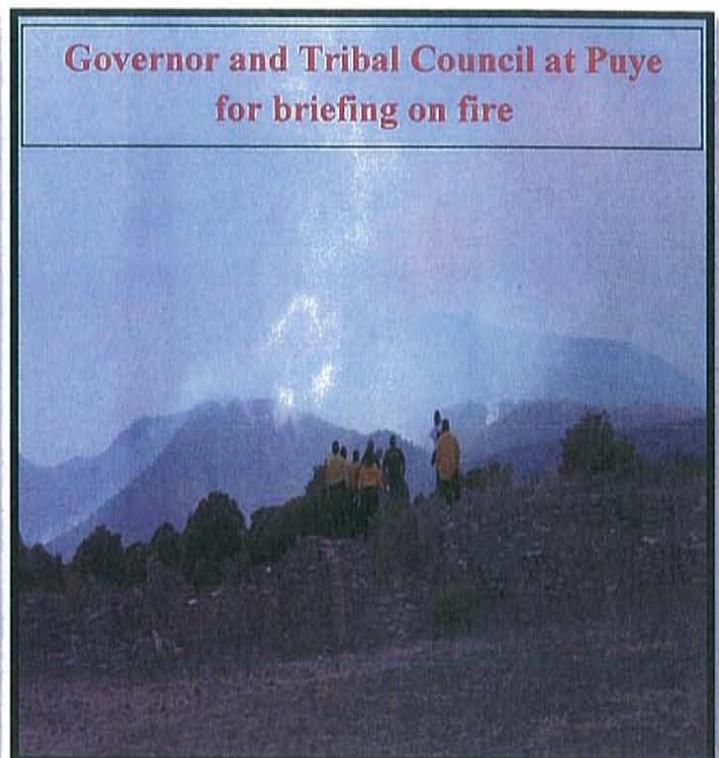
Santa Clara Pueblo has been drastically impacted by the Las Conchas Fire, the largest fire in New Mexico history. Roughly 17,000 acres of Santa Clara Pueblo's Spiritual Sanctuary has been impacted by the Las Conchas fire. Many of the Traditional Cultural Properties (TCPs) – (Live Sites) located within the 17,000 acres have been severely damaged and destroyed. The watershed and headwaters of the Santa Clara Creek have been altered and the quality of water has been degraded and has become impaired. Many of the culturally significant plants and herbs utilized for medicinal purposes have been devastated. The many wildlife species used for Traditional and Cultural purposes such as Mule Deer, Rocky Mountain Elk, Mountain Lions, Black Bears, Badgers, Rainbow Trout, Golden Eagles have been impacted with very little food to consume. The Las Conchas Fire has caused emotional, psychological and mental distress on all of the Santa Clara Pueblo Community members and has drastically altered the Pueblo's Traditional Way of Life.

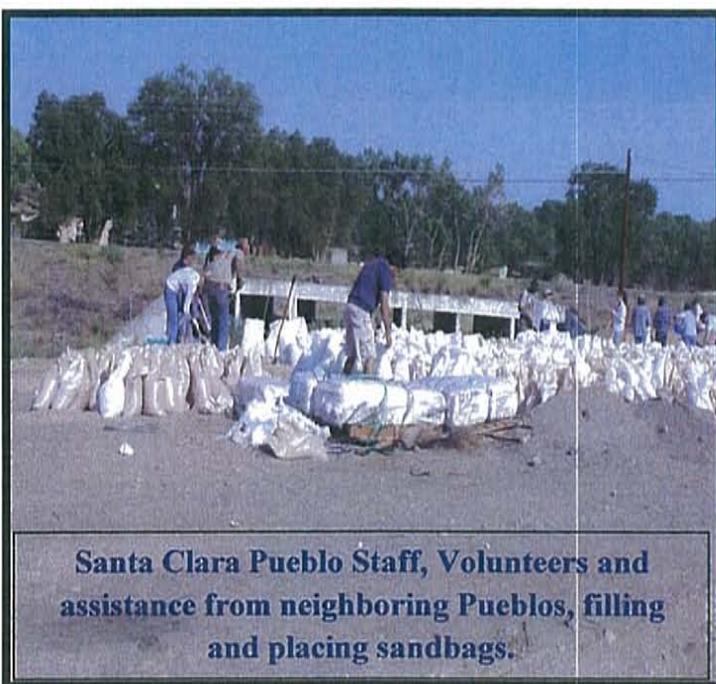
The Las Conchas Fire was one threat the Pueblo had to overcome. Now that the fire was been put out, the most important impacts are the devastating after effects the Pueblo is now facing in the form of flooding. The Las Conchas Fire severely destroyed and has caused the soil to be hydrophobic. The Pueblo has been actively engaged in implementing cost effective safety measures to eliminate immediate threats of significant damage to improved public and Pueblo property. The Pueblo through assistance and recommendations from the Army Corps of Engineers, the Pueblo has installed safety measures such as installing Jersey Barriers and sandbags, to protect the community from the immediate threat to lives, public health and safety for the community from the risk of flooding.

**Santa Clara Pueblo Staff, Volunteers and assistance from neighboring Pueblos, filling and placing sandbags.**

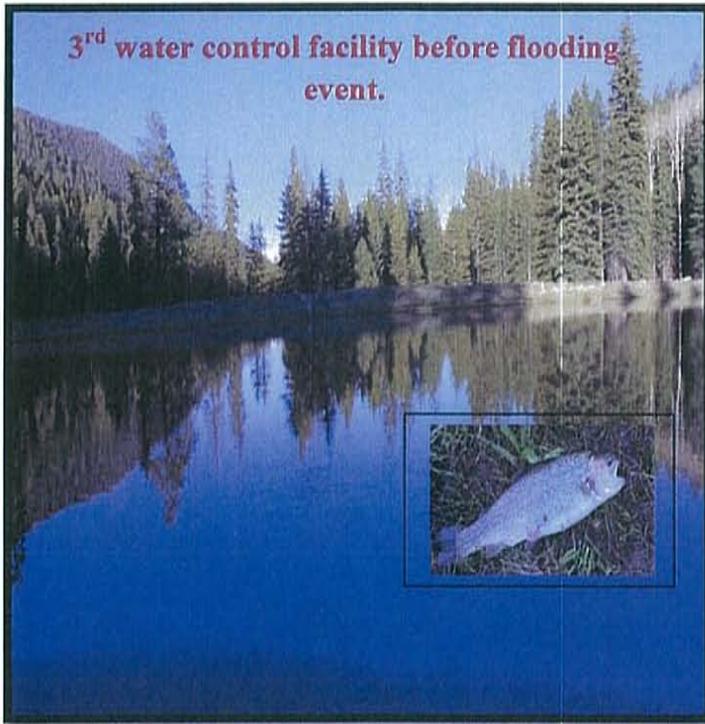
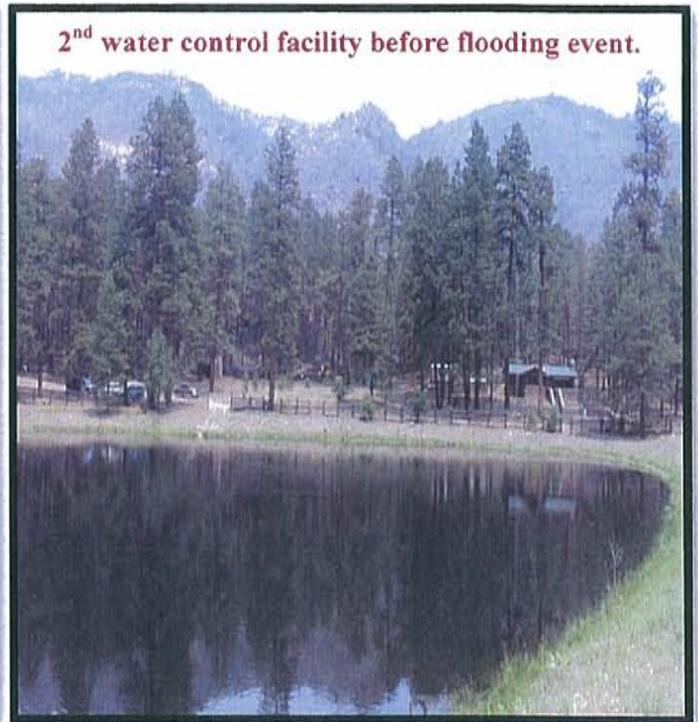
The Four water control facilities along the Santa Clara Canyon pose an immediate threat to lives, public health and safety. The four water control facilities are used for recreation, such as fishing, serve as wildlife habitat, used for water storage for irrigation, and used for actual consumption of water at the point of origin for Traditional and Cultural uses. The Pueblo has approved Water Quality Standards, approved by the EPA in 1995, and the Standards identify the various Designated Uses for each waterbody found on the Reservation which include the four water control facilities.

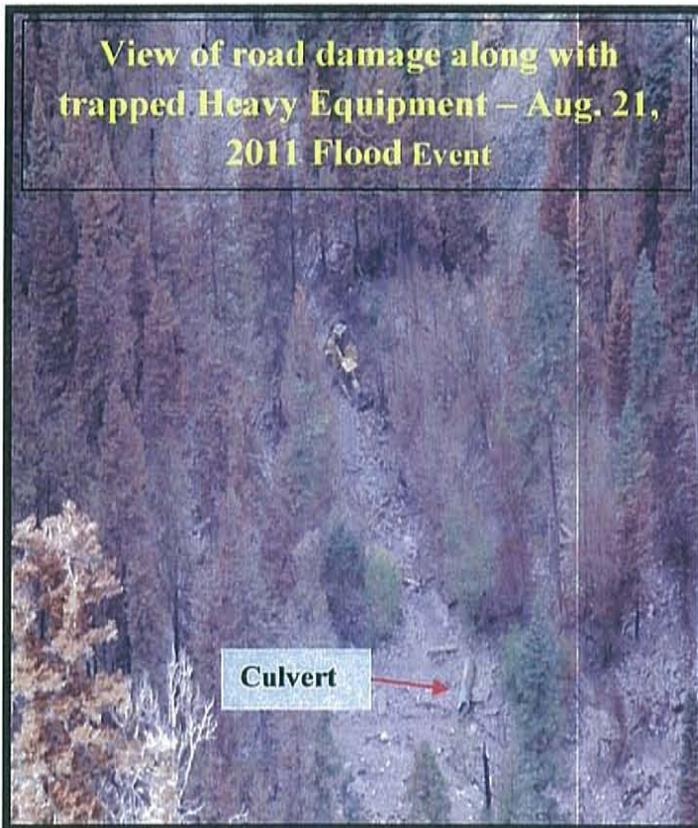
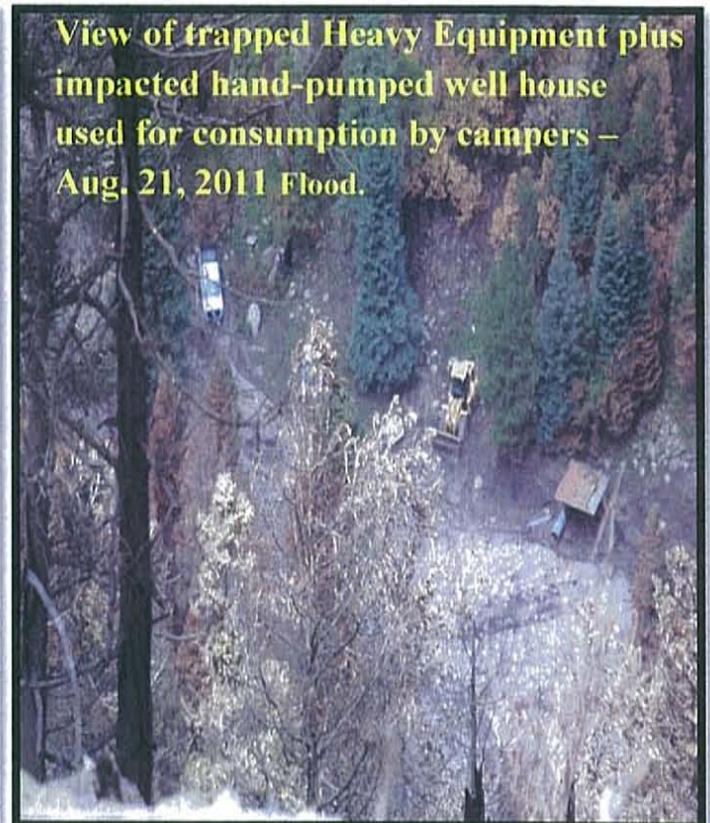
- The Pueblo experienced an estimated 1,700 cfs flood even on August 21, 2011 trapping four of the Heavy Equipment personnel in about 6 to 8 feet of water. The individuals were performing routine maintenance operations to the existing road when they were caught by the flood event.

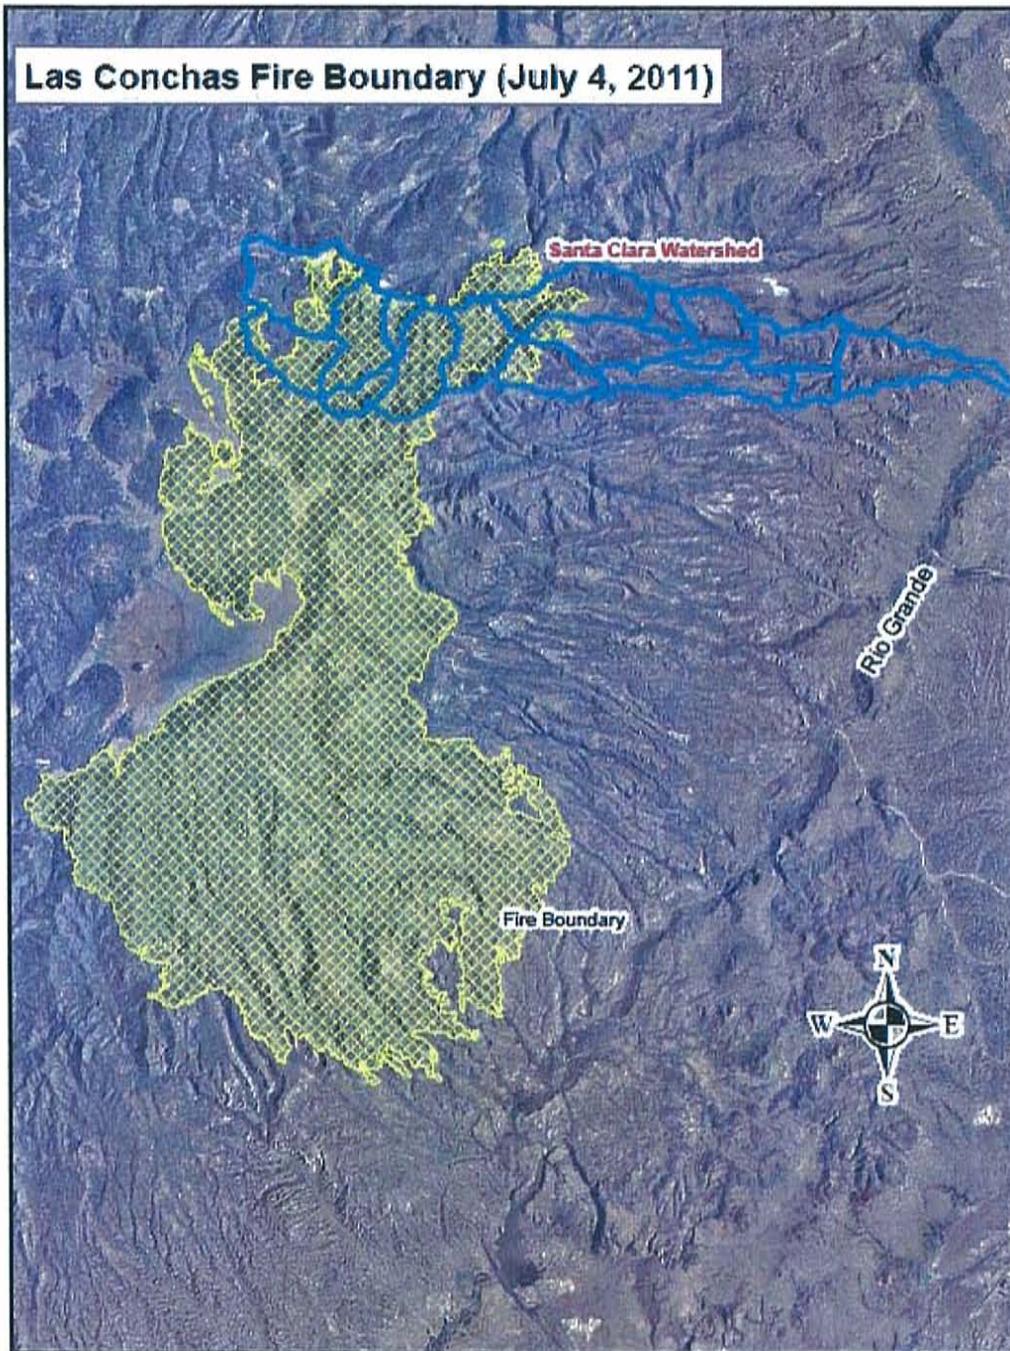
Figure 2: Fire boundary and Santa Clara Creek.

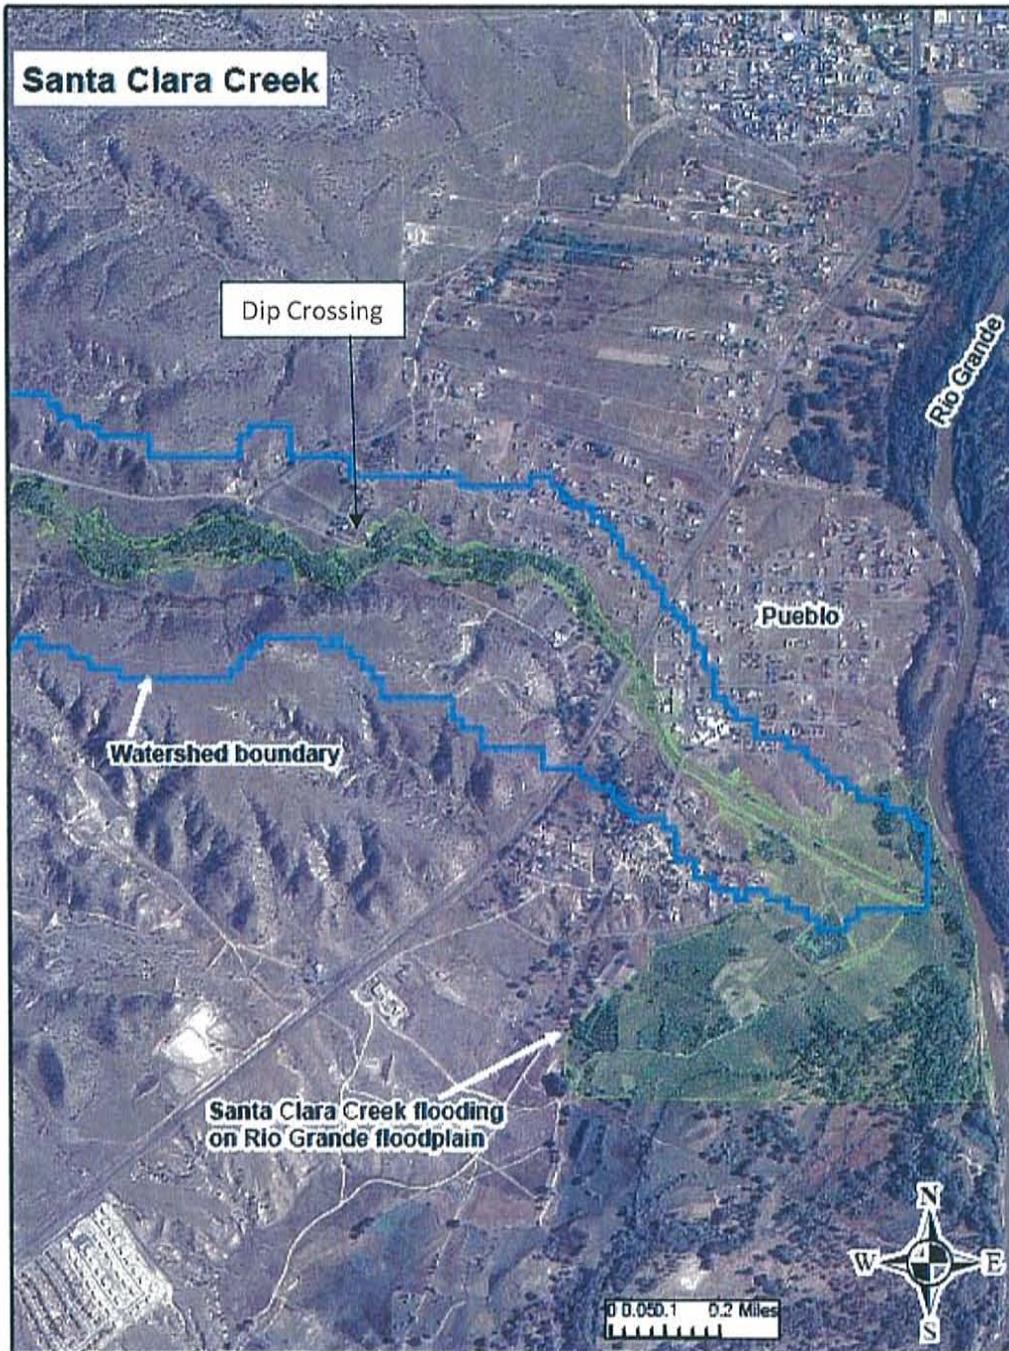
Figure 4: 100 year floodplains under non-fire scenario (~5,000 cfs).
