COUNTY OF LUNA ROAD CONDITIONS

TRANSPORTATION INFRASTRUCTURE REVENUE SUBCOMMITTEE

July 15, 2016

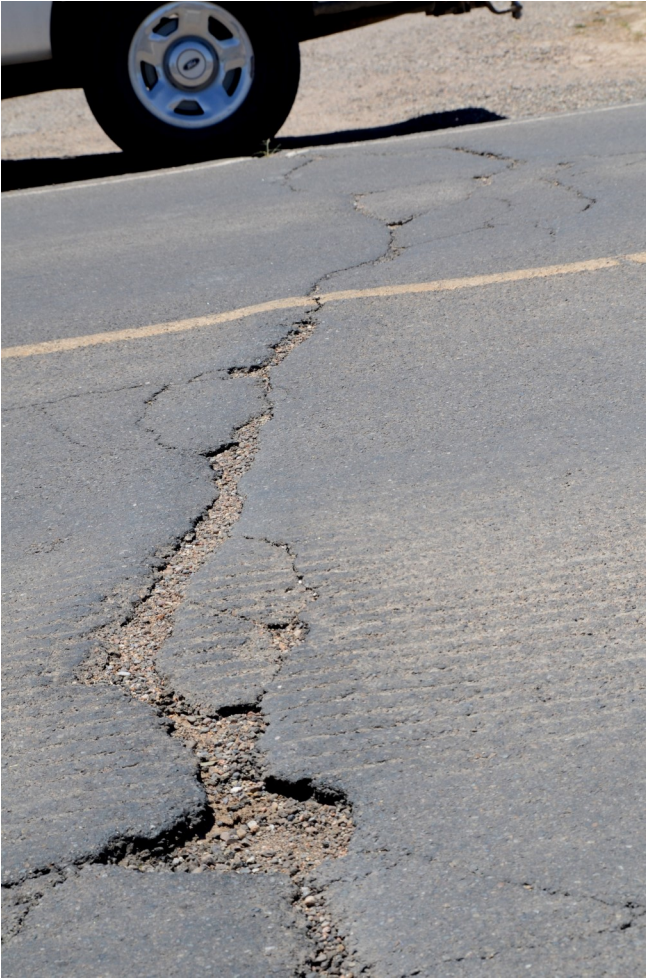
DETERIORATION OF ROADS

- Luna County maintains 1,886.3 miles of road, 210.5 of which are paved
- Of the paved roads, 18.5 miles see heavy agricultural traffic, and another 18.6 miles see heavy traffic from the Border Patrol, state park visitors and trucks hauling trash to the landfill, which is about 17 miles outside of Deming due to state mandates

- About 89 miles of county roads are former state roads with narrow lanes that still see heavy agricultural traffic
- Most county maintained roads are rated for 60,000 pounds, but much of the heavy truck traffic exceeds 80,000 pounds and sometimes over 100,000 pounds

- New county road construction aims for 80,000 pound rating
- Agriculture production leads to many overloaded trucks, but the increased weight limits along the border with Mexico and the 24/7 hours of the Columbus Port of Entry also ensures steady commercial traffic, oftentimes with trucks loaded above the capacity of county roads

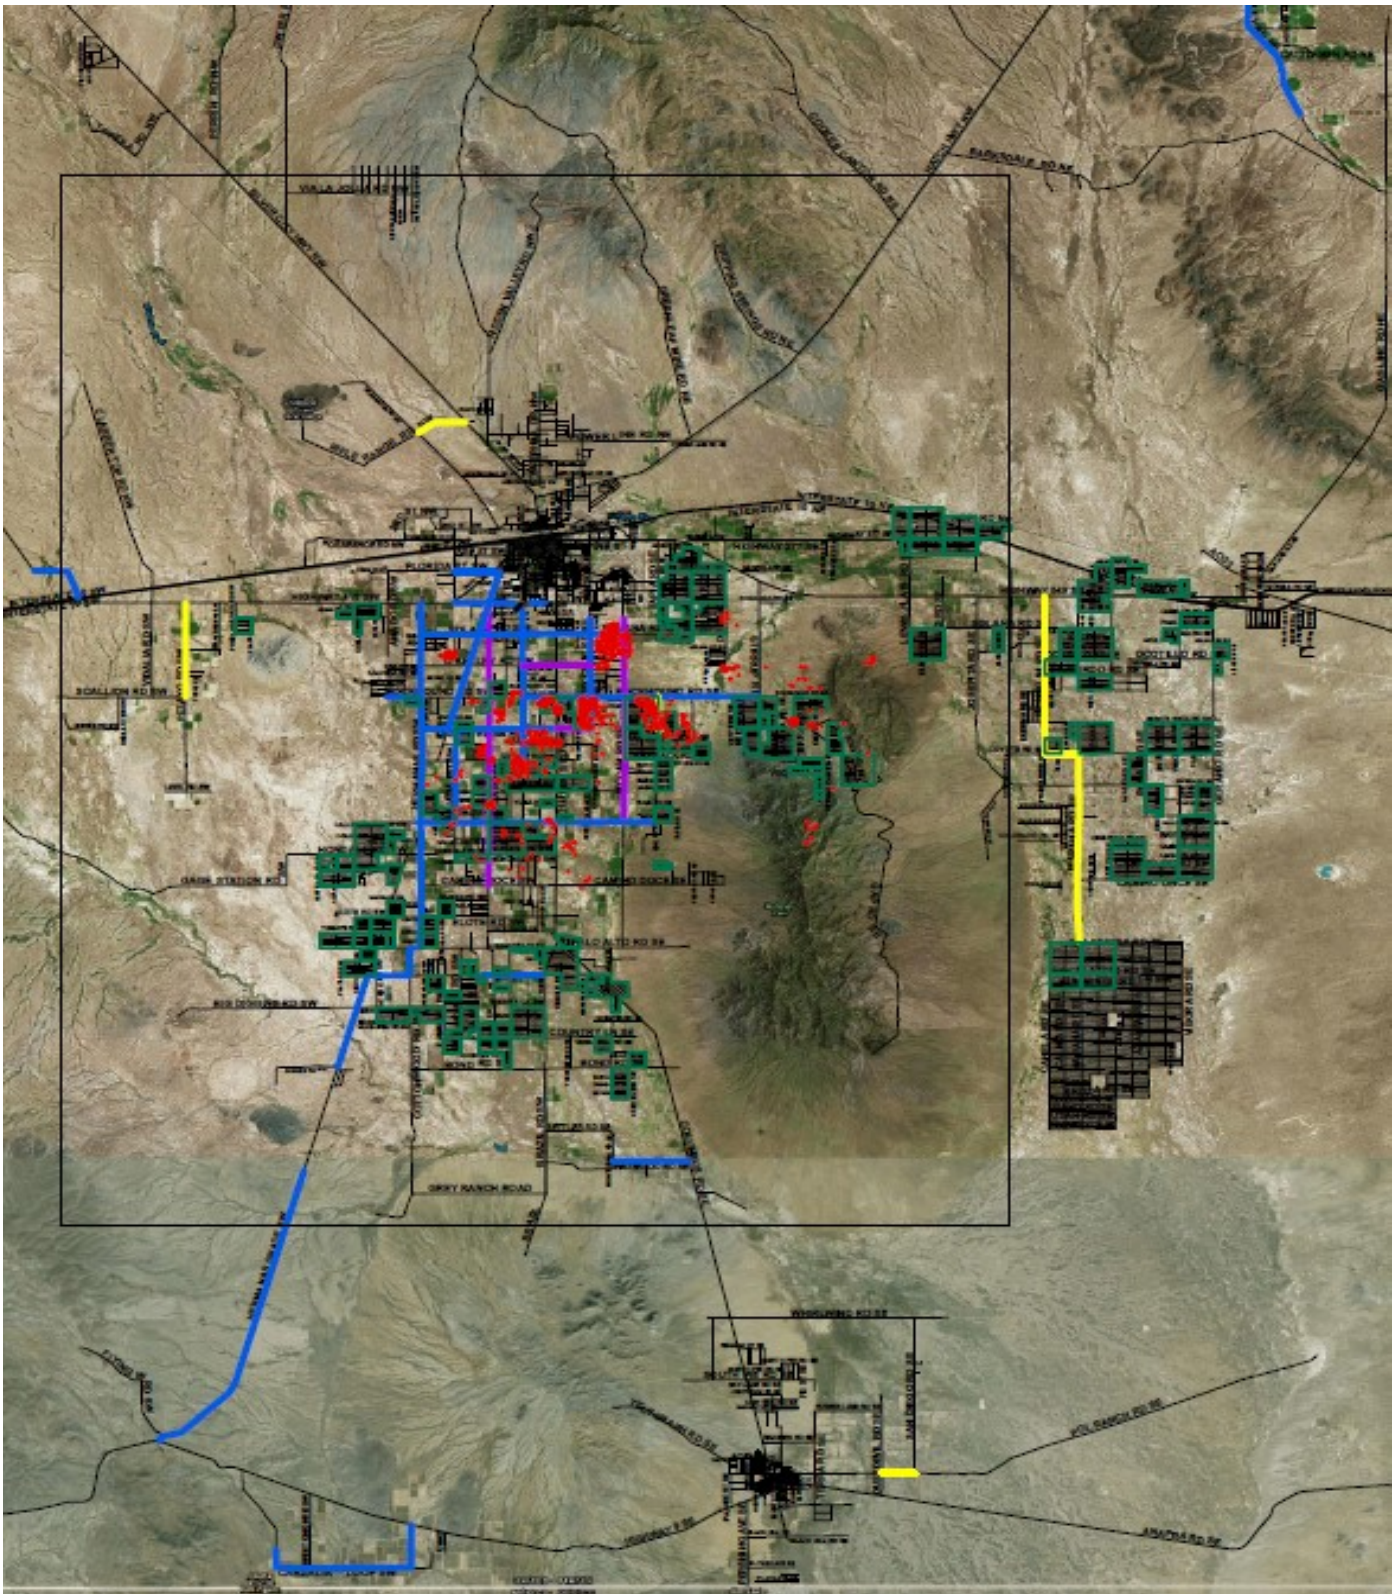
SCALE OF THE PROBLEM

Blue — 89.5 miles — Old, narrow state road with heavy agricultural use

Yellow — 18.7 miles — Heavy Border Patrol use, state park use, and agricultural use
