# Animas River Mine Water Spill

## Briefing Report

For the Water and Natural Resources Committee  
August 31, 2015

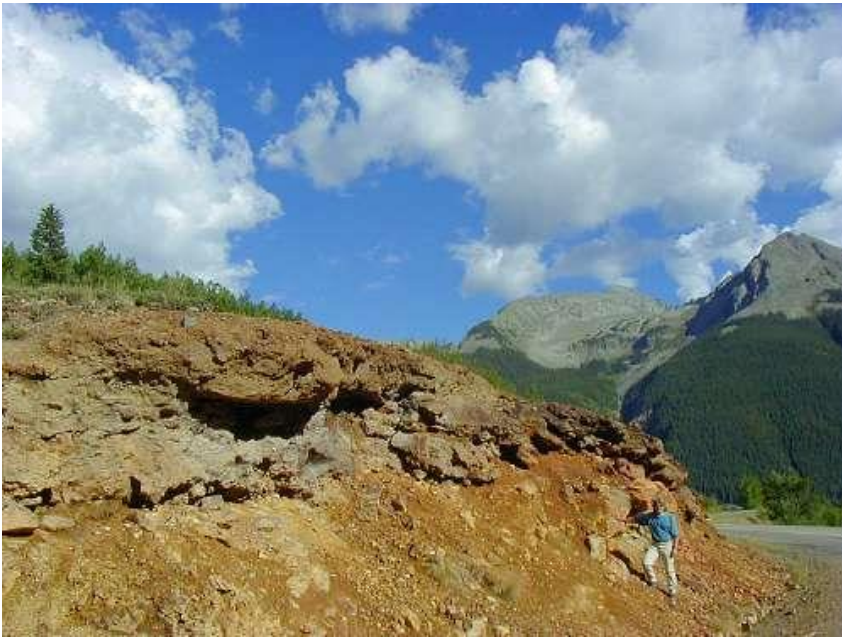
**Ferricrete**

Iron and other metals in ARD can precipitate and cement near-surface sediments into ferricrete. Geologic deposits of ferricrete in Cement Creek demonstrate that ARD has been occurring in this mineralized area long before mining began in the late 19<sup>th</sup> century.

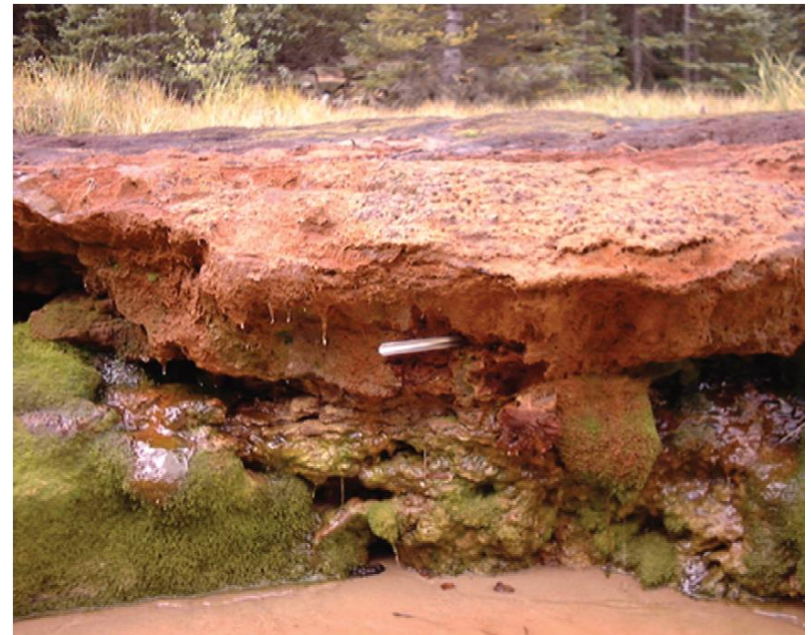
**Bog Iron**

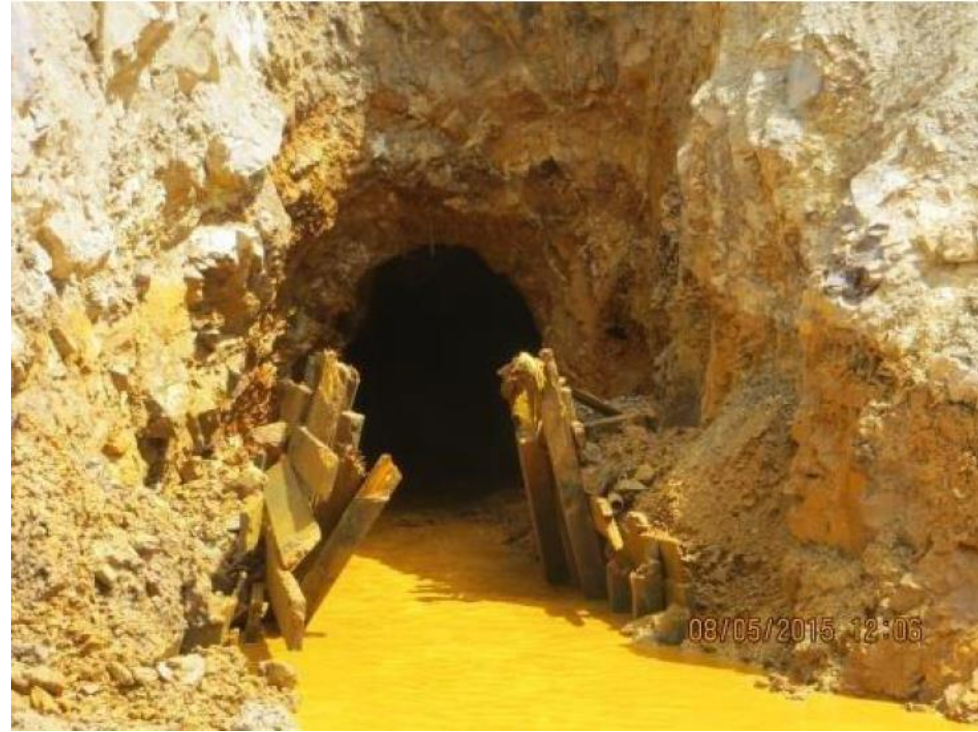
- Bulkheads installed to plug up ARD caused the impoundment of mine water in abandoned workings, and a 1,000 foot rise in the water table.
- Gold King Mine Adit #7 (mine tunnel entry) had collapsed and impounded water inside the mine.
- An EPA work crew digging into Gold King Adit #7 triggered the blowout and spill.

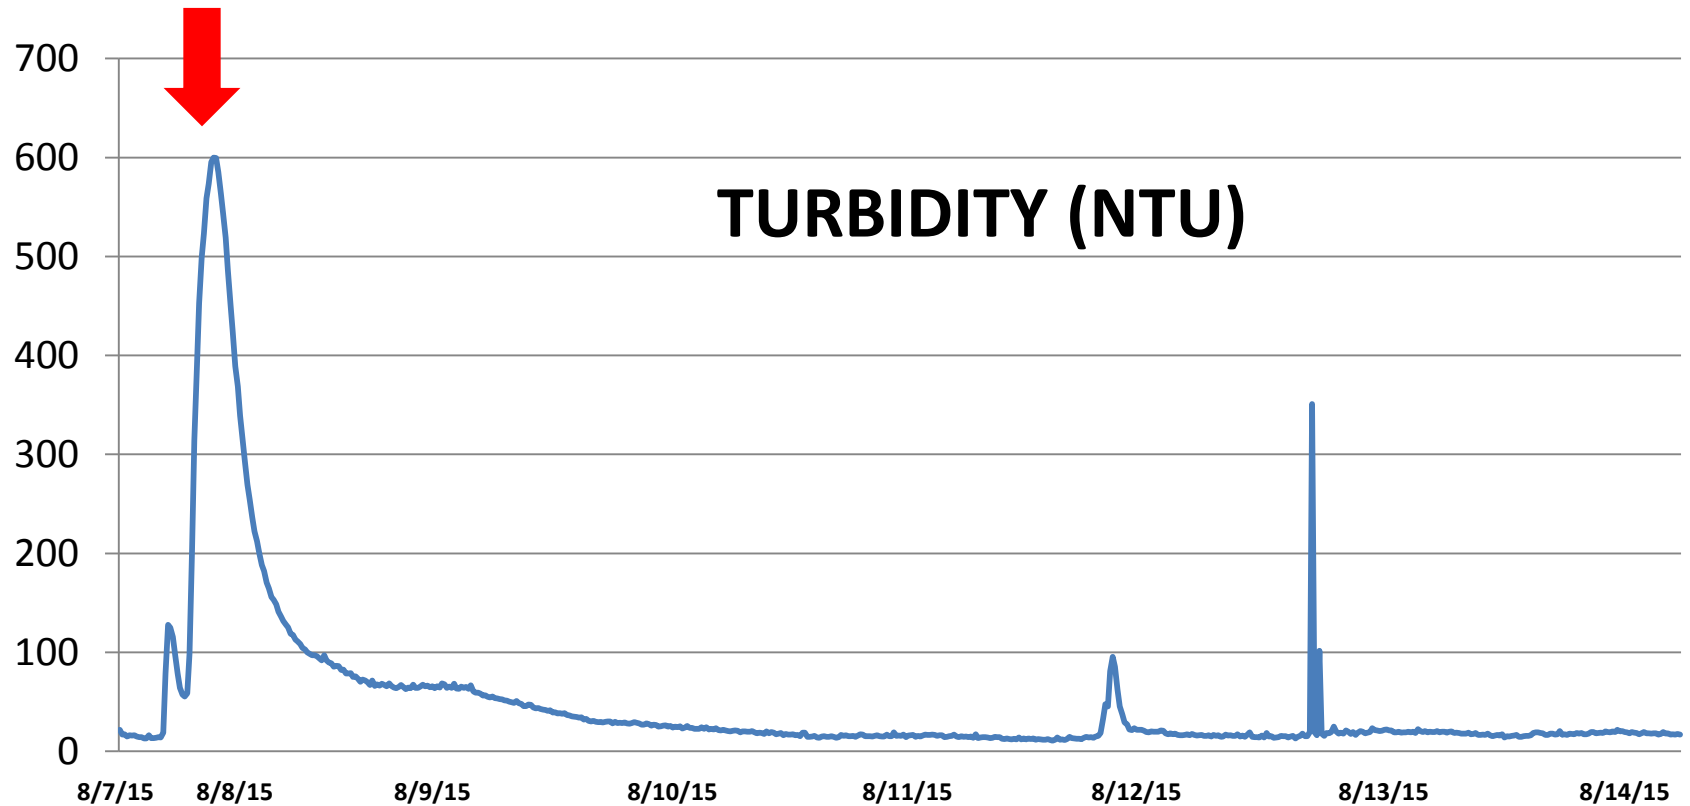
# Animas River near Aztec, NM (above Estes Arroyo)

**Plume Arrives in NM**

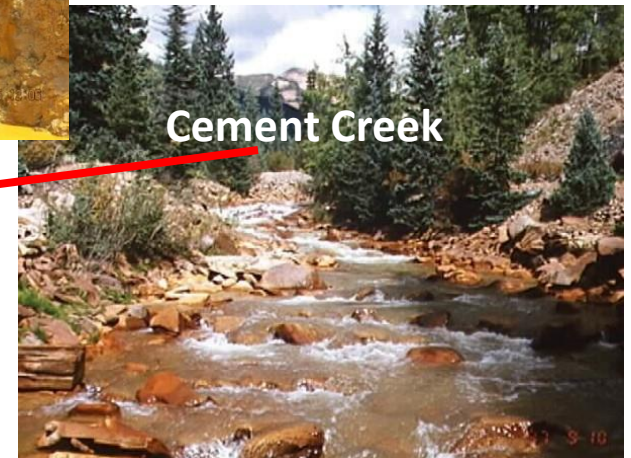
# Conceptual Model of the Gold King Mine and Release of Metals to Cement Creek and the Animas River, Colorado

- Ⓐ During mining, pyrite is exposed to oxygen.
- Ⓑ Ground water seeps into the mine.
- Ⓒ Oxygen, water and pyrite react to form sulfuric acid and in turn dissolve metals from the rocks.
- Ⓓ Water drains out of the mine.
- Ⓔ Dissolved metals react with oxygen and fall out of solution into the stream water, turning a bright color.
- Ⓕ Aquatic animals and plants are killed by the drainage.

← Mine adit (entrance)

← Confluence of Cement Creek and Animas River

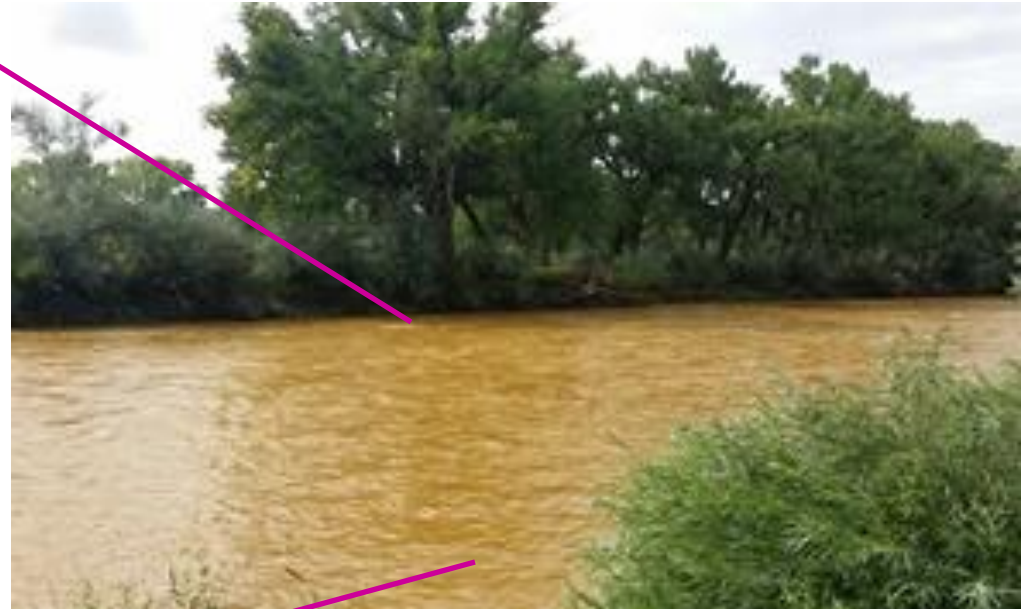
# Conceptual Model of Contaminants Released from the Gold King Mine and Their Transport Along the Animas River in Colorado and New Mexico

Suspended particles of clay- and silt-sized solids

Iron solids (iron hydroxide) containing arsenic, lead, zinc and other metals coat clay- and silt-sized particles

**The very high abundance of suspended particles containing iron hydroxide give the Animas River a brown color.**

**Contaminants also dissolve in surface water at lower concentrations compared to suspended particles.**
