# RED FEATHER DEVELOPMENT GROUP

# New Mexico Energy\$mart Program – Improving Homes, Empowering Communities

NM Energy\$mart Weatherization Program: Overcoming Challenges on the Navajo Nation

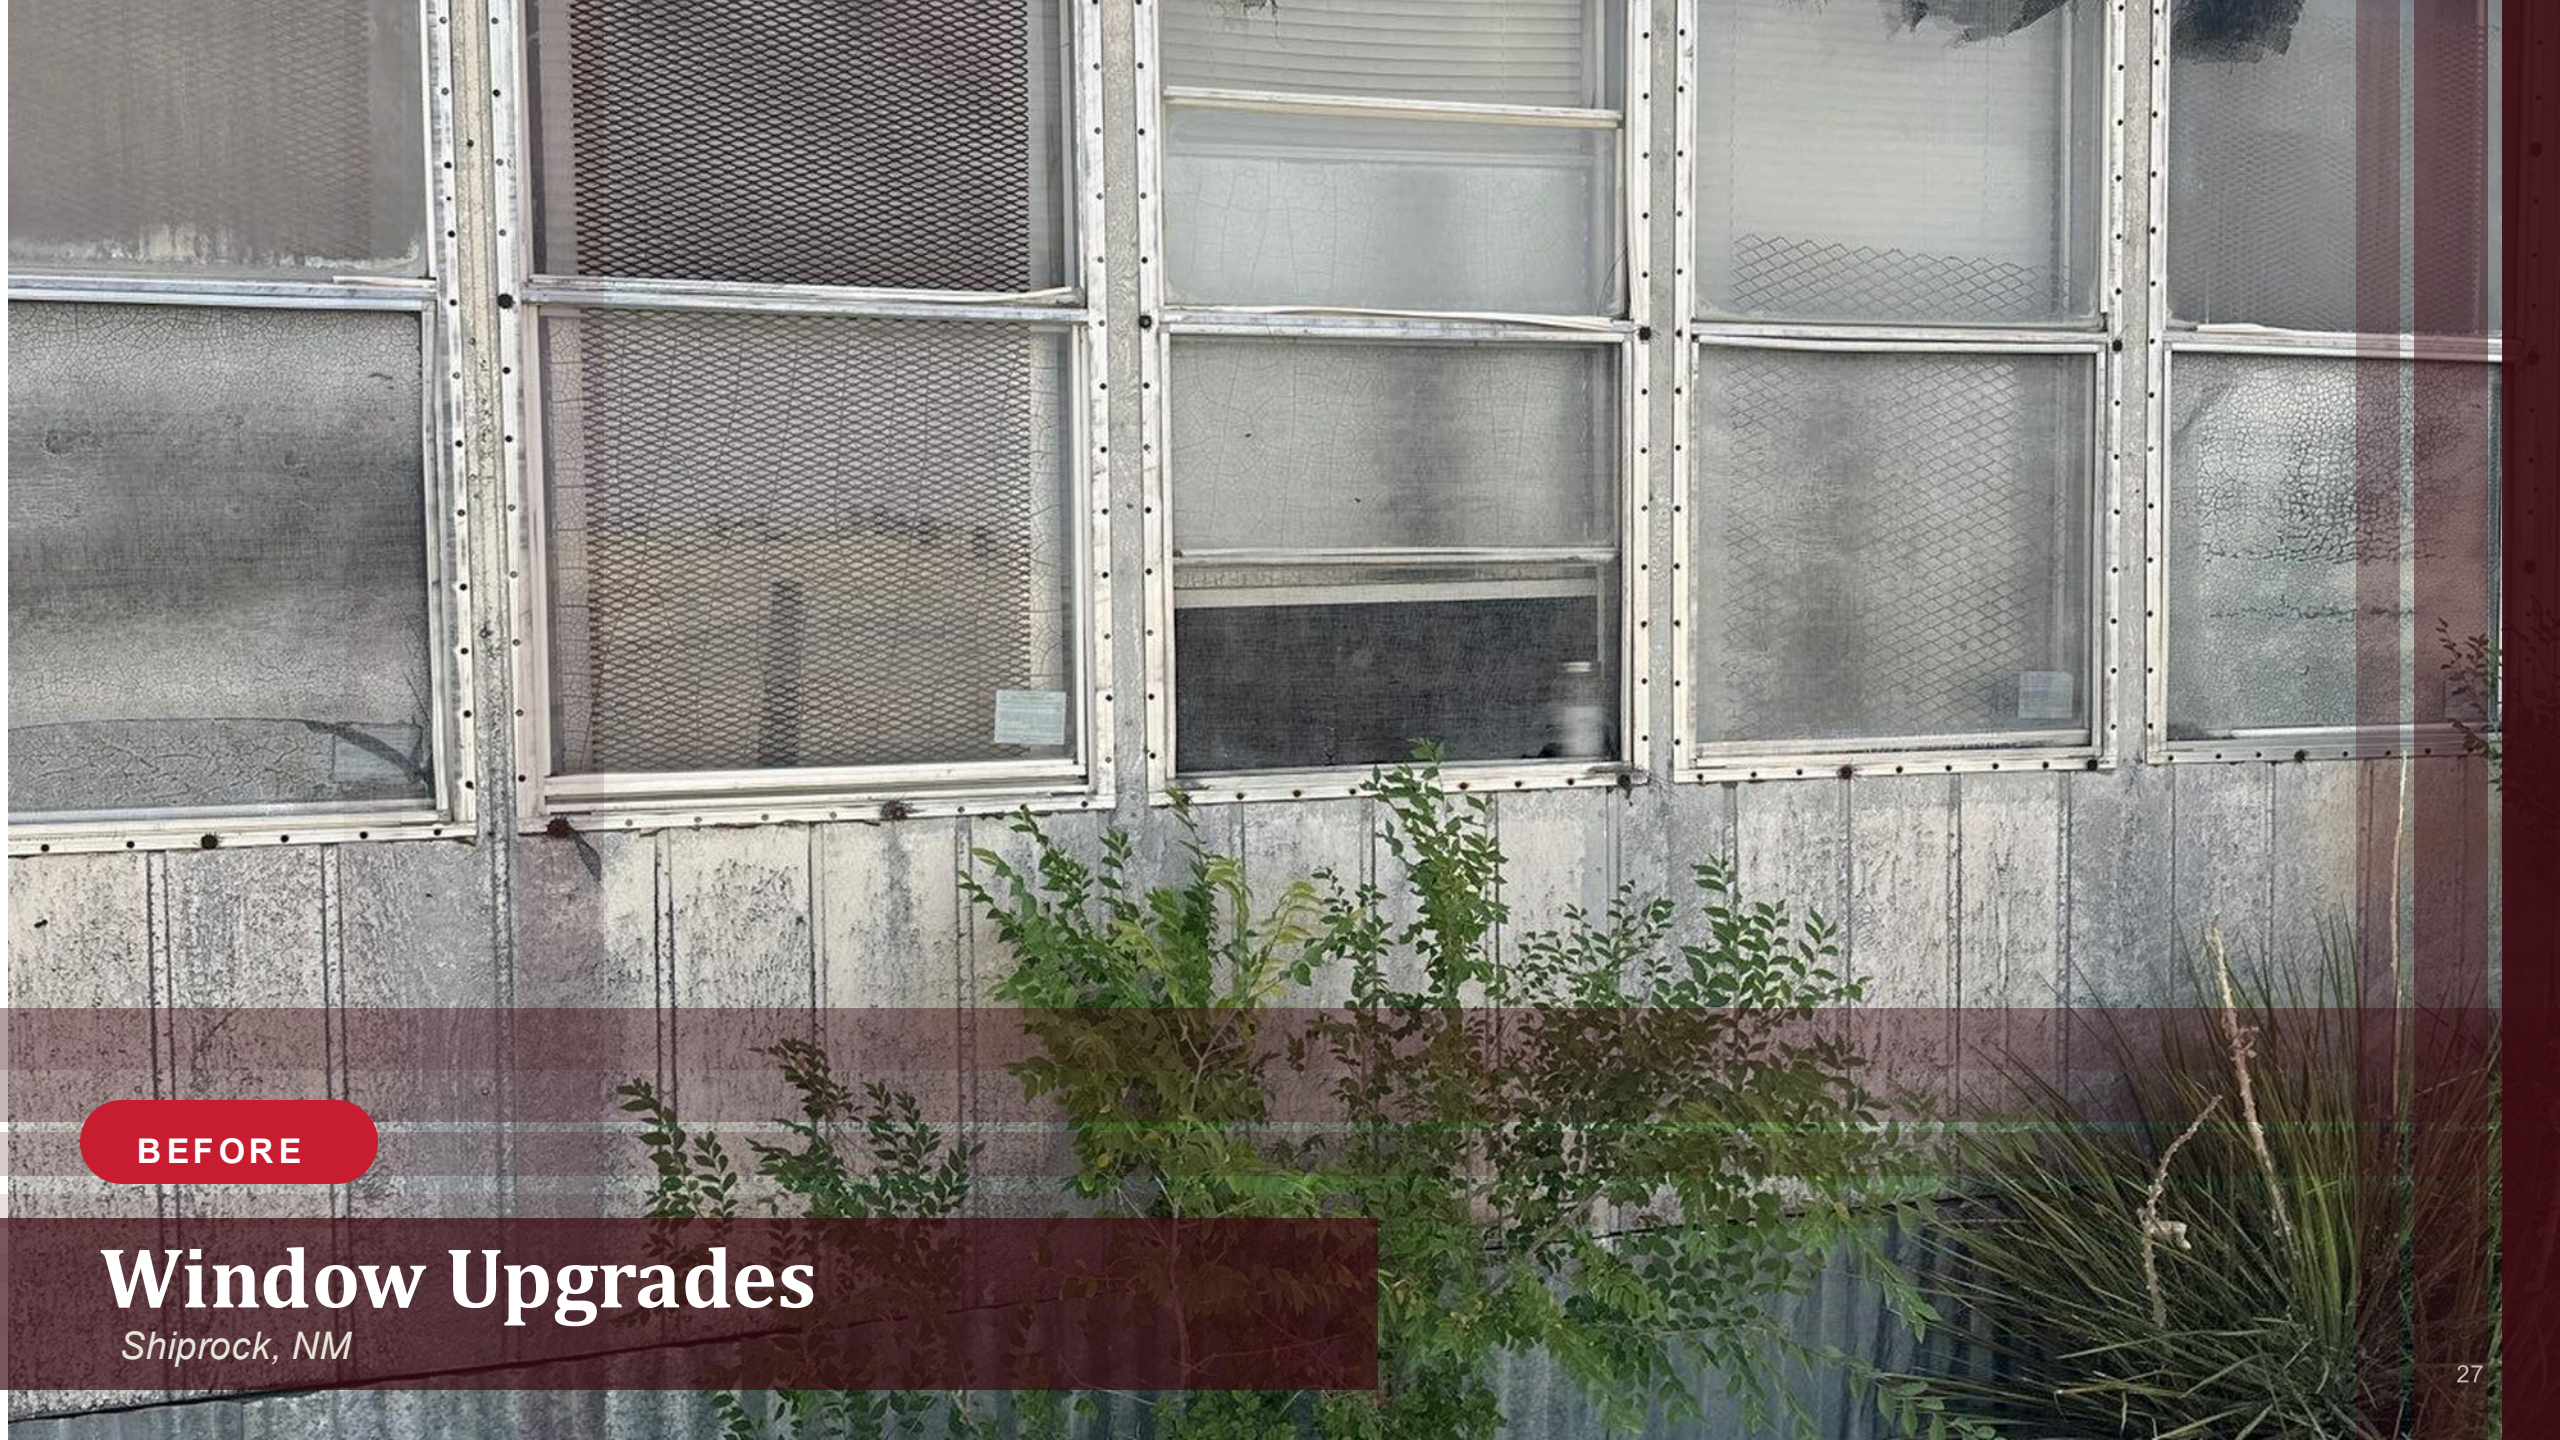
BEFORE

# Window Upgrades

*Shiprock, NM*

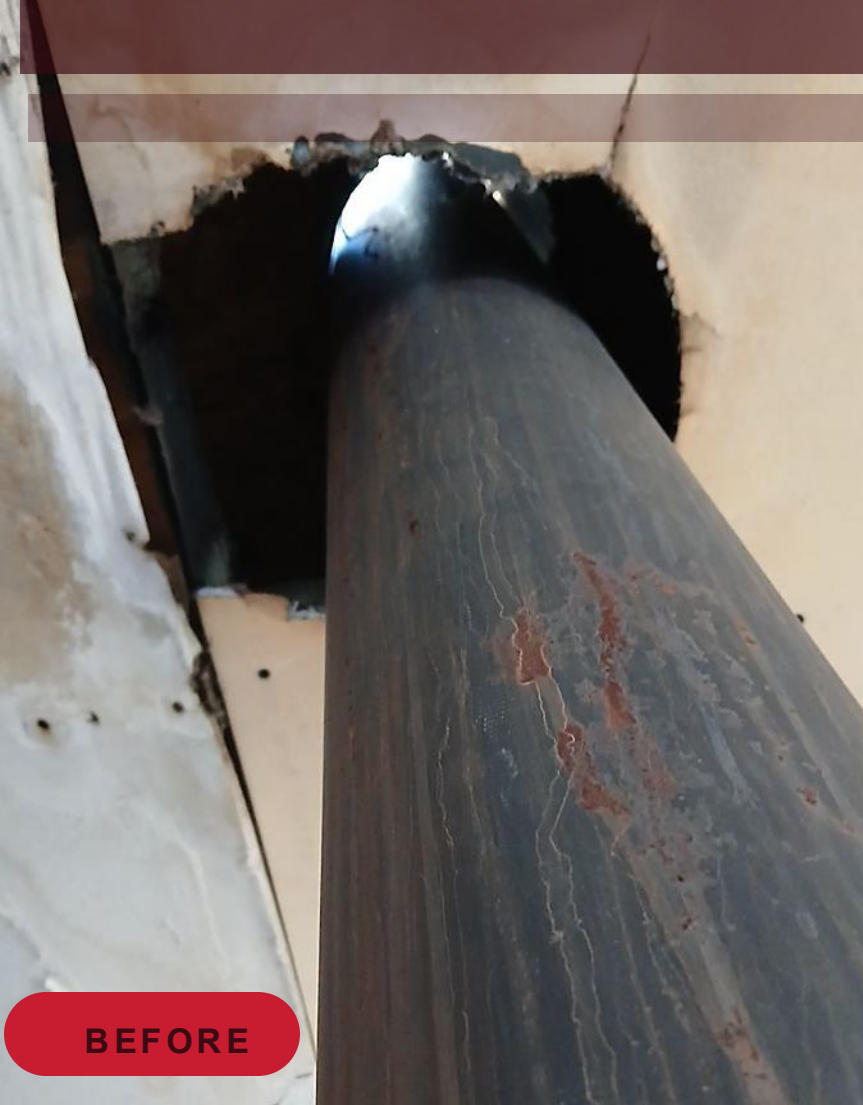
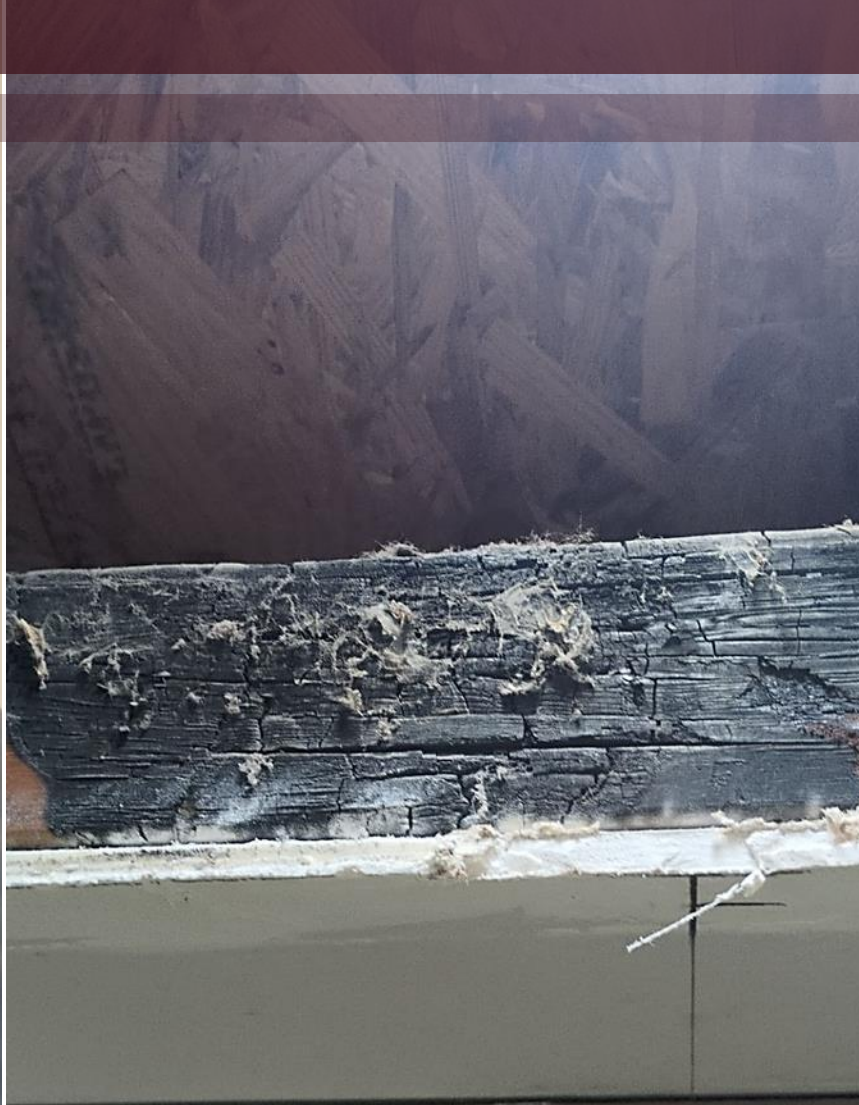
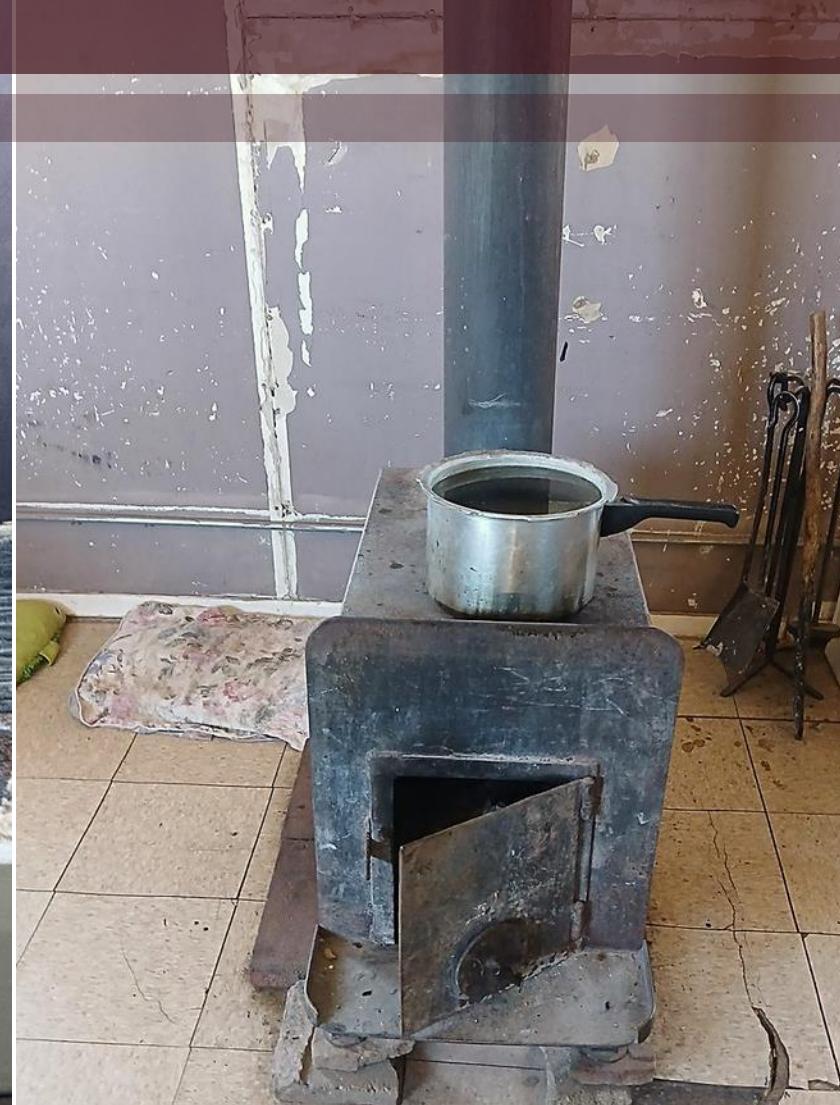
BEFORE

Existing wood stove is non-EPA-rated, lacks a door gasket/seal, and is served by an inadequate single-wall flue system.

## Installation of EPA-Approved Wood-Burning Stoves & Preventing Fire Risks

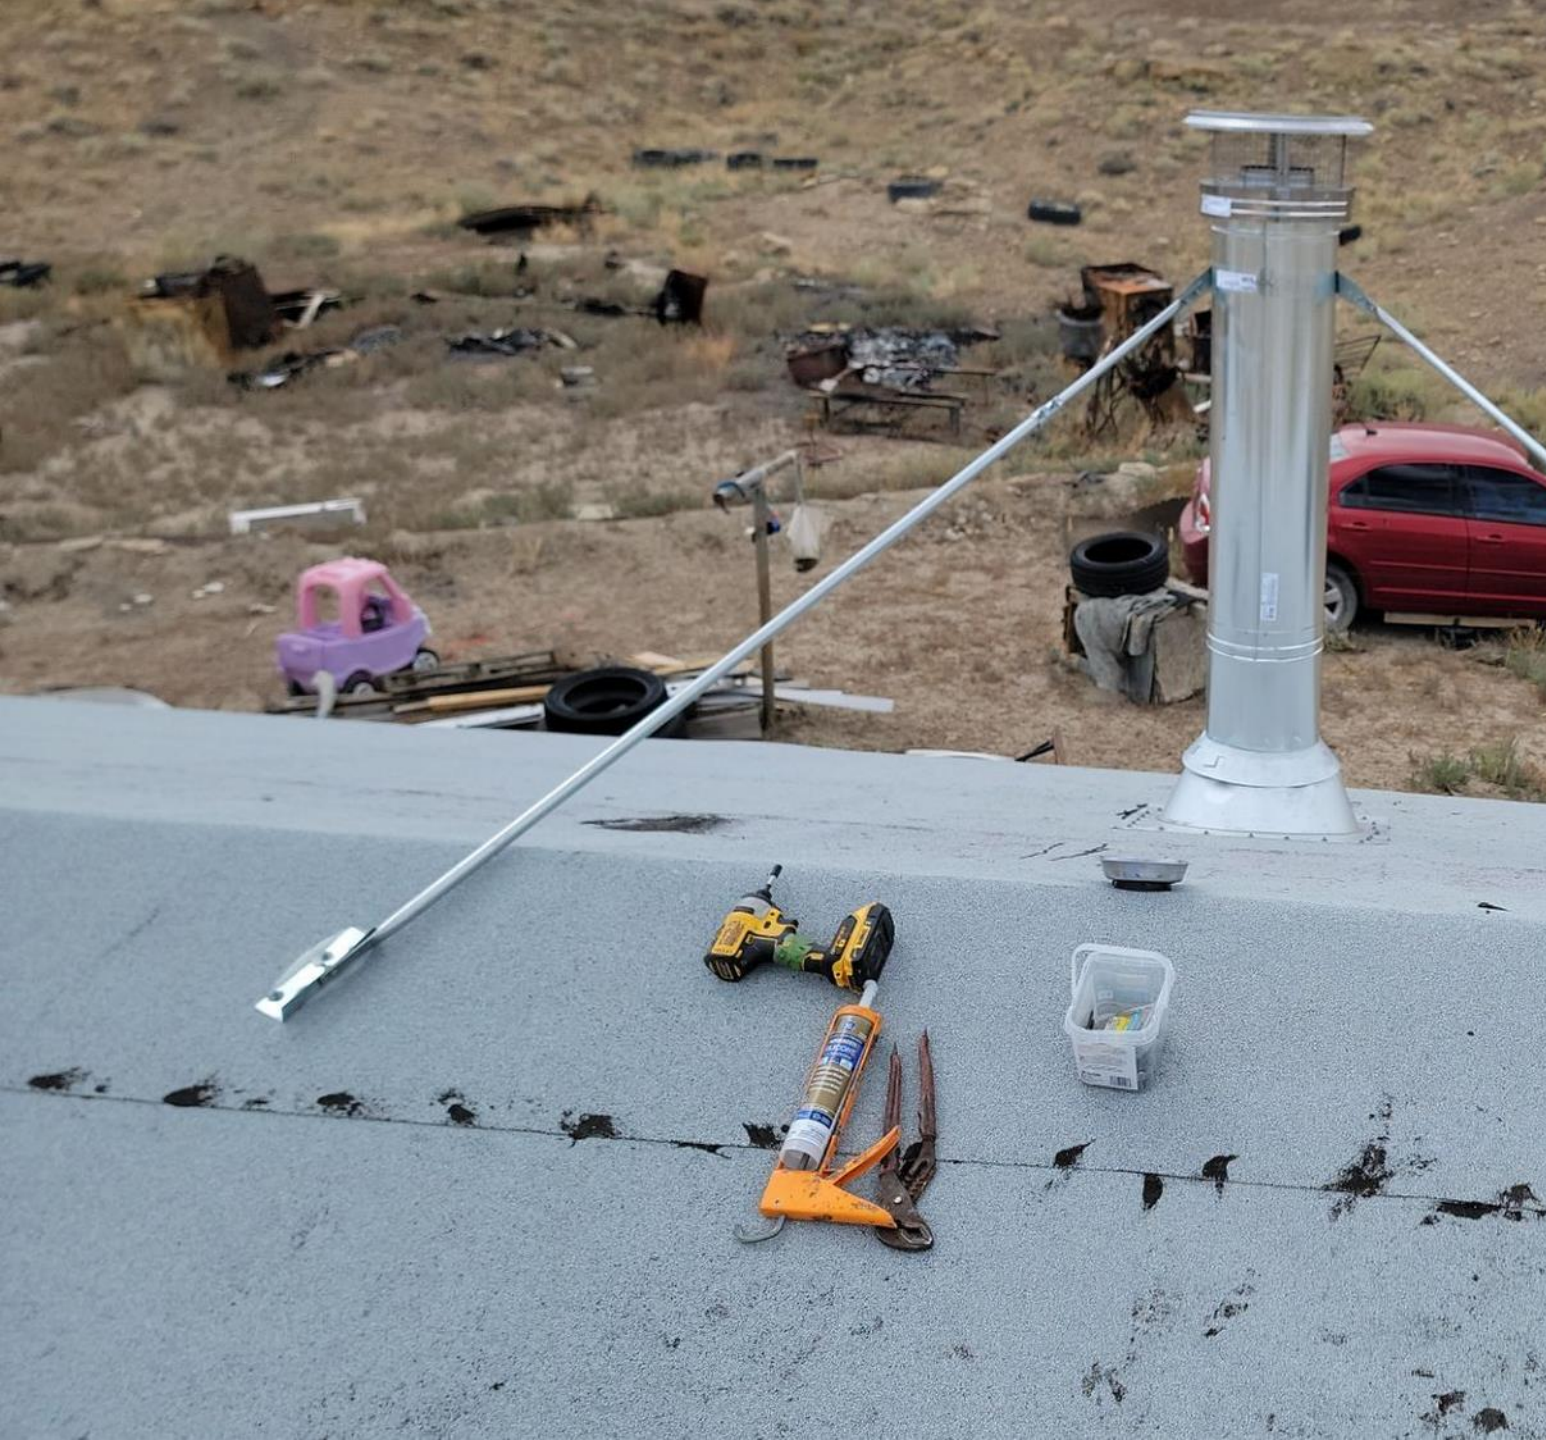
After — Torreon, NM

Now, with a certified wood stove installed properly, it's safer and burns slower.

### After (EPA-Approved Stove Installed)

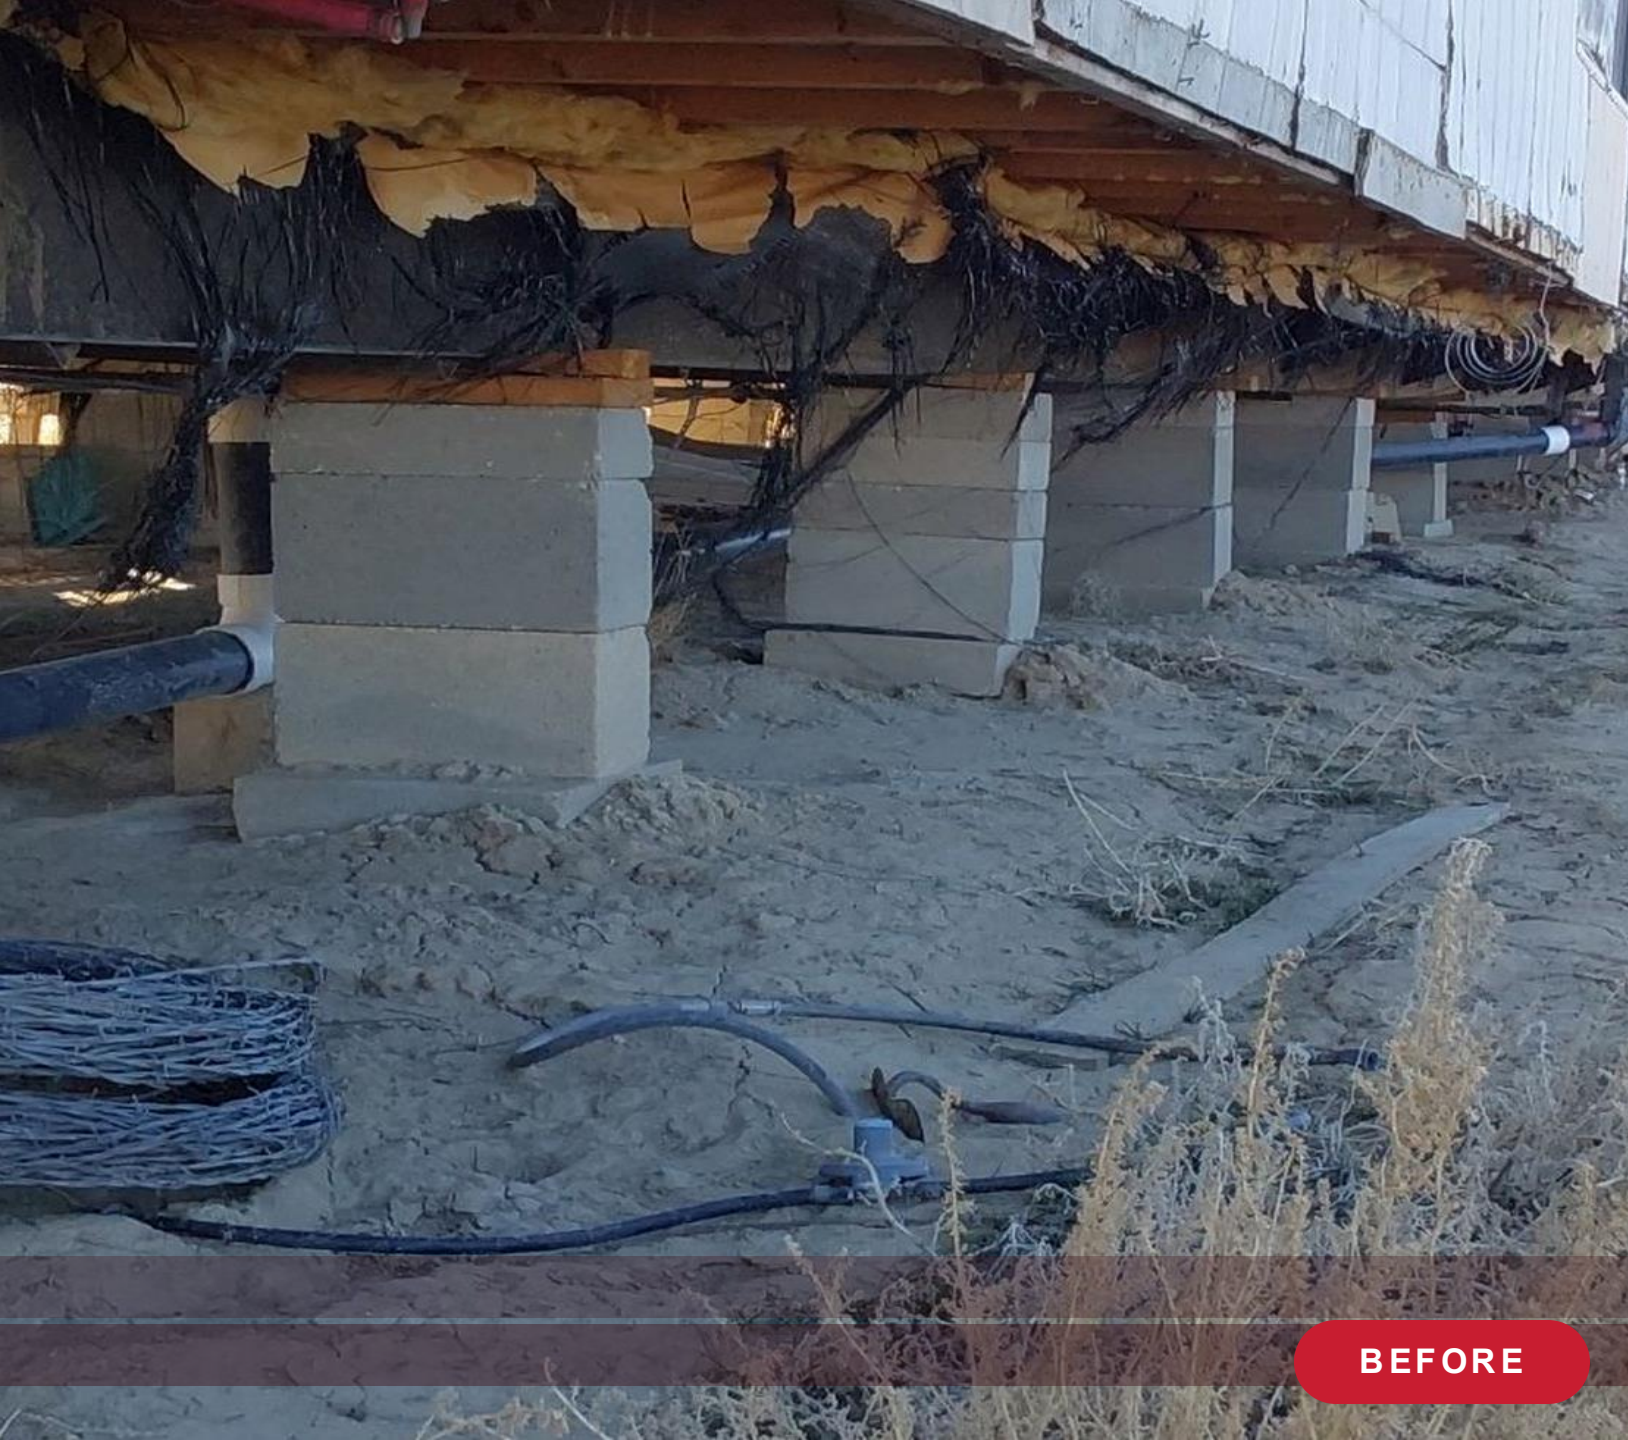
## BELLY REPAIR

# Belly Repair and Insulation

- *Shiprock, NM*
- Repair approximately 80% torn belly fabric
- Air-seal and insulate exposed pipes
- Restore underside insulation protection
- Install new vinyl skirting around the home

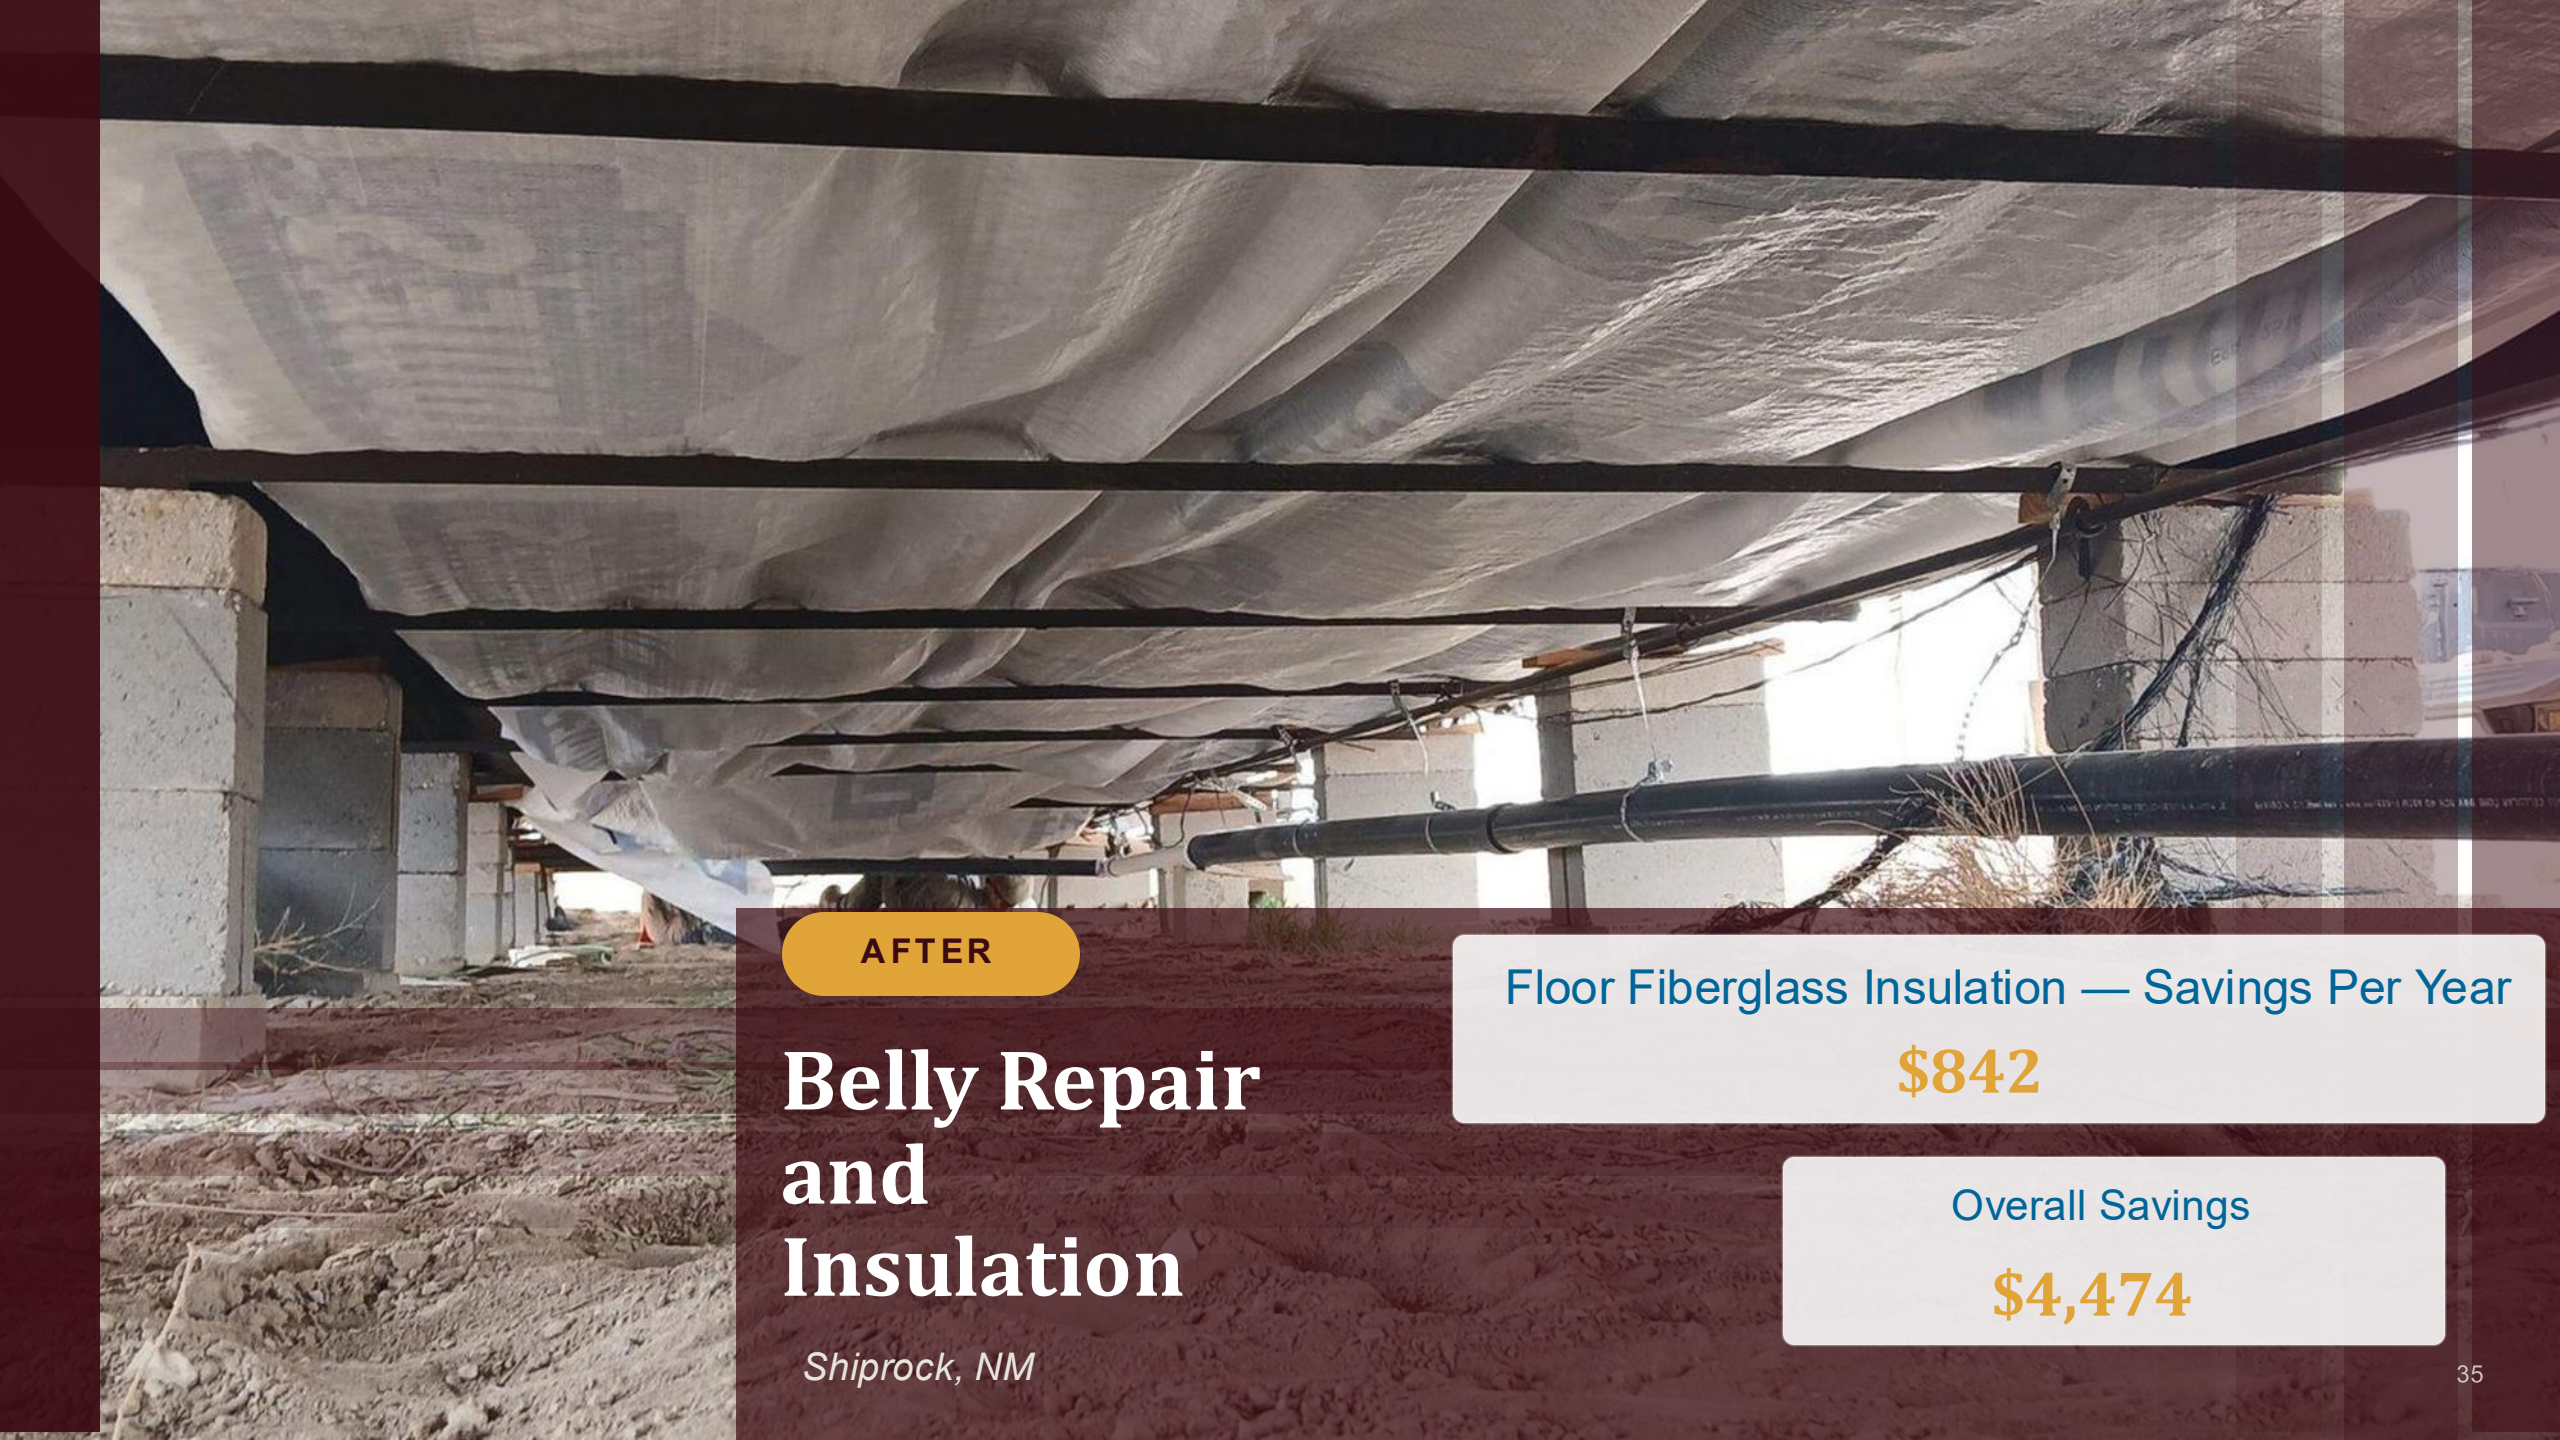
BEFORE

The image shows the underside of a building. Several horizontal concrete pillars support the structure. A network of black pipes runs across the space. Large, white, crinkled fiberglass insulation is draped over the pipes and the underside of the floor. The ground below is dirt and gravel.

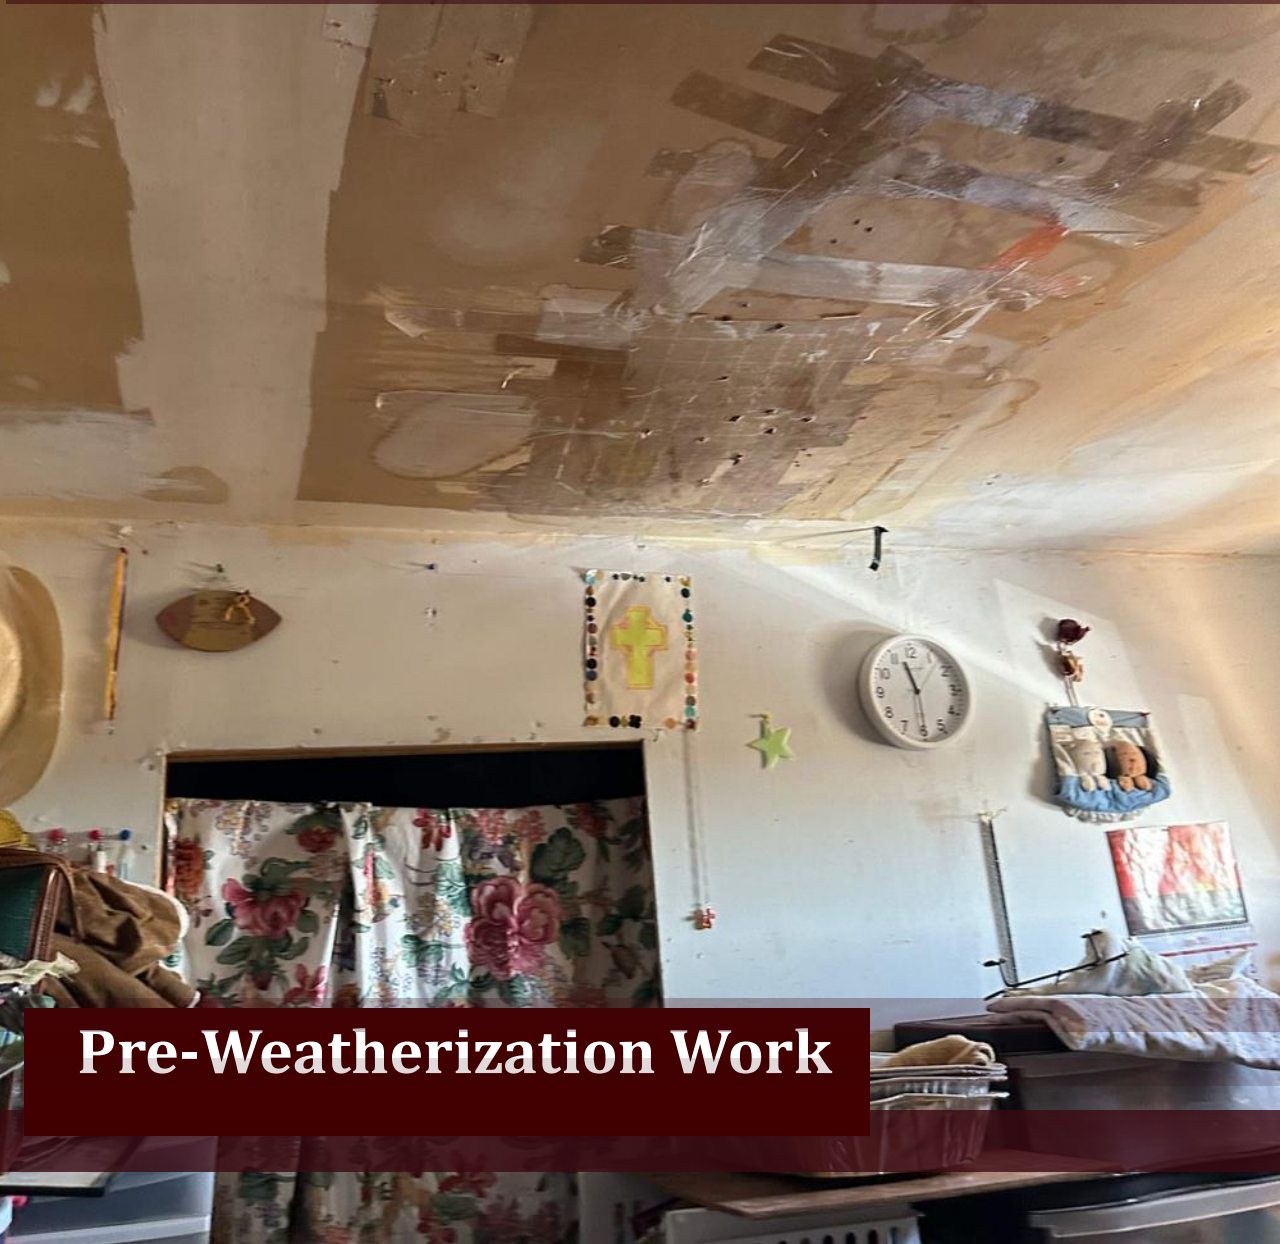
BEFORE

Pre-Weatherization Work

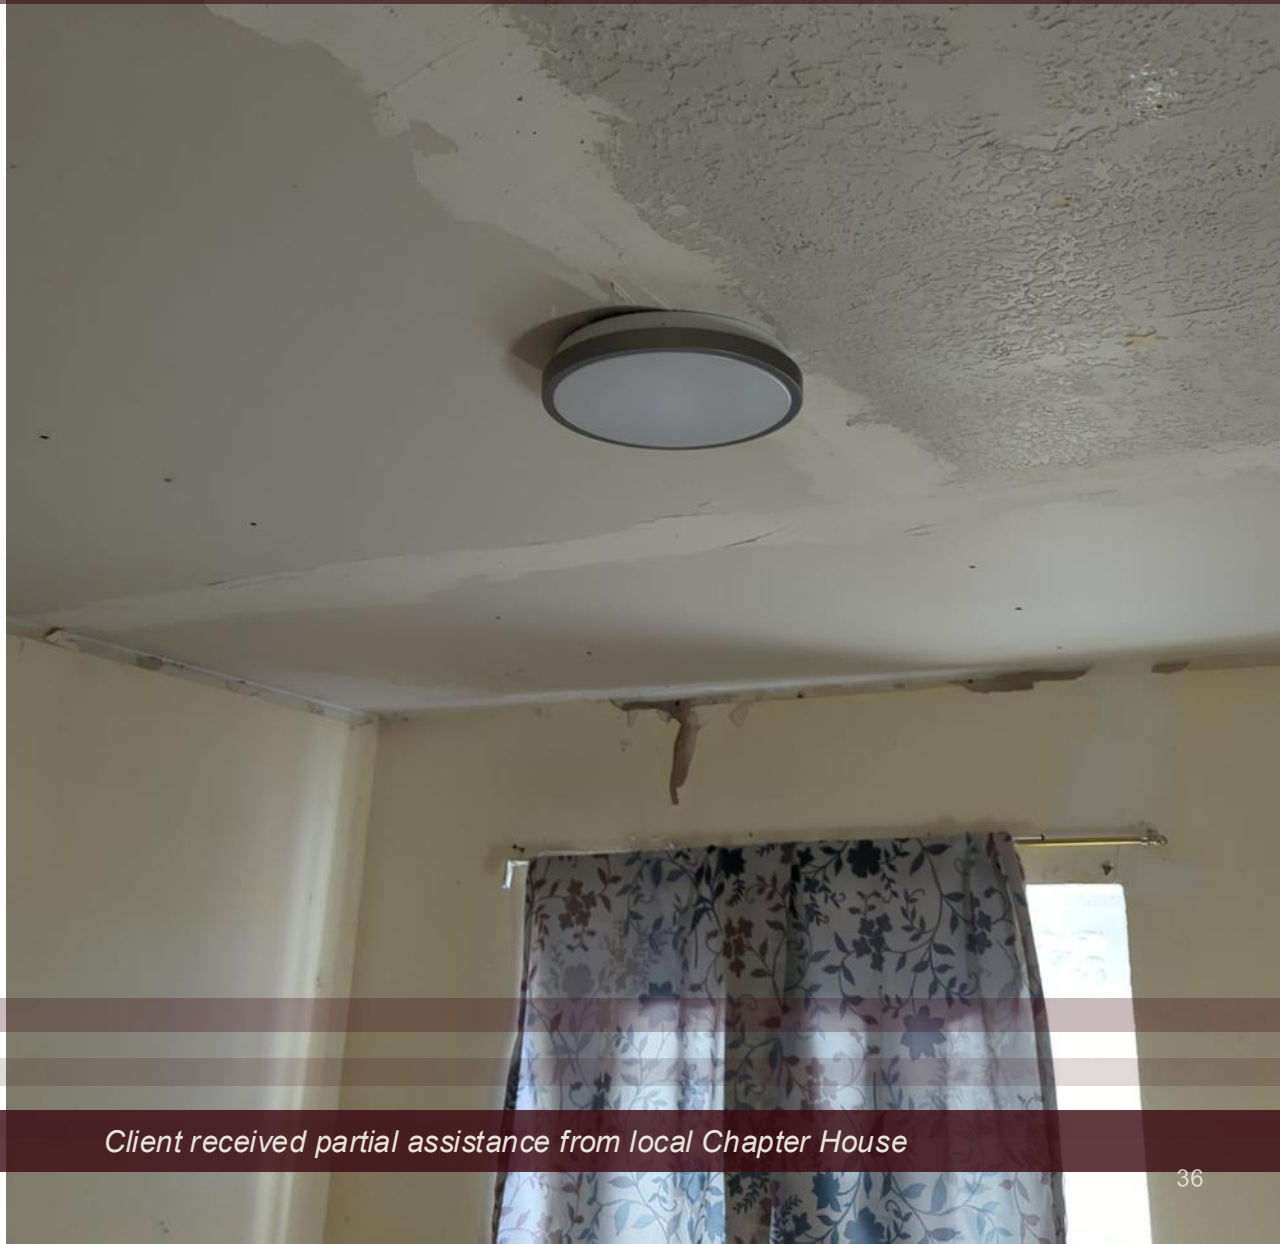
AFTER

*Client received partial assistance from local Chapter House*
